April 14, 2026

Project No. US0039040.3990

**Re: MONTHLY STATUS UPDATE – ENGLEWOOD INTERMODAL YARD – REVISED INTERIM MEASURES  
WORK PLAN POST-CONSTRUCTION AND NAPL COLLECTION SYSTEM/CONCRETE CAP REPAIR  
INSPECTIONS  
UNION PACIFIC RAILROAD HOUSTON WOOD PRESERVING WORKS FACILITY  
4910 LIBERTY ROAD FACILITY, HOUSTON, TEXAS  
POST-CLOSURE CARE PERMIT NO. HW-50343; INDUSTRIAL SWR NO. 31547**

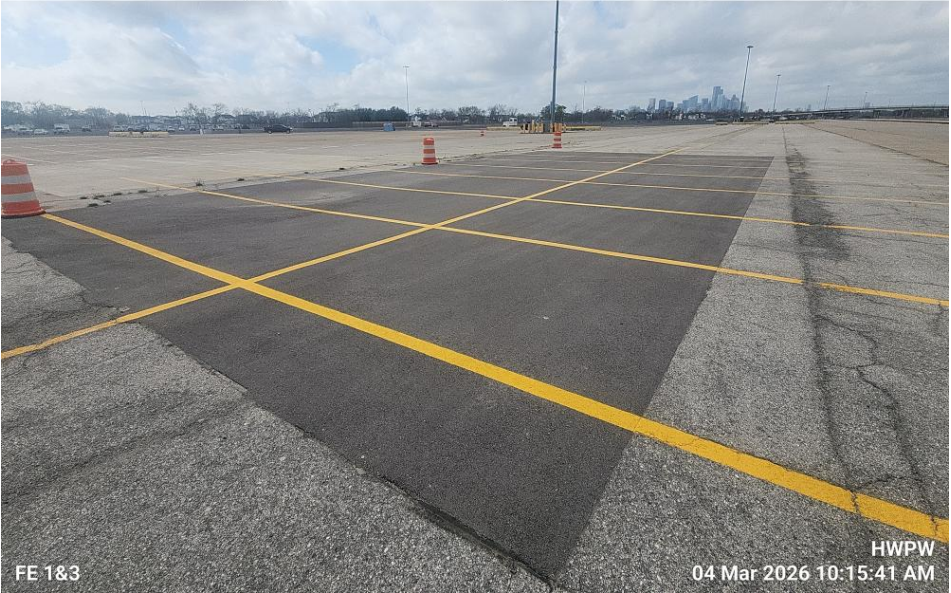
| <b>Description:</b><br>FE-1&3 weekly inspection of asphalt cap.<br>Reconstructed cap in good condition. No NAPL observed at FE location. Facing southwest.<br><br>Lat: 29.78438<br>Long: -95.32083 | | <br>FE 1&3<br>HWPW<br>04 Mar 2026 10:15:41 AM | | |

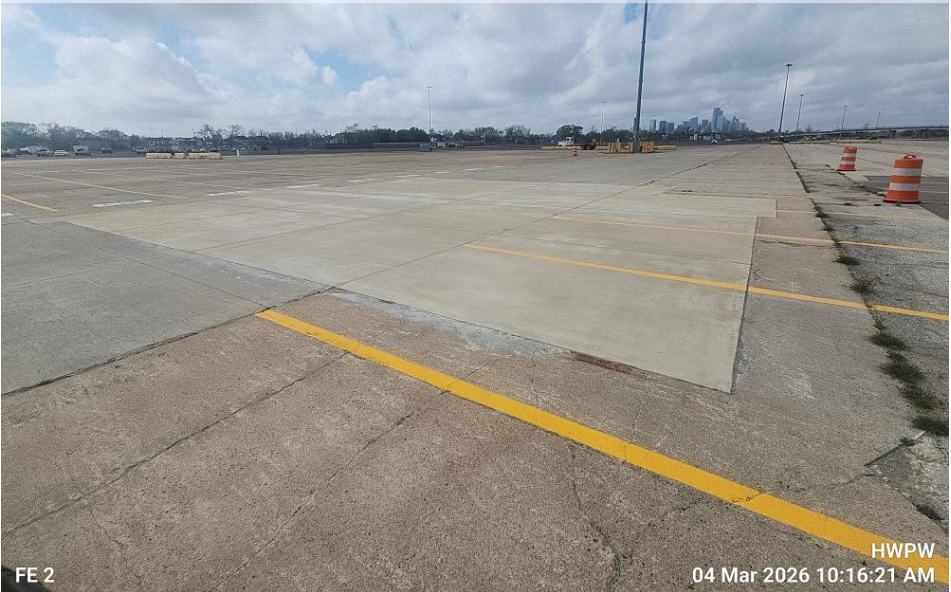
| <b>Description:</b><br>FE-2 weekly inspection of concrete cap.<br>Reconstructed cap in good condition. No NAPL observed at FE location. Facing southwest.<br><br>Lat: 29.78427<br>Long: -95.32075 | | <br>FE 2<br>HWPW<br>04 Mar 2026 10:16:21 AM | | |

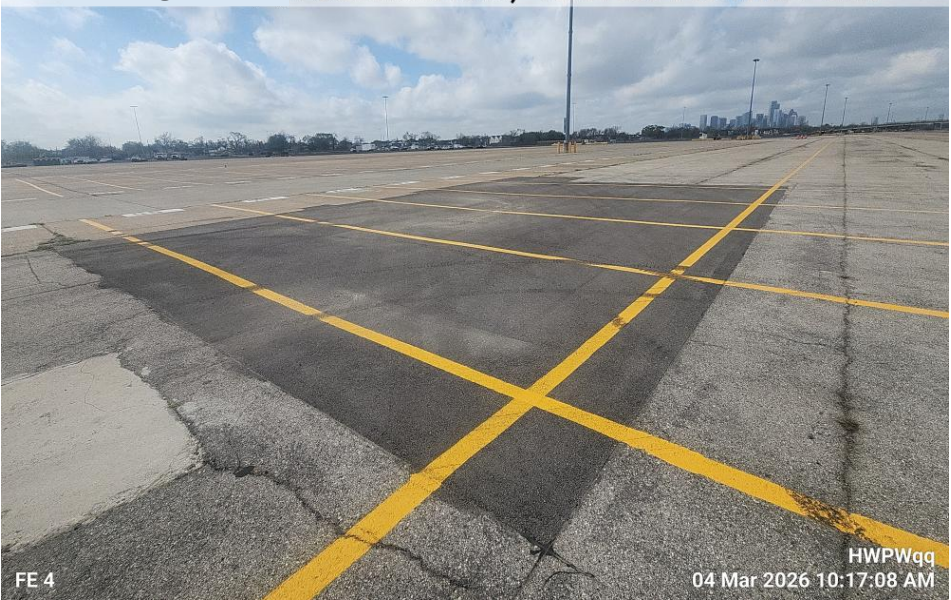
| <b>Photo No.</b><br>3 | <b>Inspection Date:</b><br>03/04/2026 | <b>SW</b> <b>POS: 29.784896, -95.31953 ±13ft ALT: -32ft</b><br> |
| <b>Description:</b><br>FE-4 weekly inspection of asphalt cap.<br>Reconstructed cap in good condition. No NAPL observed at FE location. Facing southwest.<br><br>Lat: 29.7849<br>Long: -95.31953 | | |

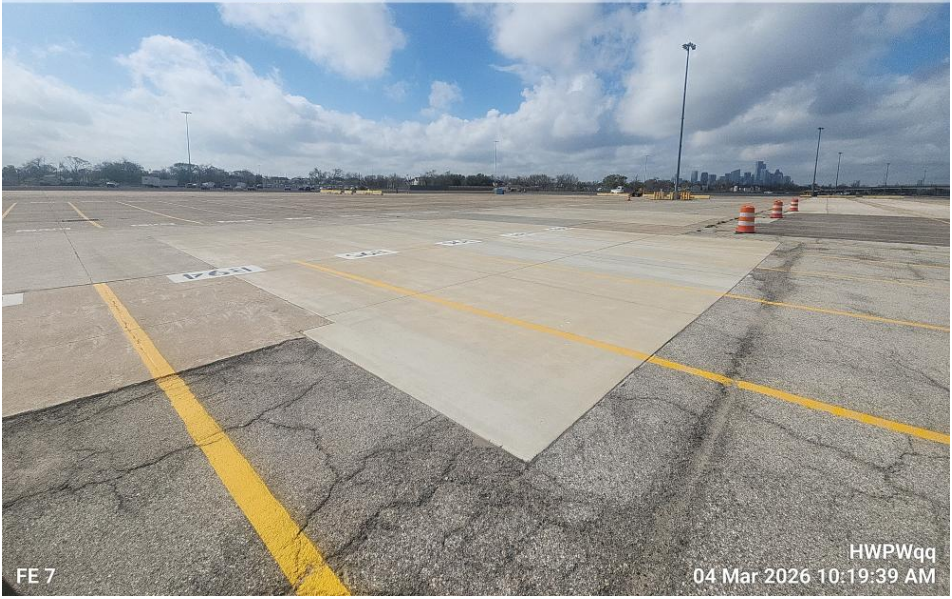
| <b>Photo No.</b><br>10 | <b>Inspection Date:</b><br>03/04/2026 | <div>SW POS: 29.784375, -95.320621 ±9ft ALT: -36ft</div> <div>FE 7</div> <div>HWPWqq<br/>04 Mar 2026 10:19:39 AM</div> |
| <b>Description:</b><br>FE-7 weekly inspection of concrete cap. Reconstructed cap in good condition. No NAPL observed at FE location. Facing southwest.<br><br>Lat: 29.78438<br>Long: -95.32062 | | |

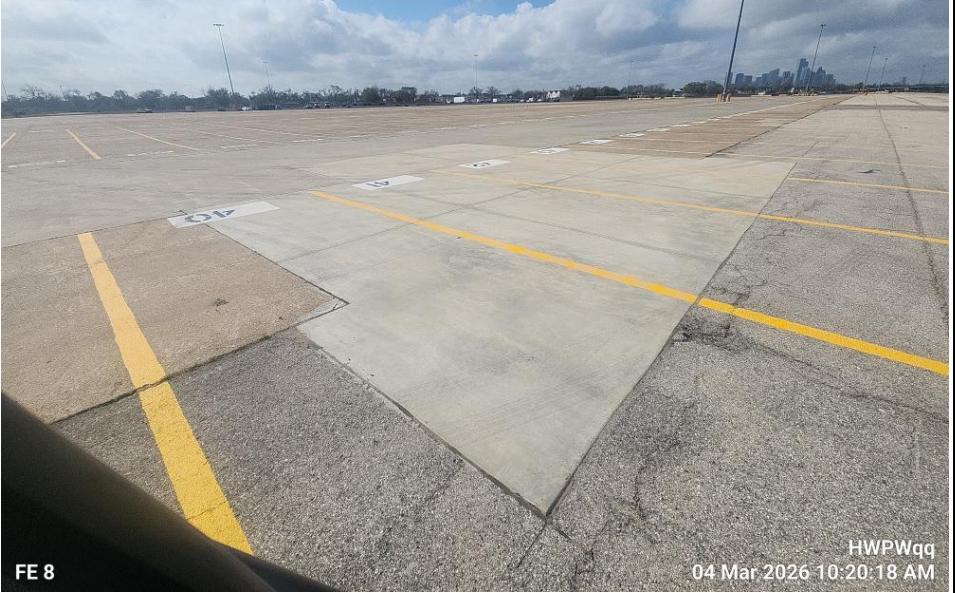
| <b>Photo No.</b><br>11 | <b>Inspection Date:</b><br>03/04/2026 | <b>SW POS: 29.785014, -95.319065 ±19ft ALT: -39ft</b><br><br><b>FE 8</b> HWPWqq<br>04 Mar 2026 10:20:18 AM |
| <b>Description:</b><br>FE-8 weekly inspection of concrete cap.<br>Reconstructed cap in good condition. No NAPL observed at FE location. Facing southwest.<br>Lat: 29.78501<br>Long: -95.31907 | | |

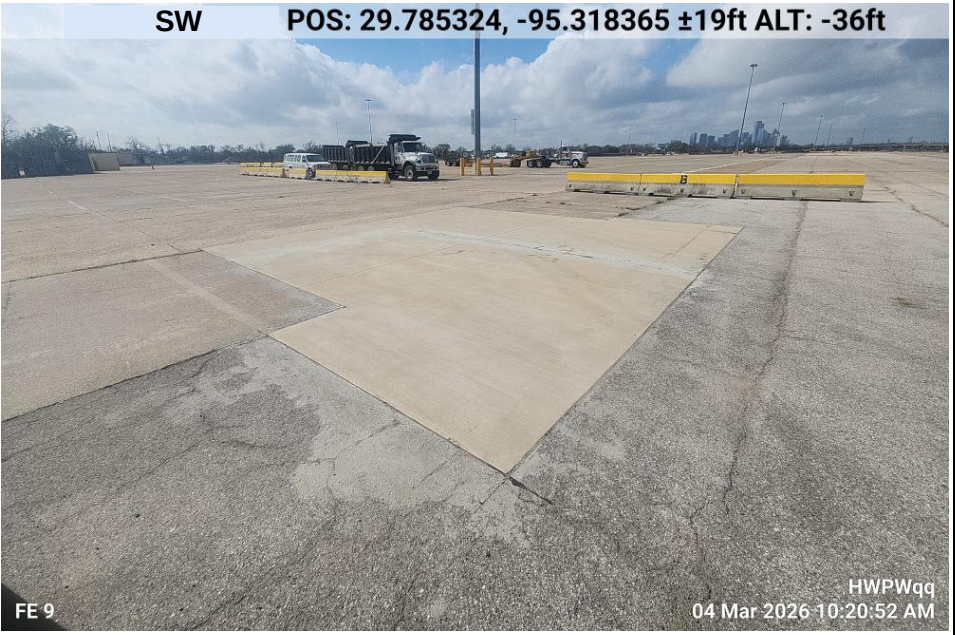
| <b>Photo No.</b><br>12 | <b>Inspection Date:</b><br>03/04/2026 | <b>SW POS: 29.785324, -95.318365 ±19ft ALT: -36ft</b><br><br><b>FE 9</b> HWPWqq<br>04 Mar 2026 10:20:52 AM |
| <b>Description:</b><br>FE-9 weekly inspection of concrete cap.<br>Reconstructed cap in good condition. No NAPL observed at FE location. Facing southwest.<br>Lat: 29.78532<br>Long: -95.31837 | | |

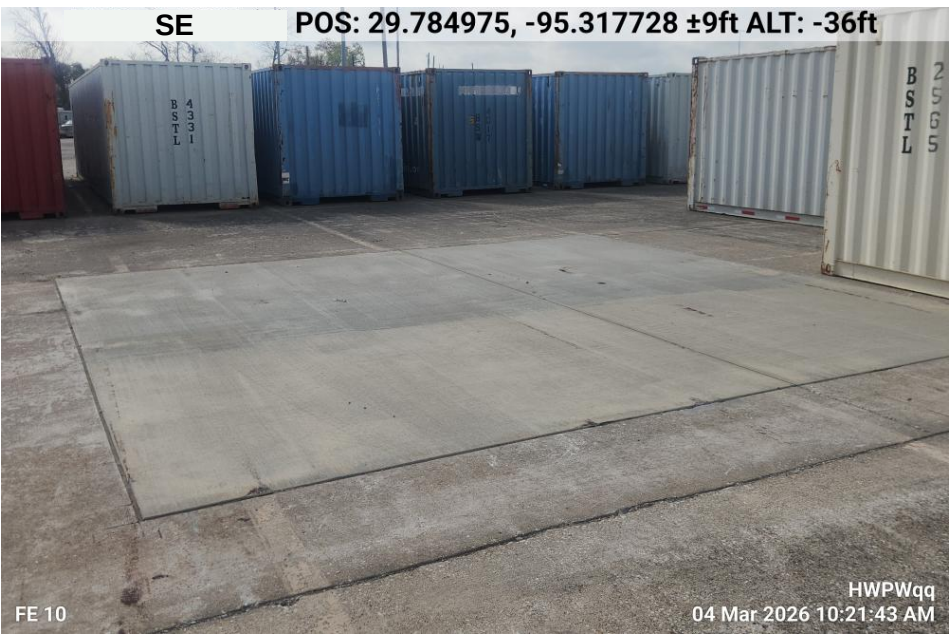
| <b>Photo No.</b><br>13 | <b>Inspection Date:</b><br>03/04/2026 | <b>SE</b> <b>POS: 29.784975, -95.317728 ±9ft ALT: -36ft</b><br><br>FE 10<br>HWPWqq<br>04 Mar 2026 10:21:43 AM |
| <b>Description:</b><br>FE-10 weekly inspection of concrete cap.<br>Reconstructed cap in good condition. No NAPL observed at FE location. Facing southeast.<br><br>Lat: 29.78498<br>Long: -95.31773 | | |

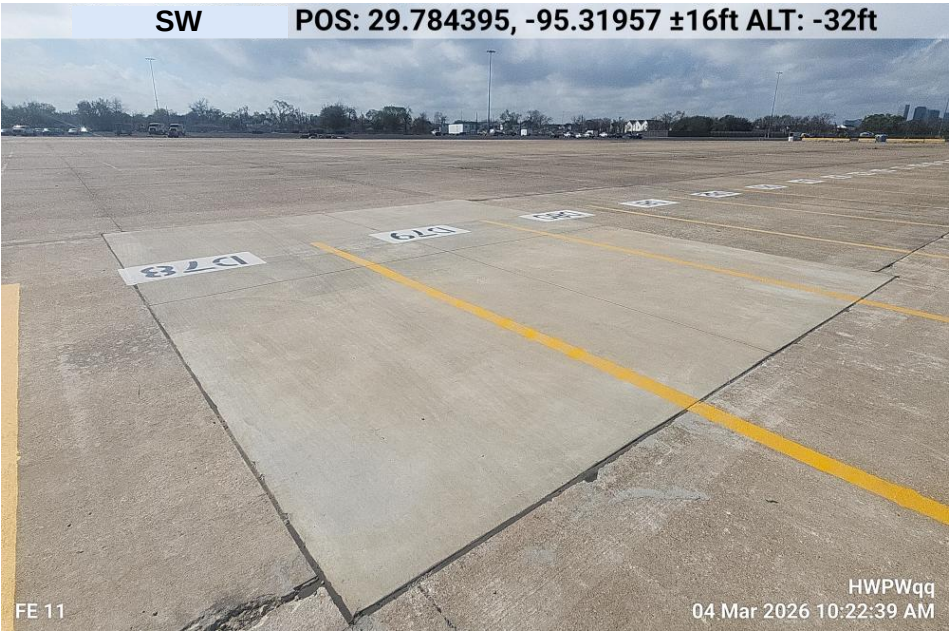
| <b>Photo No.</b><br>14 | <b>Inspection Date:</b><br>03/04/2026 | <b>SW</b> <b>POS: 29.784395, -95.31957 ±16ft ALT: -32ft</b><br><br>FE 11<br>HWPWqq<br>04 Mar 2026 10:22:39 AM |
| <b>Description:</b><br>FE-11 weekly inspection of concrete cap.<br>Reconstructed cap in good condition. No NAPL observed at FE location. Facing southwest.<br><br>Lat: 29.7844<br>Long: -95.31957 | | |

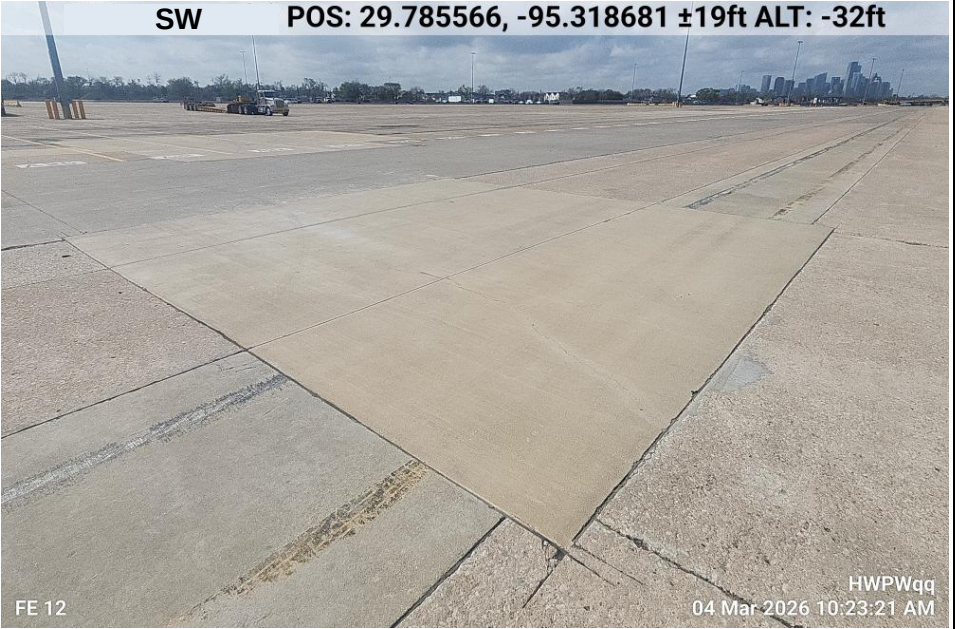
| <b>Photo No.</b><br>15 | <b>Inspection Date:</b><br>03/04/2026 | <b>SW POS: 29.785566, -95.318681 ±19ft ALT: -32ft</b><br><br>FE 12<br>HWPWqq<br>04 Mar 2026 10:23:21 AM |

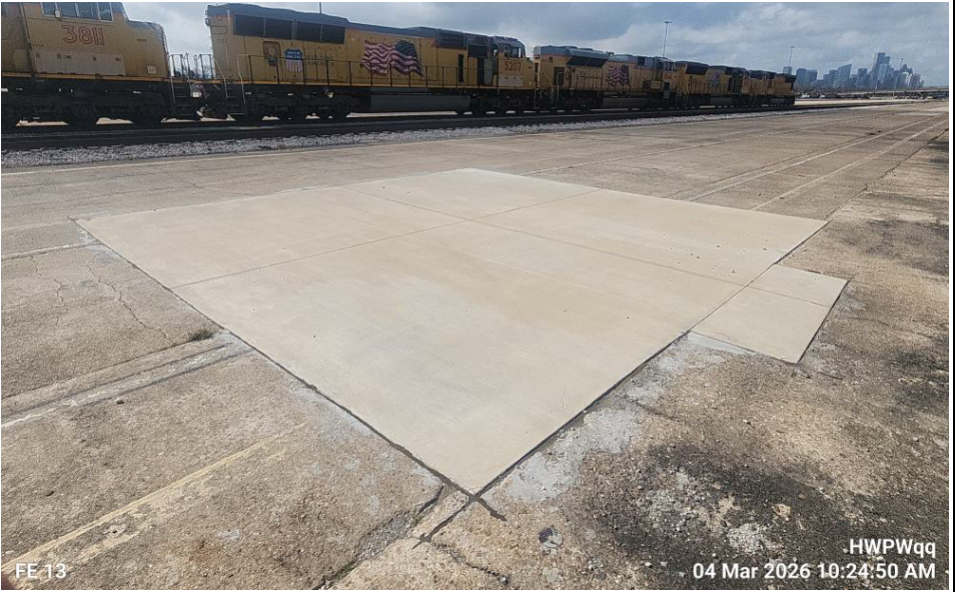
| <b>Photo No.</b><br>16 | <b>Inspection Date:</b><br>03/04/2026 | <br>FE 13<br>HWPWqq<br>04 Mar 2026 10:24:50 AM |

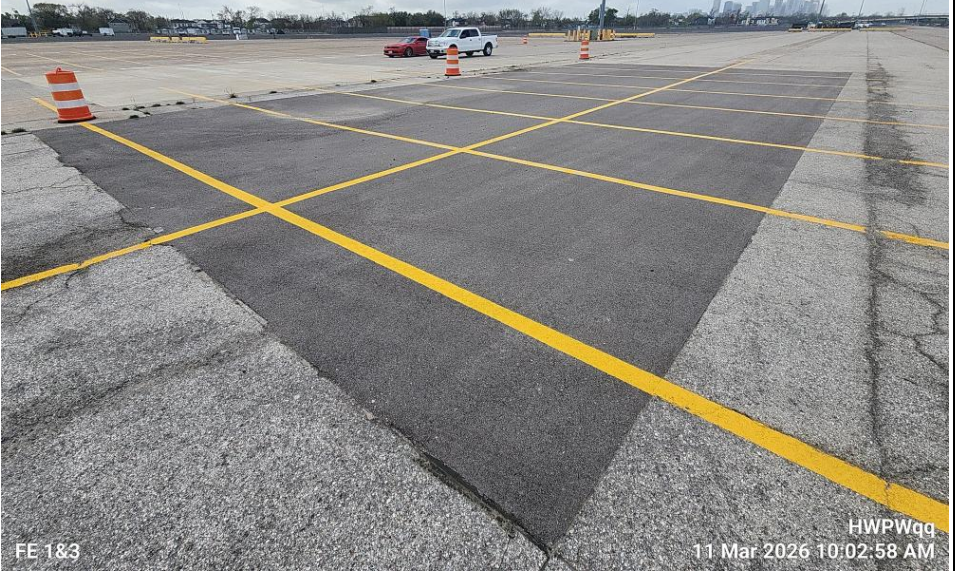
| <b>Description:</b><br>FE-1&3 weekly inspection of asphalt cap.<br>Reconstructed cap in good condition. No NAPL observed at FE location. Facing southwest.<br><br>Lat: 29.78442<br>Long: -95.32083 | | <br>FE 1&3      HWPWqq<br>11 Mar 2026 10:02:58 AM | |

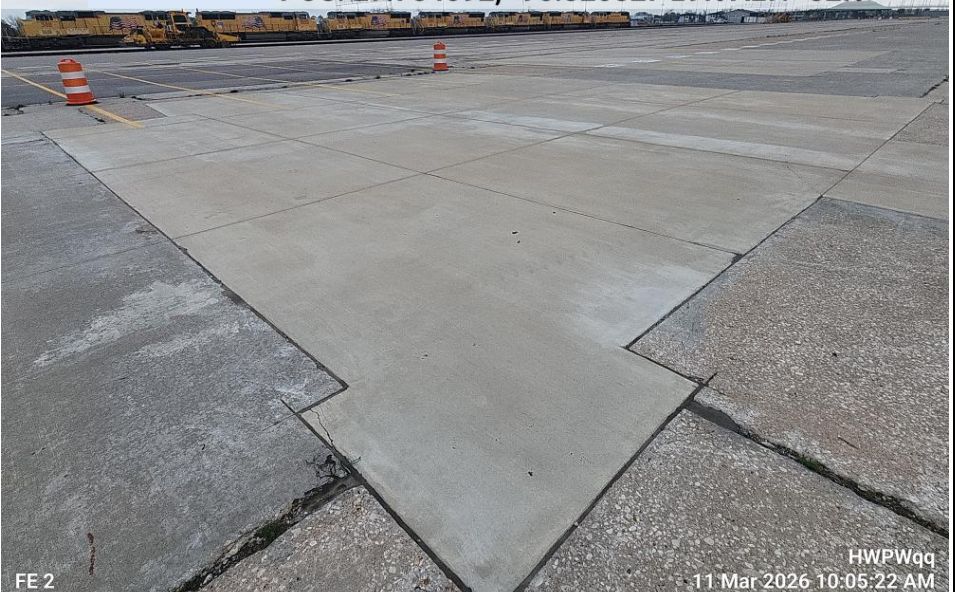
| <b>Description:</b><br>FE-2 weekly inspection of concrete cap.<br>Reconstructed cap in good condition. No NAPL observed at FE location. Facing northeast.<br><br>Lat: 29.78409<br>Long: -95.32083 | | <br>FE 2      HWPWqq<br>11 Mar 2026 10:05:22 AM | |

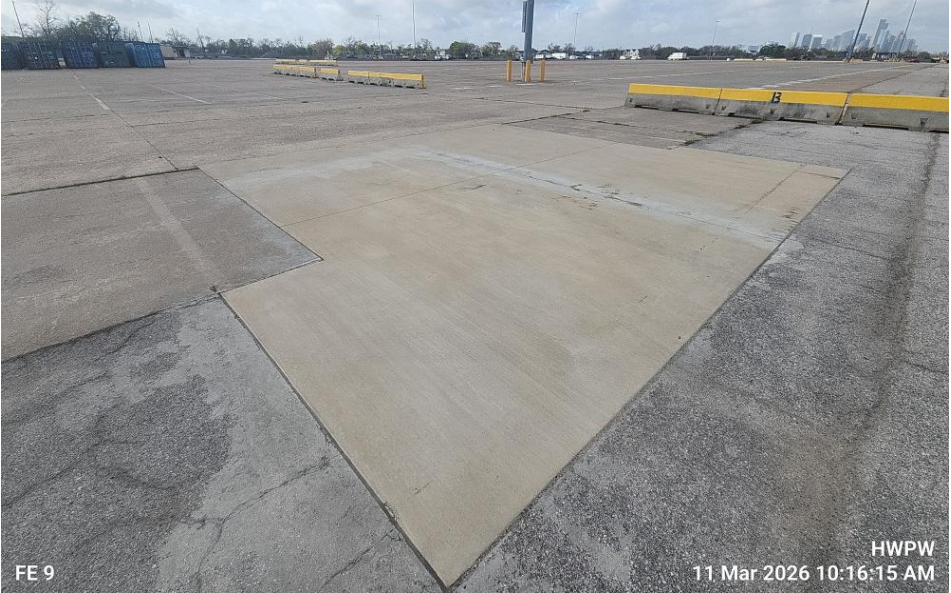
| <b>Photo No.</b><br>27 | <b>Inspection Date:</b><br>03/11/2026 | <b>SW POS: 29.785346, -95.318367 ±9ft ALT: -42ft</b><br> <p>FE 9</p> <p>HWPW<br/>11 Mar 2026 10:16:15 AM</p> |
| <b>Description:</b><br>FE-9 weekly inspection of concrete cap.<br>Reconstructed cap in good condition. No NAPL observed at FE location. Facing southwest.<br>Lat: 29.78535<br>Long: -95.31837 | | |

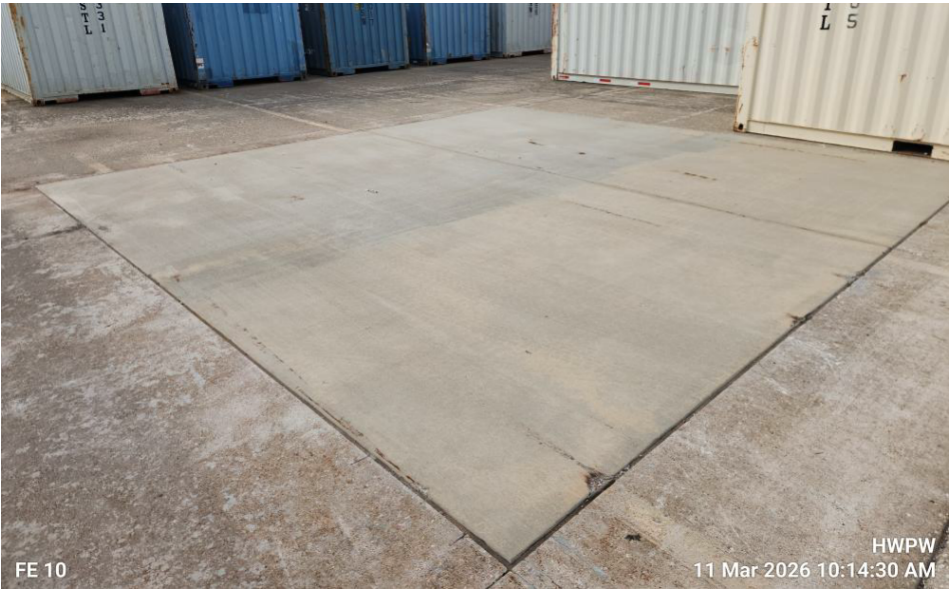
| <b>Photo No.</b><br>28 | <b>Inspection Date:</b><br>03/11/2026 | <p>FE 10</p> <p>HWPW<br/>11 Mar 2026 10:14:30 AM</p> |
| <b>Description:</b><br>FE-10 weekly inspection of concrete cap.<br>Reconstructed cap in good condition. No NAPL observed at FE location. Facing southwest.<br>Lat: 29.78497<br>Long: -95.31771 | | |

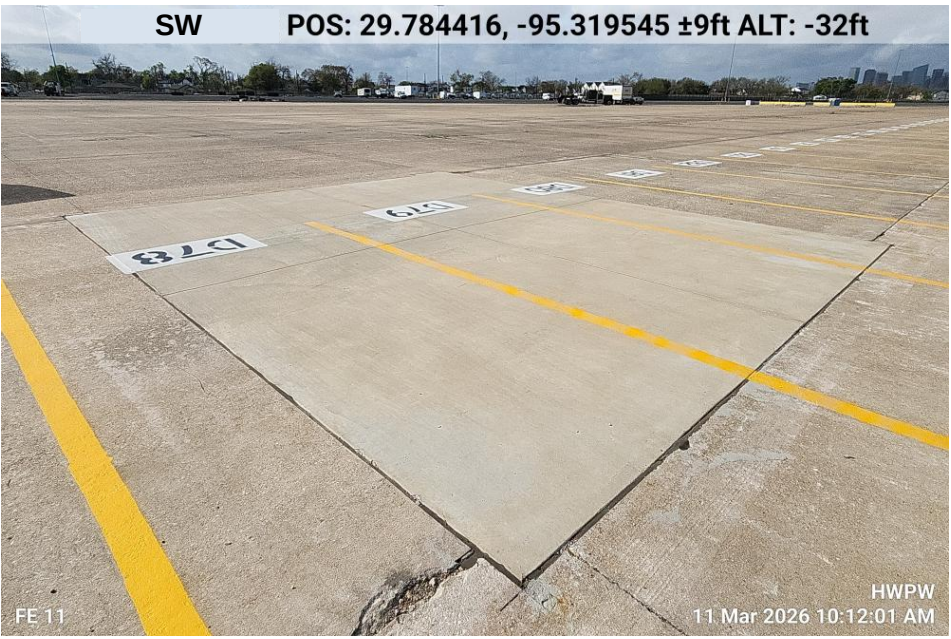
| <b>Description:</b><br>FE-11 weekly inspection of concrete cap.<br>Reconstructed cap in good condition. No NAPL observed at FE location. Facing southwest.<br><br>Lat: 29.78442<br>Long: -95.31955 | | |

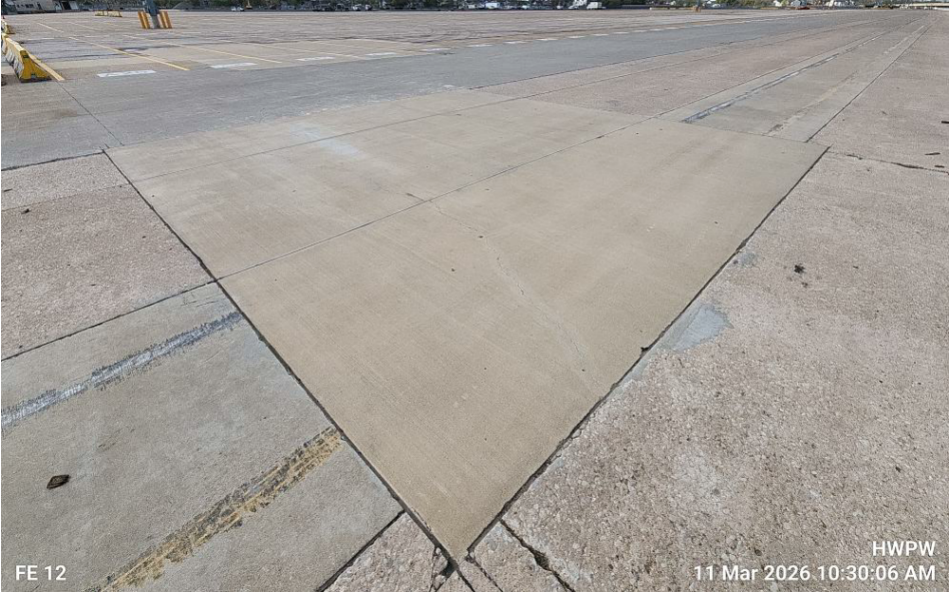
| <b>Description:</b><br>FE-12 weekly inspection of concrete cap.<br>Reconstructed cap in good condition. No NAPL observed at FE location. Facing southwest.<br><br>Lat: 29.78558<br>Long: -95.31868 | | |

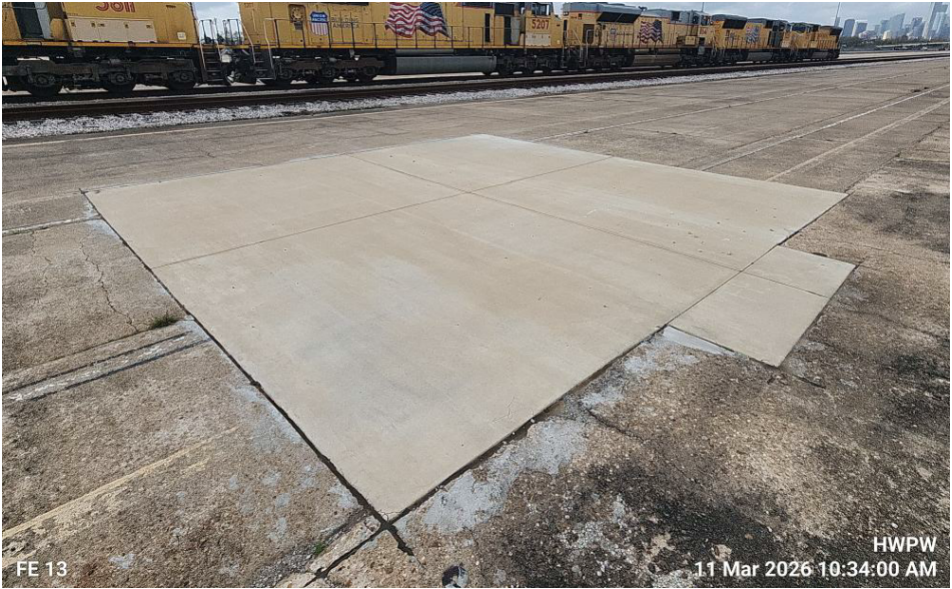
| <b>Description:</b><br>FE-13 weekly inspection of concrete cap.<br>Reconstructed cap in good condition. No NAPL observed at FE location. Facing southwest.<br><br>Lat: 29.78513<br>Long: -95.32124 | | |

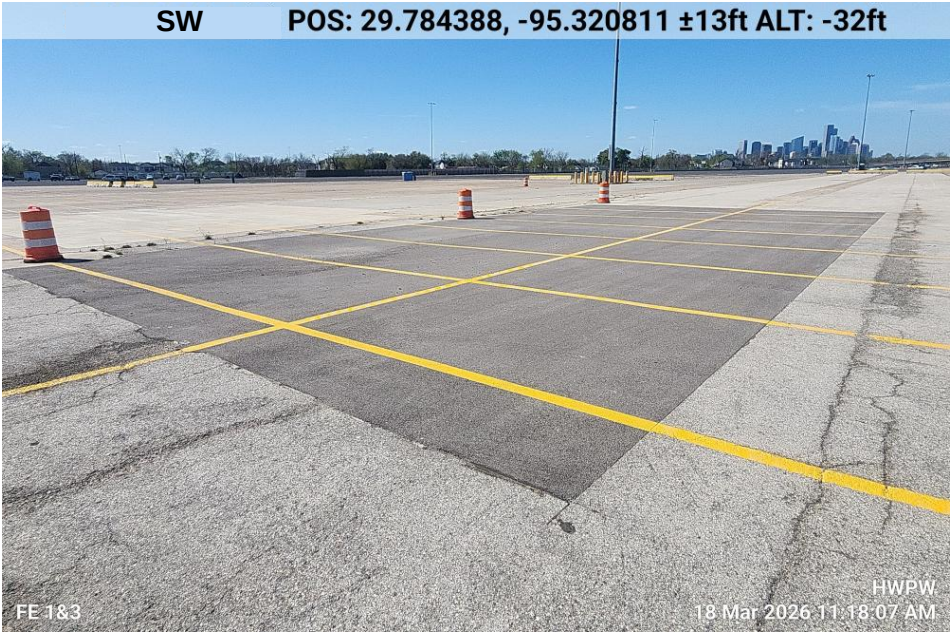
| <b>Photo No.</b><br>32 | <b>Inspection Date:</b><br>03/18/2026 | <div><b>SW</b>      <b>POS: 29.784388, -95.320811 ±13ft ALT: -32ft</b></div> |
| <b>Description:</b><br>FE-1&3 weekly inspection of asphalt cap.<br>Reconstructed cap in good condition. No NAPL observed at FE location. Facing southwest.<br><br>Lat: 29.78439<br>Long: -95.32081 | | |

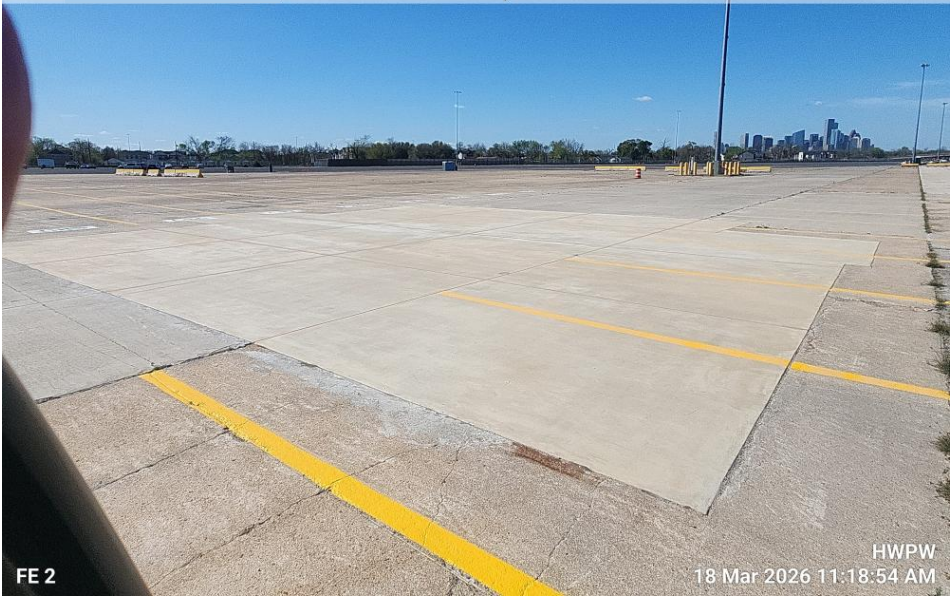
| <b>Description:</b><br>FE-2 weekly inspection of concrete cap.<br>Reconstructed cap in good condition. No NAPL observed at FE location. Facing southwest.<br><br>Lat: 29.78428<br>Long: -95.32075 | | <br><b>FE 2</b> <b>HWPW</b><br>18 Mar 2026 11:18:54 AM | |

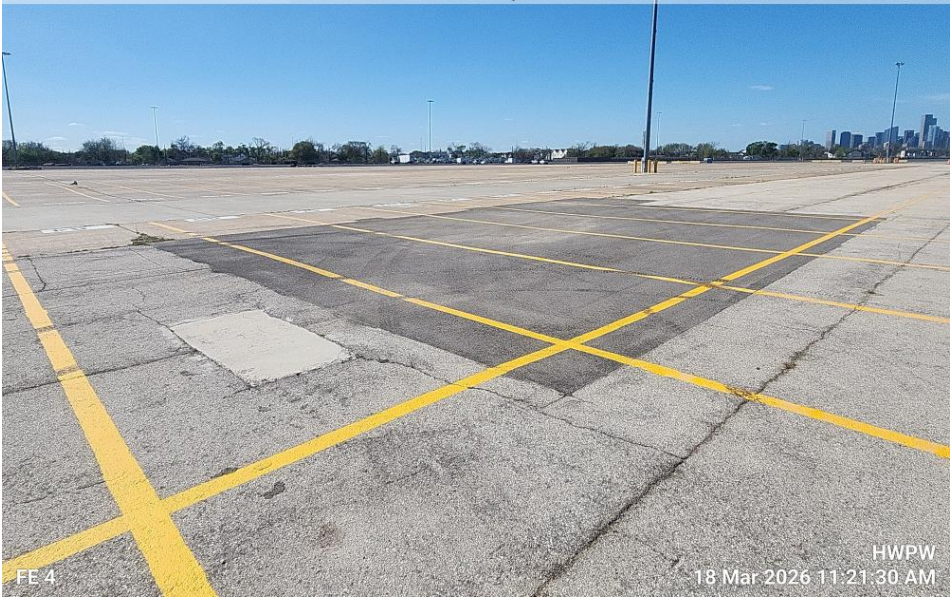
| <b>Description:</b><br>FE-4 weekly inspection of asphalt cap.<br>Reconstructed cap in good condition. No NAPL observed at FE location. Facing south.<br><br>Lat: 29.78493<br>Long: -95.31949 | | <br><b>FE 4</b> <b>HWPW</b><br>18 Mar 2026 11:21:30 AM | |

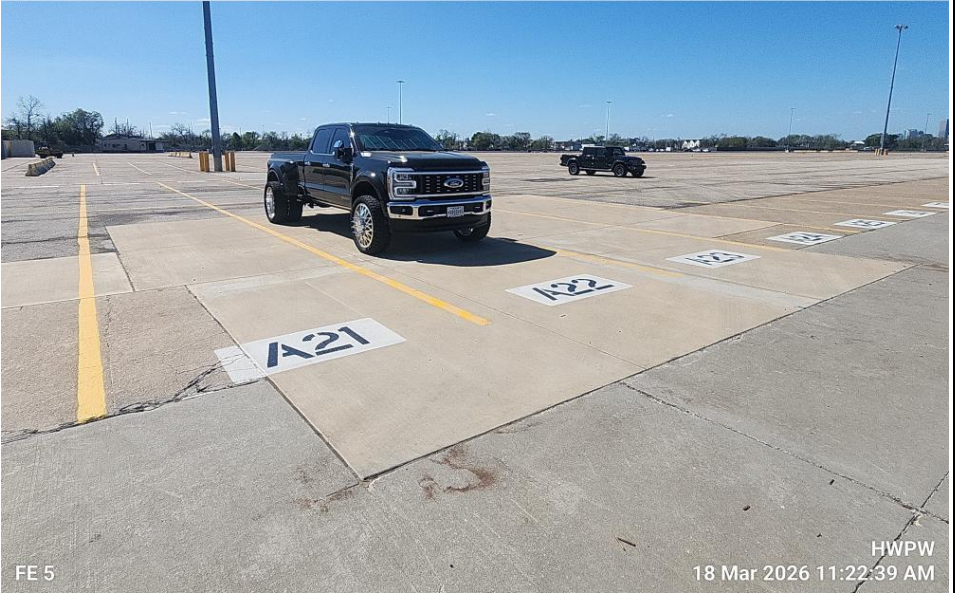
| <b>Description:</b><br>FE-5 weekly inspection of concrete cap.<br>Reconstructed cap in good condition. No NAPL observed at FE location. Facing south.<br><br>Lat: 29.78544<br>Long: -95.31862 | | <div>FE 5</div> <div>HWPW<br/>18 Mar 2026 11:22:39 AM</div> | |

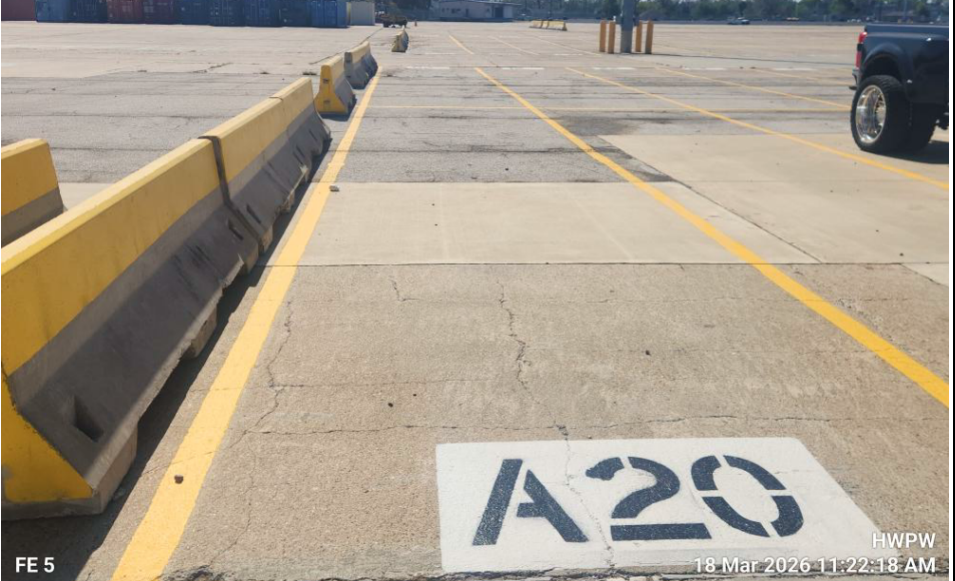
| <b>Photo No.</b><br>36 | <b>Inspection Date:</b><br>03/18/2026 | <div>FE 5</div> <div>HWPW<br/>18 Mar 2026 11:22:18 AM</div> | |
| <b>Description:</b><br>FE-5 weekly inspection of concrete cap.<br>Reconstructed cap in good condition. No NAPL observed at FE location. Facing southeast.<br><br>Lat: 29.78541<br>Long: -95.31867 | | | |

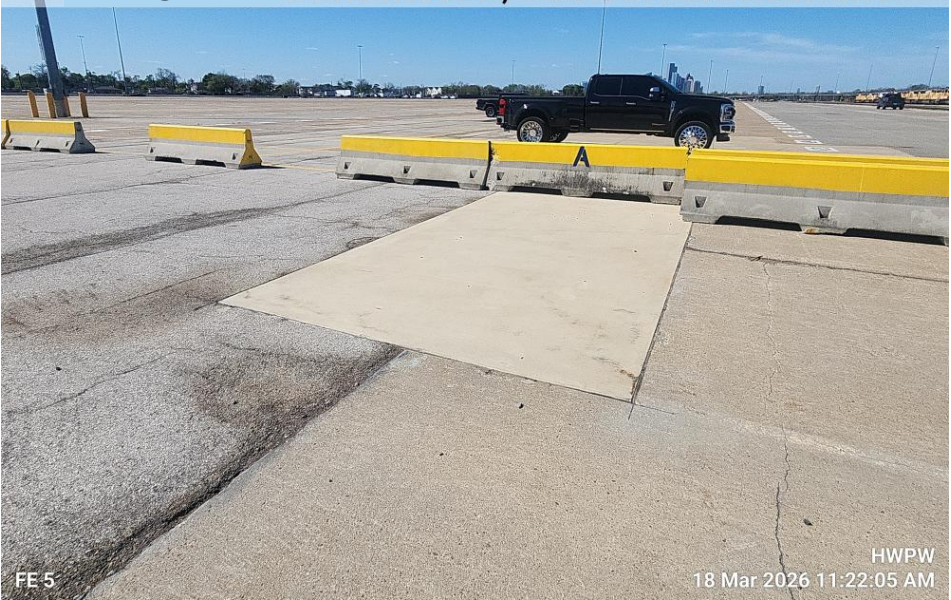
| <b>Photo No.</b><br>37 | <b>Inspection Date:</b><br>03/18/2026 | <b>SW POS: 29.785442, -95.318511 ±23ft ALT: -29ft</b><br><br>FE 5 HWPW 18 Mar 2026 11:22:05 AM | |

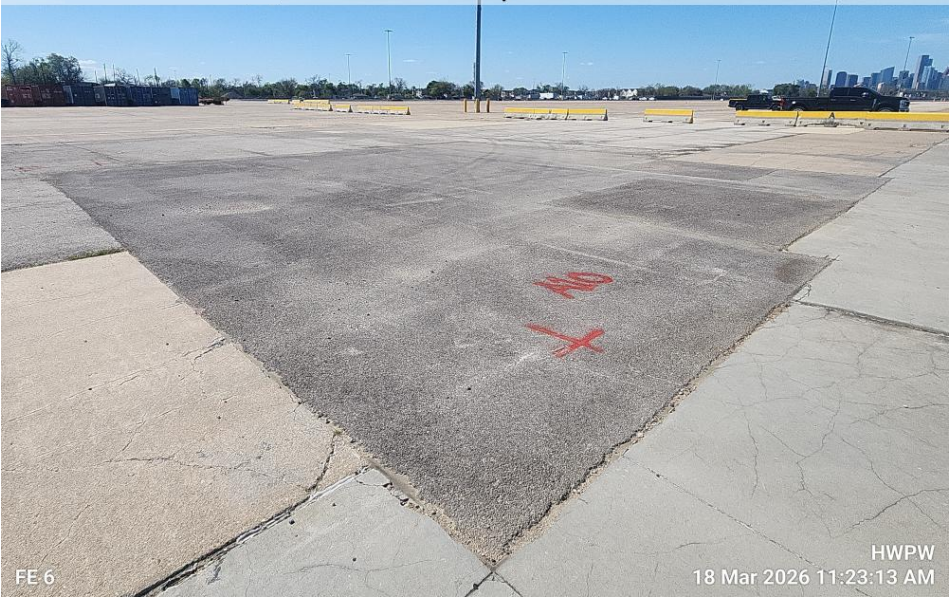
| <b>Description:</b><br>FE-5 weekly inspection of concrete cap.<br>Reconstructed cap in good condition. No NAPL observed at FE location. Facing southwest.<br><br>Lat: 29.78544<br>Long: -95.31851 | | <b>SW POS: 29.785573, -95.318303 ±23ft ALT: -36ft</b><br><br>FE 6 HWPW 18 Mar 2026 11:23:13 AM | |
| <b>Photo No.</b><br>38 | <b>Inspection Date:</b><br>03/18/2026 | <b>Description:</b><br>FE-6 weekly inspection of asphalt cap.<br>Reconstructed cap in good condition. No NAPL observed at FE location. Facing southwest.<br><br>Lat: 29.78557<br>Long: -95.3183 | |

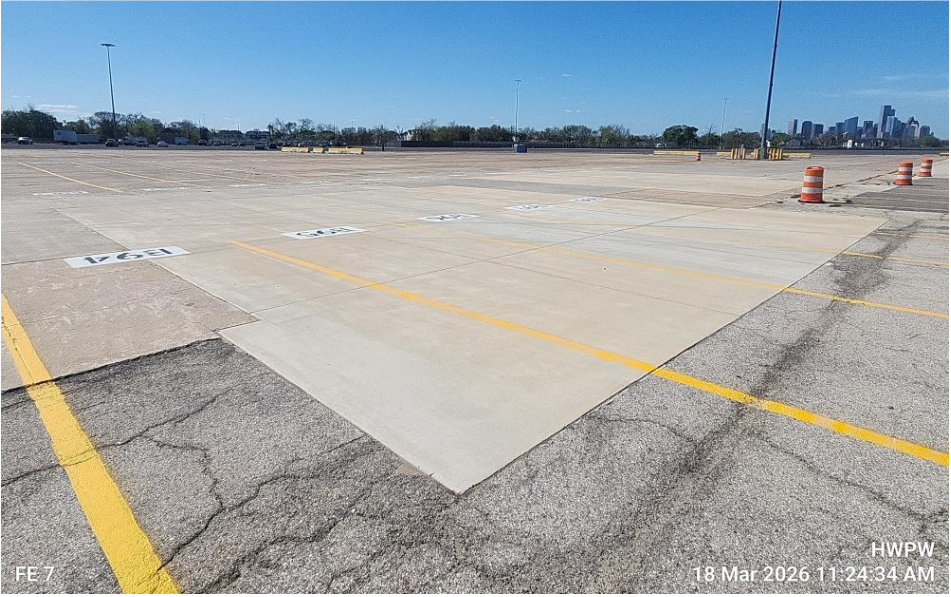
| <b>Description:</b><br>FE-7 weekly inspection of concrete cap.<br>Reconstructed cap in good condition. No NAPL observed at FE location. Facing southwest.<br><br>Lat: 29.78438<br>Long: -95.32062 | | <p>FE 7</p> <p>HWPW<br/>18 Mar 2026 11:24:34 AM</p> | |

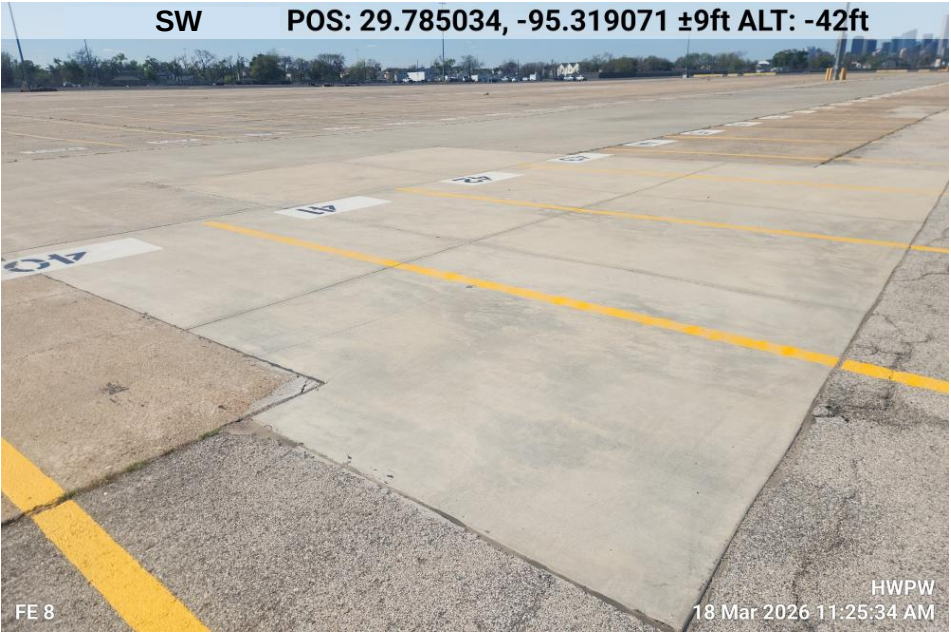
| <b>Description:</b><br>FE-8 weekly inspection of concrete cap.<br>Reconstructed cap in good condition. No NAPL observed at FE location. Facing southwest.<br><br>Lat: 29.78503<br>Long: -95.31907 | | <p>FE 8</p> <p>HWPW<br/>18 Mar 2026 11:25:34 AM</p> | |

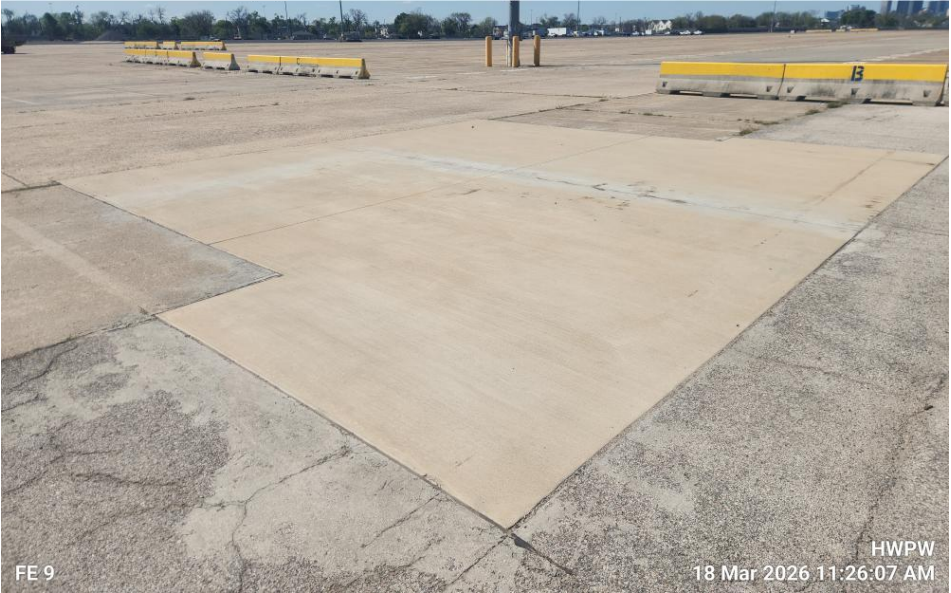
| <b>Description:</b><br>FE-9 weekly inspection of concrete cap.<br>Reconstructed cap in good condition. No NAPL observed at FE location. Facing southwest.<br><br>Lat: 29.78535<br>Long: -95.31837 | | |

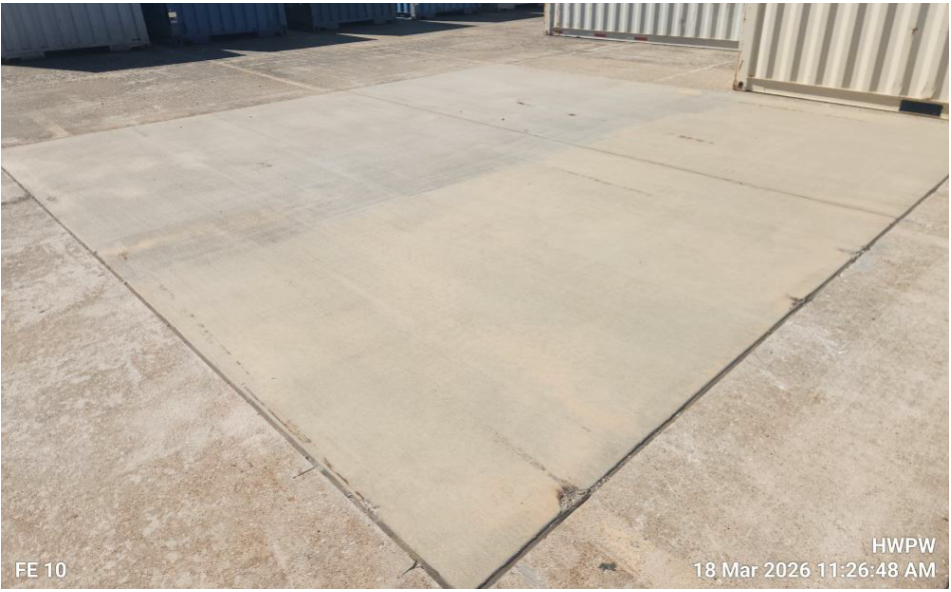
| <b>Description:</b><br>FE-10 weekly inspection of concrete cap.<br>Reconstructed cap in good condition. No NAPL observed at FE location. Facing southwest.<br><br>Lat: 29.78497<br>Long: -95.31771 | | |

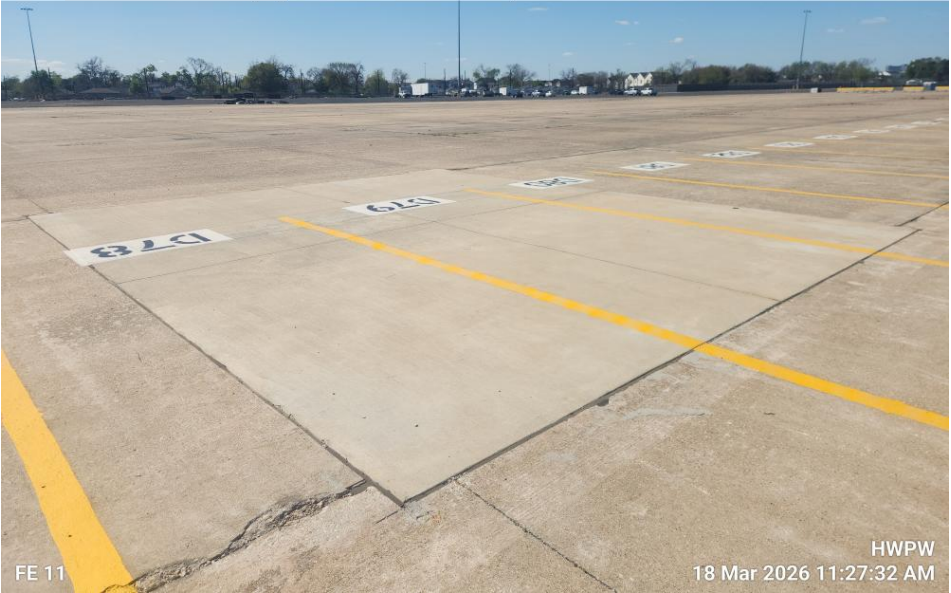
| <b>Description:</b><br>FE-11 weekly inspection of concrete cap.<br>Reconstructed cap in good condition. No NAPL observed at FE location. Facing southwest.<br><br>Lat: 29.78442<br>Long: -95.31956 | | |

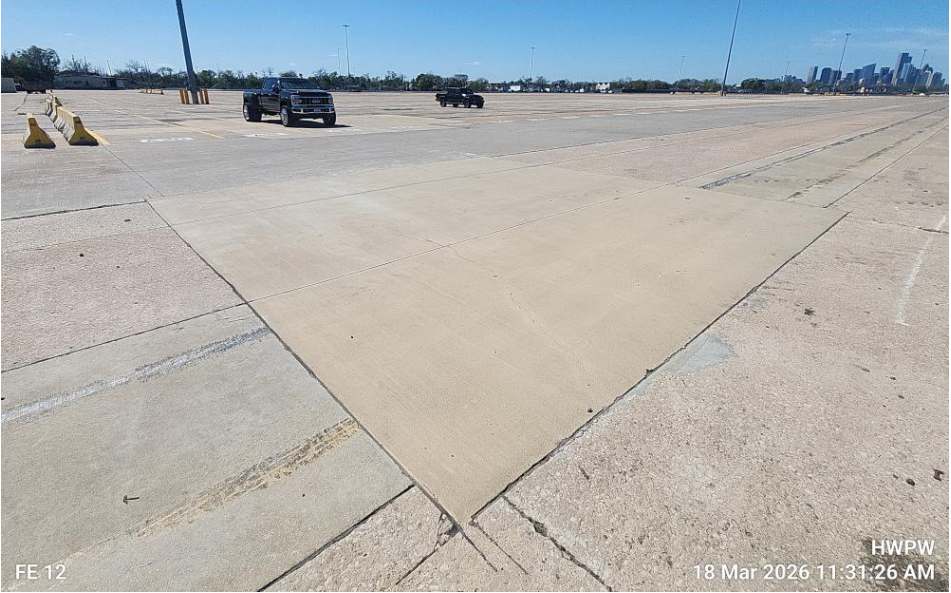
| <b>Description:</b><br>FE-12 weekly inspection of concrete cap.<br>Reconstructed cap in good condition. No NAPL observed at FE location. Facing southwest.<br><br>Lat: 29.78558<br>Long: -95.31869 | | |

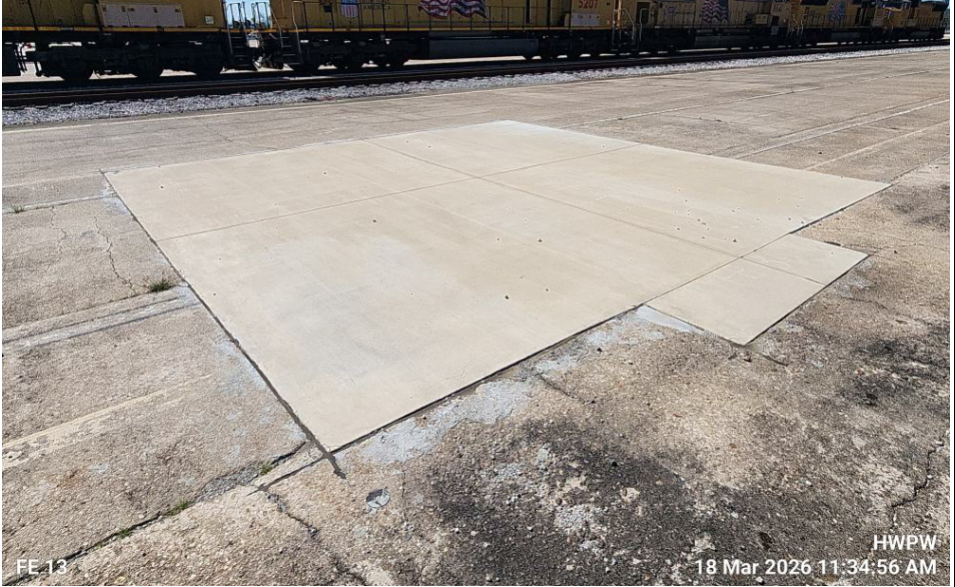
| <b>Description:</b><br>FE-13 weekly inspection of concrete cap.<br>Reconstructed cap in good condition. No NAPL observed at FE location. Facing southwest.<br><br>Lat: 29.78513<br>Long: -95.32124 | | |

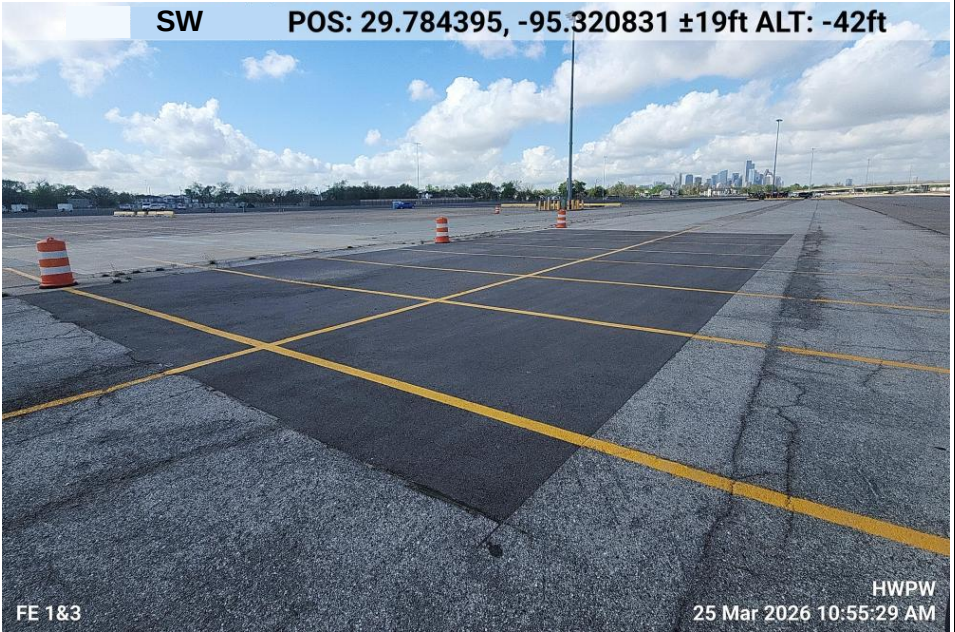
| <b>Description:</b><br>FE-1&3 weekly inspection of asphalt cap.<br>Reconstructed cap in good condition. No NAPL observed at FE location. Facing southwest.<br><br>Lat: 29.7844<br>Long: -95.32083 | | |

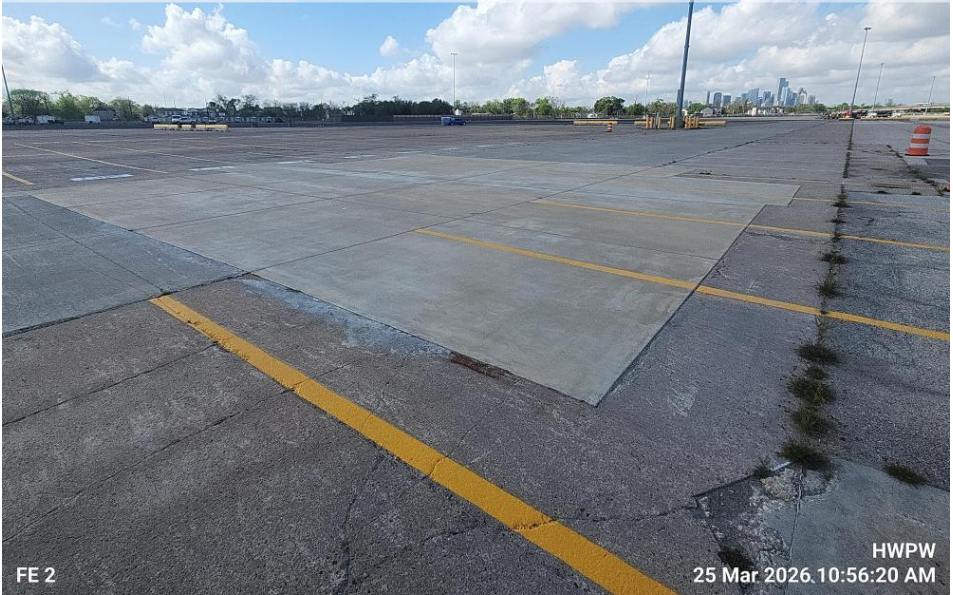
| <b>Description:</b><br>FE-2 weekly inspection of concrete cap.<br>Reconstructed cap in good condition. No NAPL observed at FE location. Facing southwest.<br><br>Lat: 29.7843<br>Long: -95.32077 | | | <div>FE 2</div> <div>HWPW<br/>25 Mar 2026 10:56:20 AM</div> | |

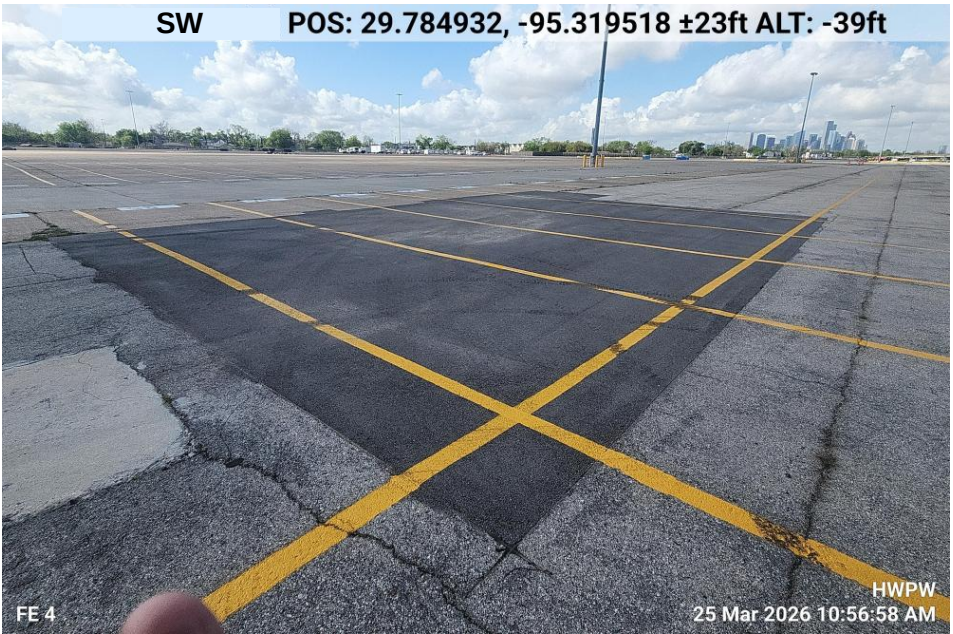
| <b>Description:</b><br>FE-4 weekly inspection of asphalt cap.<br>Reconstructed cap in good condition. No NAPL observed at FE location. Facing southwest.<br><br>Lat: 29.78493<br>Long: -95.31952 | | | <div>FE 4</div> <div>HWPW<br/>25 Mar 2026 10:56:58 AM</div> | |

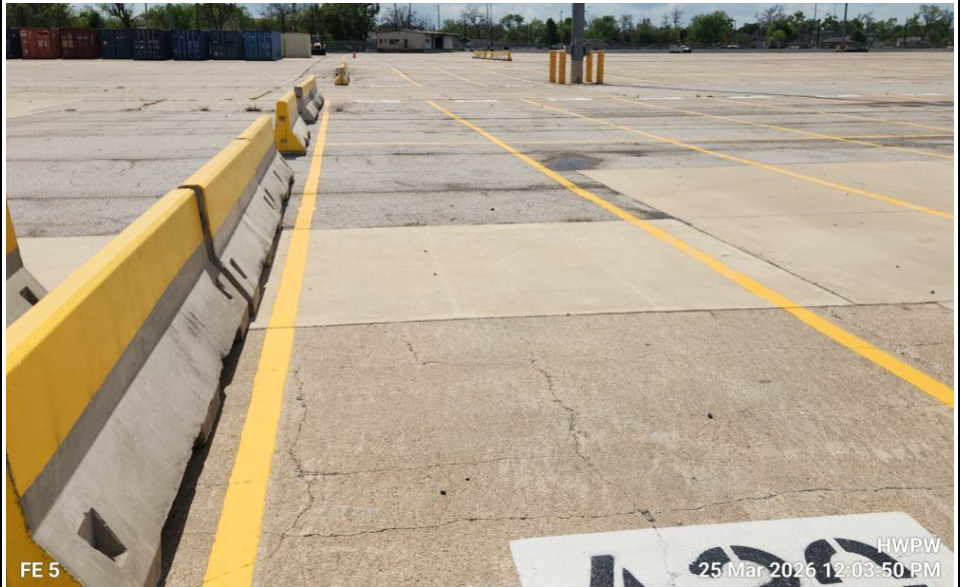
**Photo No.**  
50

FE-5 weekly inspection of concrete cap.  
Reconstructed cap in good condition. No NAPL  
observed at FE location. Facing southeast.
