April 14, 2026

Project No. US0039040.3990

**Re: MONTHLY STATUS UPDATE – ENGLEWOOD INTERMODAL YARD – REVISED INTERIM MEASURES  
WORK PLAN POST-CONSTRUCTION AND NAPL COLLECTION SYSTEM/CONCRETE CAP REPAIR  
INSPECTIONS  
UNION PACIFIC RAILROAD HOUSTON WOOD PRESERVING WORKS FACILITY  
4910 LIBERTY ROAD FACILITY, HOUSTON, TEXAS  
POST-CLOSURE CARE PERMIT NO. HW-50343; INDUSTRIAL SWR NO. 31547**

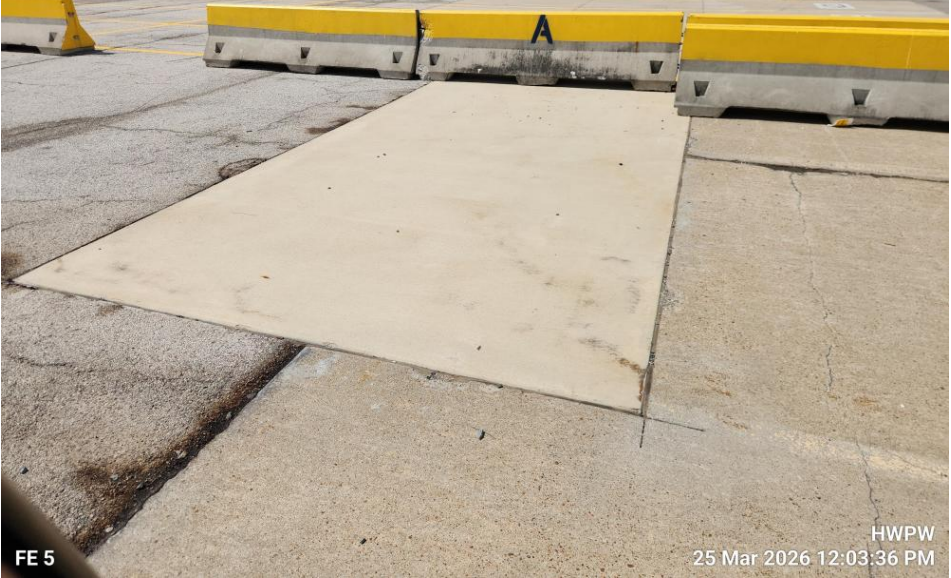
| <b>Description:</b><br>FE-5 weekly inspection of concrete cap.<br>Reconstructed cap in good condition. No NAPL observed at FE location. Facing southwest.<br>Lat: 29.78542<br>Long: -95.31853 | | |

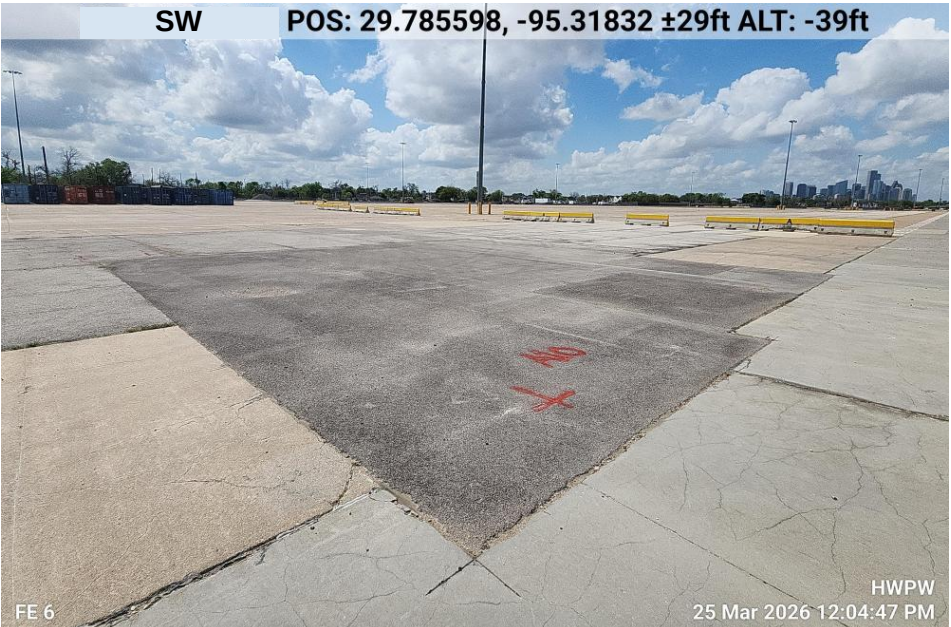
| <b>Description:</b><br>FE-6 weekly inspection of asphalt cap.<br>Reconstructed cap in good condition. No NAPL observed at FE location. Facing southwest.<br>Lat: 29.7856<br>Long: -95.31832 | | |

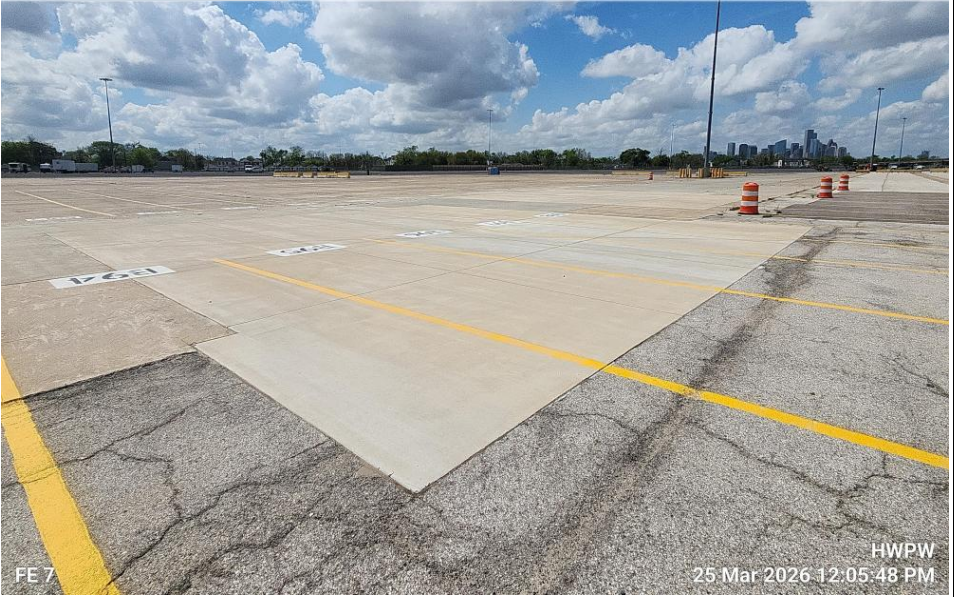
| <b>Description:</b><br>FE-7 weekly inspection of concrete cap.<br>Reconstructed cap in good condition. No NAPL observed at FE location. Facing southwest.<br><br>Lat: 29.7844<br>Long: -95.32064 | | <b>Description:</b><br>FE-8 weekly inspection of concrete cap.<br>Reconstructed cap in good condition. No NAPL observed at FE location. Facing southwest.<br><br>Lat: 29.78505<br>Long: -95.3191 | |

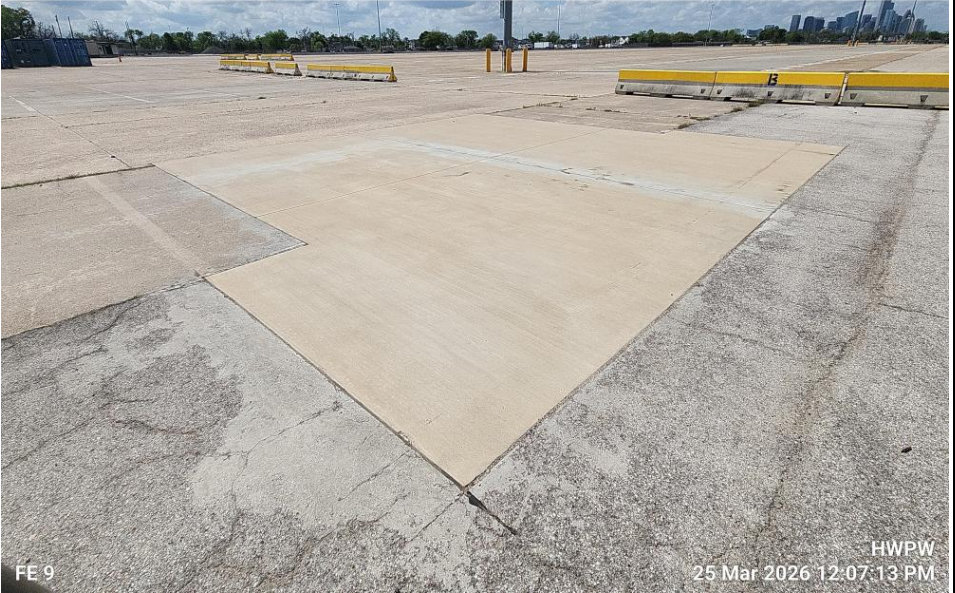
| <b>Description:</b><br>FE-9 weekly inspection of concrete cap.<br>Reconstructed cap in good condition. No NAPL observed at FE location. Facing southwest.<br>Lat: 29.78536<br>Long: -95.31839 | | |

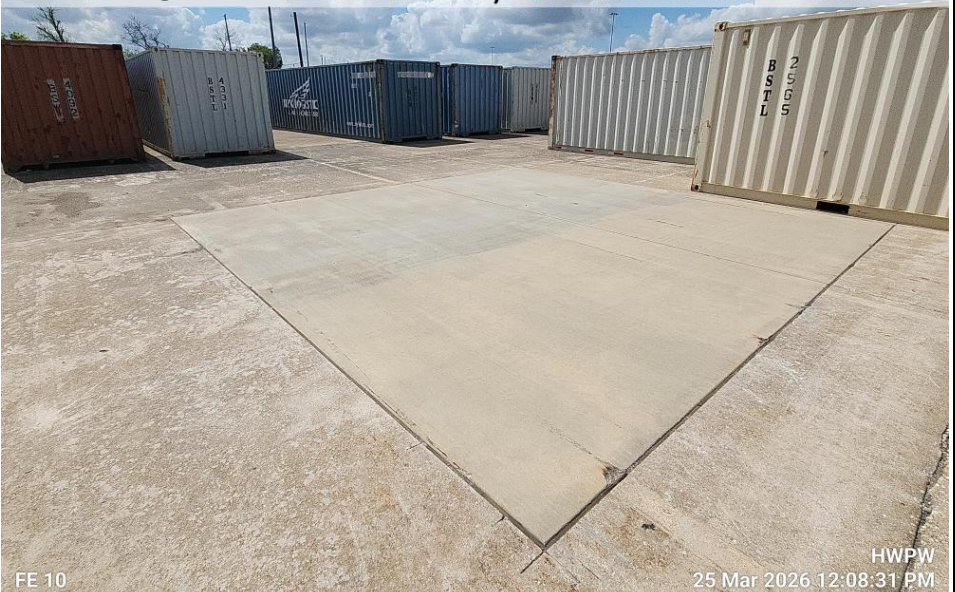
| <b>Description:</b><br>FE-10 weekly inspection of concrete cap.<br>Reconstructed cap in good condition. No NAPL observed at FE location. Facing southwest.<br>Lat: 29.78499<br>Long: -95.31772 | | |

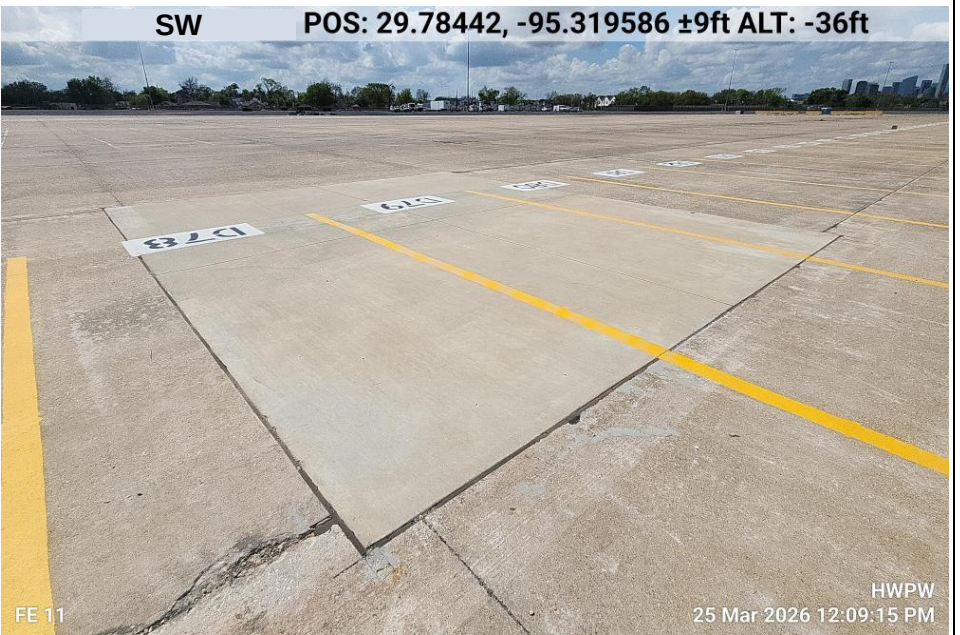
| <b>Description:</b><br>FE-11 weekly inspection of concrete cap.<br>Reconstructed cap in good condition. No NAPL observed at FE location. Facing southwest.<br><br>Lat: 29.78442<br>Long: -95.31959 | | |

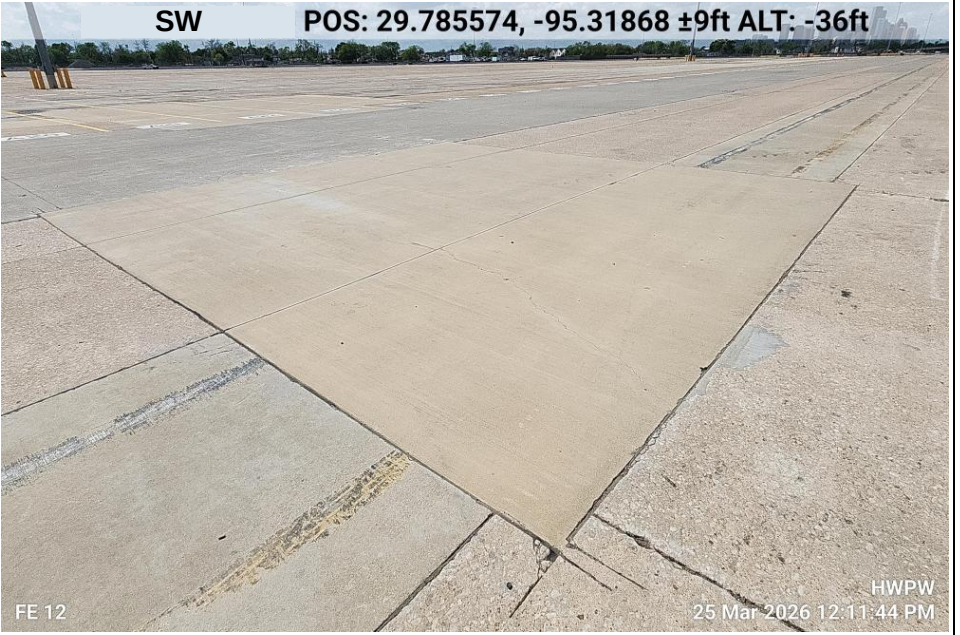
| <b>Description:</b><br>FE-12 weekly inspection of concrete cap.<br>Reconstructed cap in good condition. No NAPL observed at FE location. Facing southwest.<br><br>Lat: 29.78557<br>Long: -95.31868 | | |

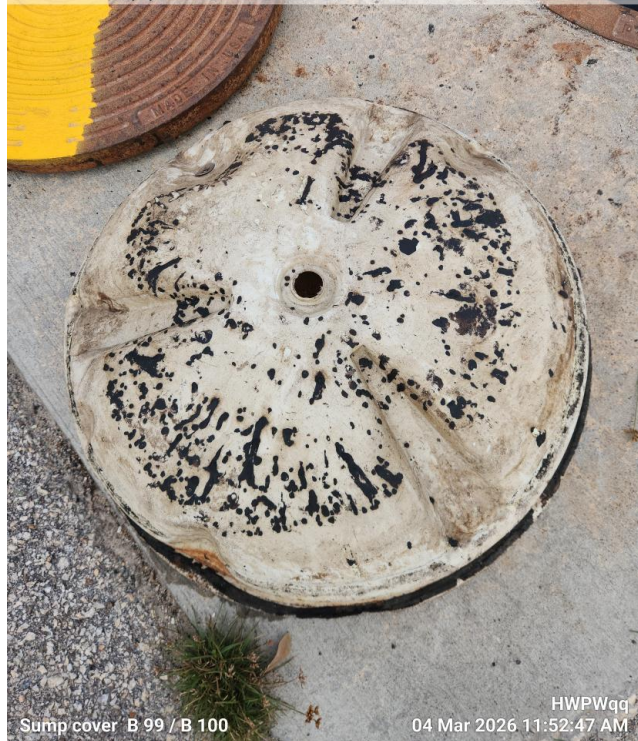
Sump 1 (B99/B100), the small amount of NAPL accumulated on the underside of the inflow protector for Sump 1 was similar in appearance to the amount observed in February.

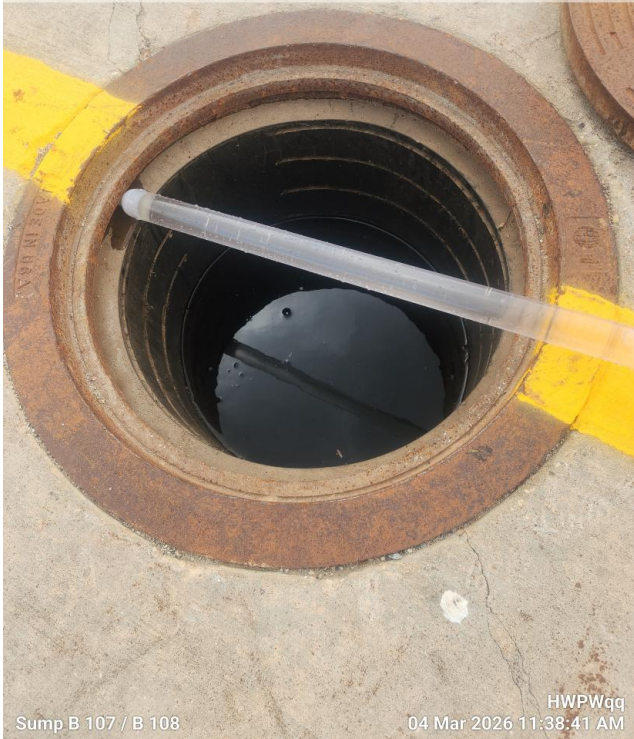
| <b>Description:</b><br>Sump 3 (B107/B108), 11.5 inches of freeboard in sump. Color is clear, and no sheen or odor was reported.<br><br>Lat: 29.78419<br>Long: -95.32102 | | | |

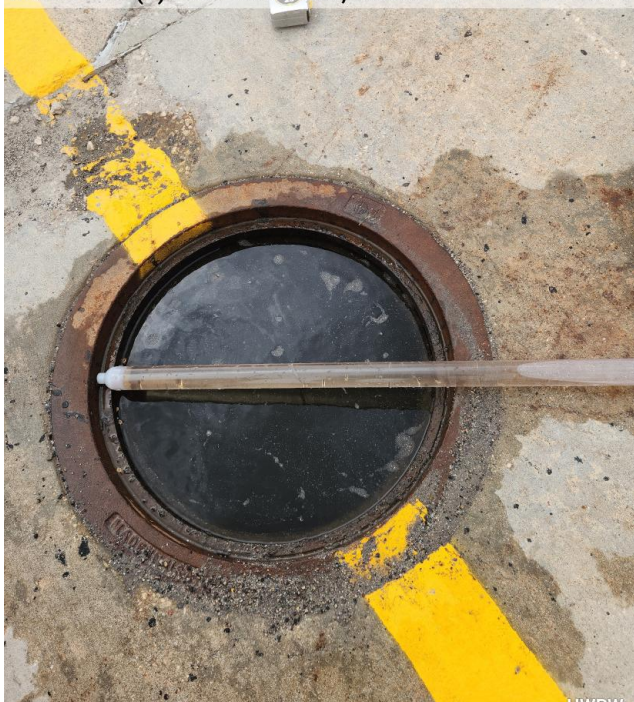
| <b>Description:</b><br>Sump 1 (B99/B100), 1 inches of freeboard in sump. Color is clear, and no sheen or odor was reported.<br><br>Lat: 29.78428<br>Long: -95.32078 | | | |

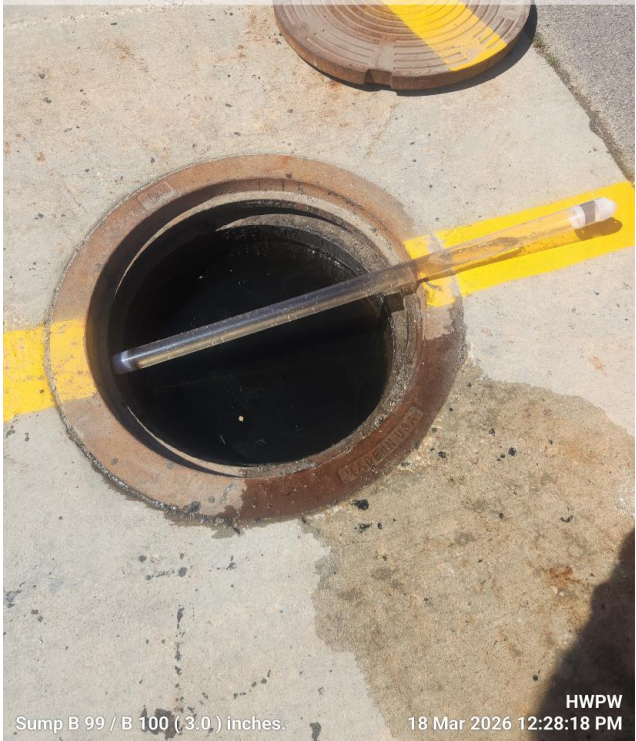
| <b>Photo No.</b><br>67 | <b>Inspection Date:</b><br>03/18/2026 | <p>BRG: 280°W (T) POS: 29.784274, -95.320816 ±19ft ALT: -39ft</p> <p>Sump B 99 / B 100 ( 3.0 ) inches.</p> <p>HWPW<br/>18 Mar 2026 12:28:18 PM</p> |

Sump 1 (B99/B100), 3 inches of freeboard in sump. Color is light brown, and a sheen was observed. No odor was reported.

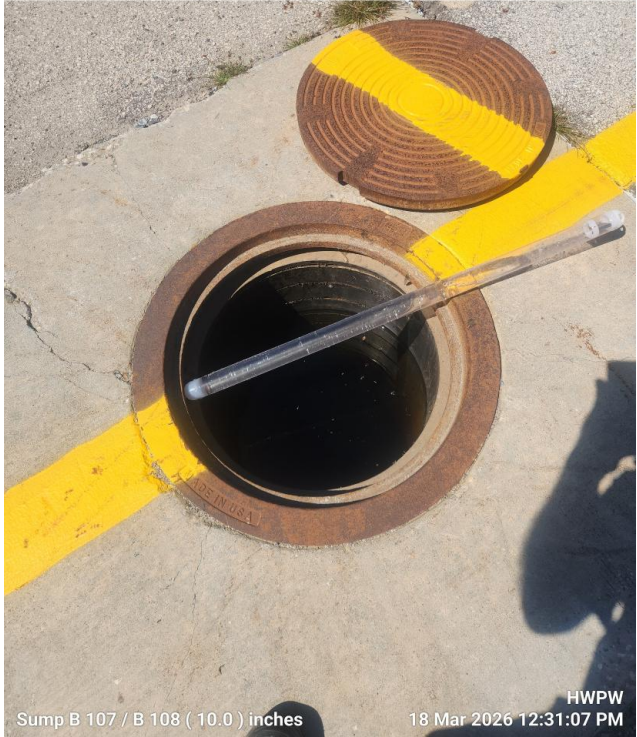
| <b>Photo No.</b><br>69 | <b>Inspection Date:</b><br>03/18/2026 | <p>BRG: 287°W (T) POS: 29.784238, -95.320988 ±9ft ALT: -39ft</p> <p>Sump B 107 / B 108 ( 10.0 ) inches</p> <p>HWPW<br/>18 Mar 2026 12:31:07 PM</p> |

Sump 3 (B107/B108), 10 inches of freeboard in sump. Color is clear, and no sheen or odor was reported.

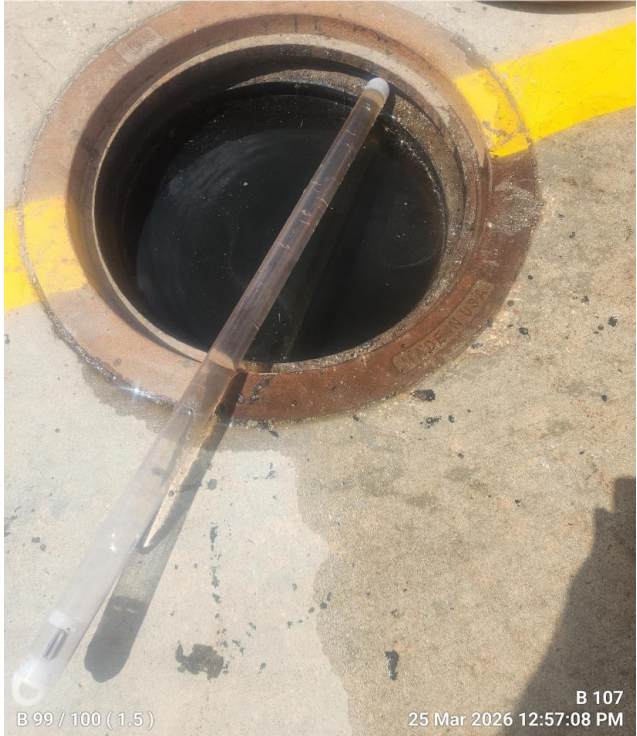
| <b>Photo No.</b><br>70 | <b>Inspection Date:</b><br>03/25/2026 | <p>BRG: 263°W (T) POS: 29.784274, -95.320772 ±9ft ALT: -42ft</p> <p>B 99 / 100 ( 1.5 )</p> <p>B 107<br/>25 Mar 2026 12:57:08 PM</p> |

Sump 1 (B99/B100), 1.5 inches of freeboard in sump. Color is light brown, and a sheen was observed. No odor was reported.

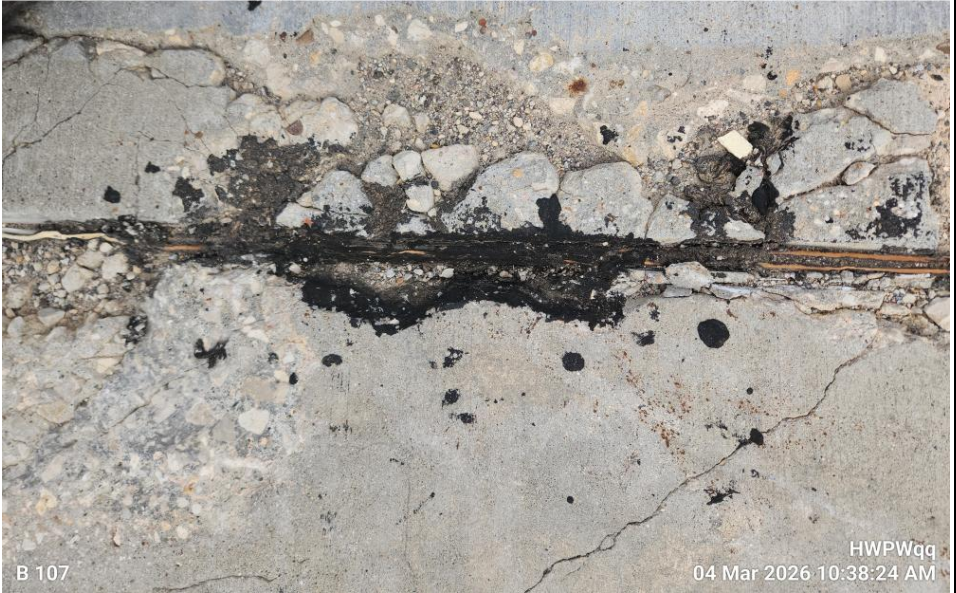
| <b>Description:</b><br>B107 weekly inspection of joint. Surrounding concrete in good condition. No active NAPL seep observed along joint.<br>Lat: 29.78417<br>Long: -95.32096 | | |

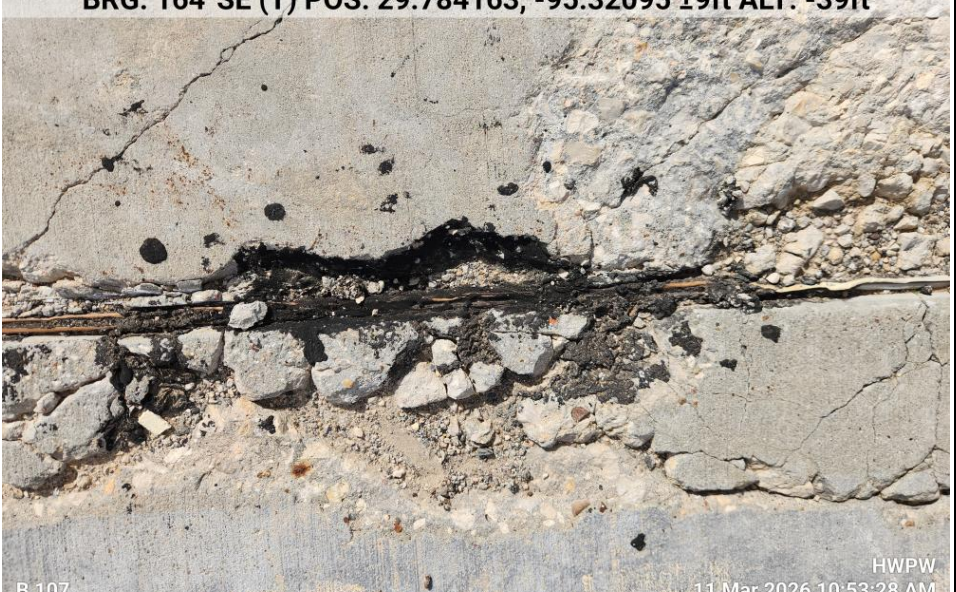
| <b>Description:</b><br>B107 weekly inspection of joint. Surrounding concrete in good condition. No active NAPL seep observed along joint.<br>Lat: 29.78416<br>Long: -95.32095 | | |

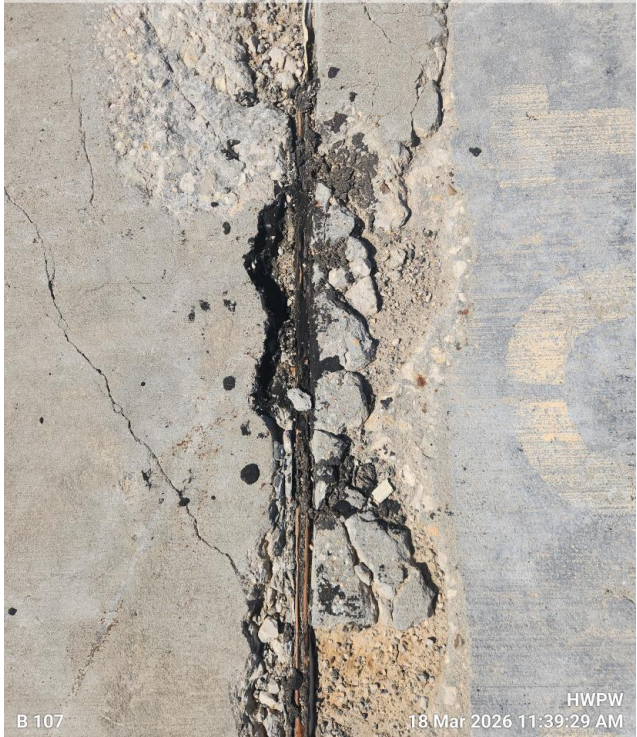
| <b>Description:</b><br>B107 weekly inspection of joint. Surrounding concrete in good condition. No active NAPL seep observed along joint.<br><br>Lat: 29.78415<br>Long: -95.32096 | | | |

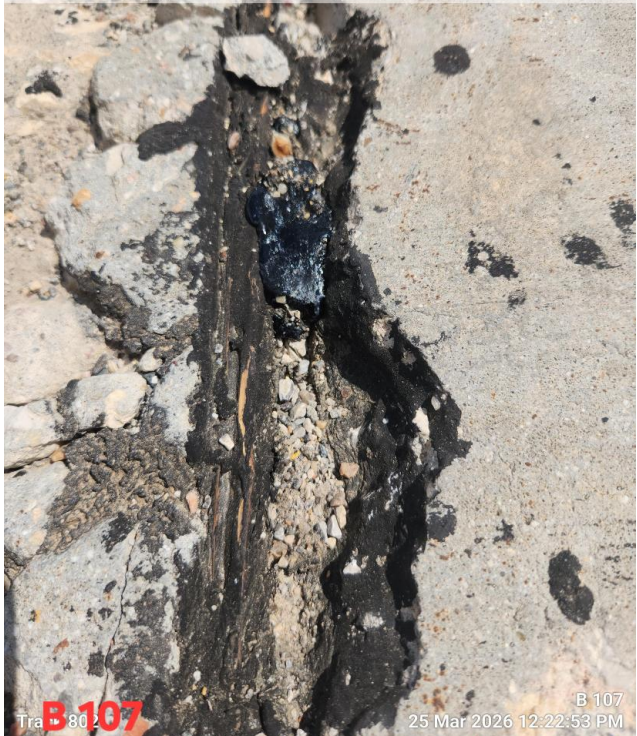
| <b>Description:</b><br>B107 weekly inspection of joint. Surrounding concrete in good condition. Approximately 2 cubic inches of NAPL observed at seep location.<br><br>Lat: 29.78415<br>Long: -95.32096 | | | |

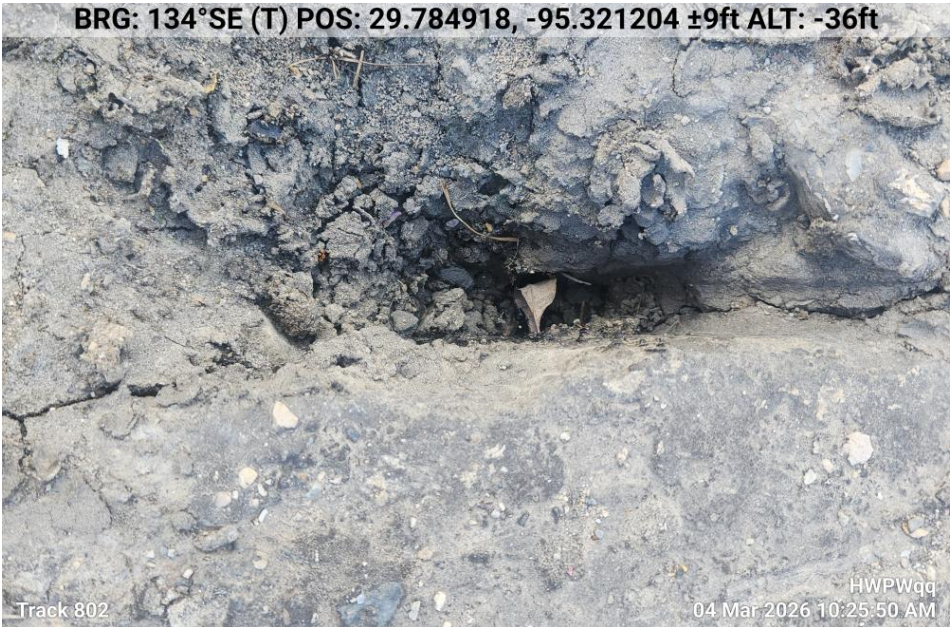
| <b>Description:</b><br>Track 802 weekly inspection of track. Surrounding concrete and ballast in good condition. Approximately 3.5 cubic inches of NAPL observed at seep location.<br><br>Lat: 29.78497<br>Long: -95.32121 | | <b>Description:</b><br>Track 802 weekly inspection of track. Surrounding concrete and ballast in good condition. Approximately 3.5 cubic inches of NAPL observed at seep location.<br><br>Lat: 29.78495<br>Long: -95.32118 | |
