May 14, 2026

Project No. US0039040.3990

**Re: MONTHLY STATUS UPDATE – ENGLEWOOD INTERMODAL YARD – REVISED INTERIM MEASURES  
WORK PLAN POST-CONSTRUCTION AND NAPL COLLECTION SYSTEM/CONCRETE CAP REPAIR  
INSPECTIONS  
UNION PACIFIC RAILROAD HOUSTON WOOD PRESERVING WORKS FACILITY  
4910 LIBERTY ROAD FACILITY, HOUSTON, TEXAS  
POST-CLOSURE CARE PERMIT NO. HW-50343; INDUSTRIAL SWR NO. 31547**

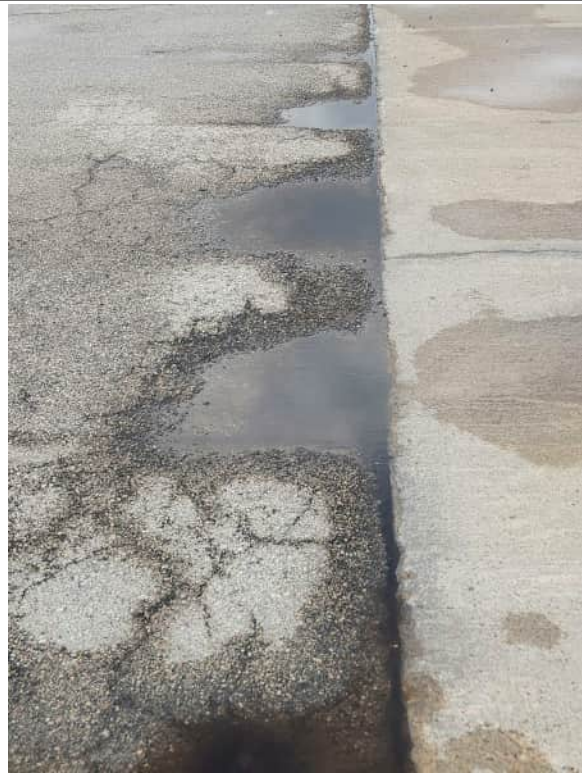
| <b>Description:</b><br>FE-6 weekly inspection of asphalt cap. Reconstructed cap in good condition. No NAPL observed at FE location. Brown standing water was along the joint perpendicular to western edge of FE-6. Facing southwest.<br><br>Lat: 29.78542<br>Long: -95.31841 | | |

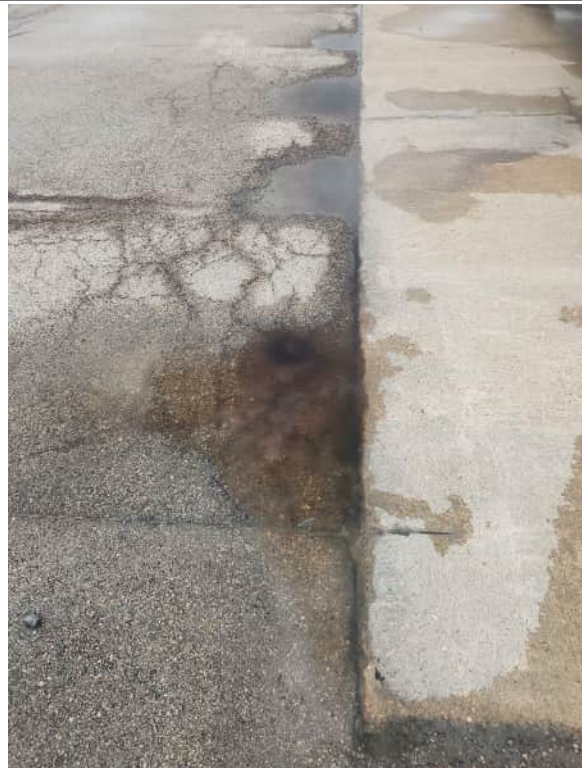
| <b>Description:</b><br>FE-6 weekly inspection of asphalt cap. Reconstructed cap in good condition. No NAPL observed at FE location. Brown standing water was along the joint perpendicular to western edge of FE-6. Facing southwest.<br><br>Lat: 29.78542<br>Long: -95.31839 | | |

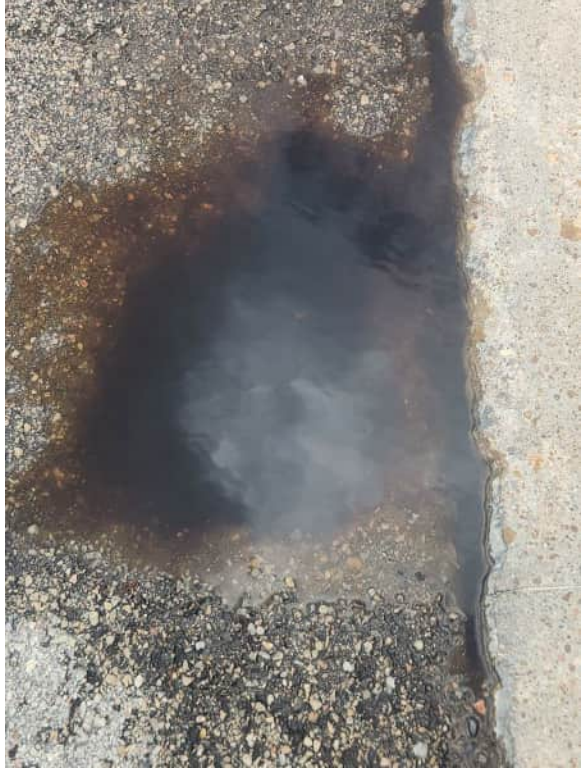
| <b>Description:</b><br>FE-6 weekly inspection of asphalt cap. Reconstructed cap in good condition. No NAPL observed at FE location. Brown standing water was along the joint perpendicular to western edge of FE-6. Facing southwest.<br><br>Lat: 29.78542<br>Long: -95.31839 | | |

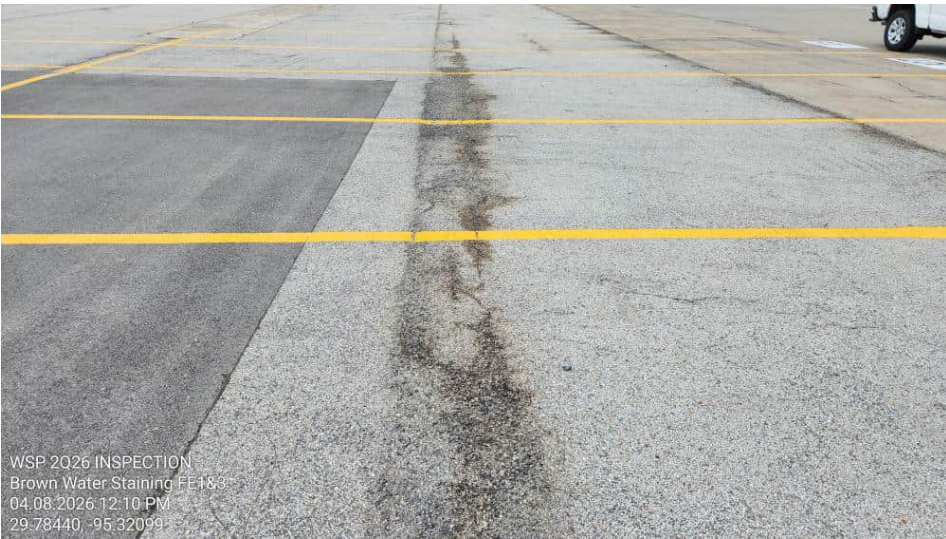
| <b>Photo No.</b><br>18 | <b>Inspection Date:</b><br>04/08/2026 | <b>Description:</b><br>FE-1&3 weekly inspection of asphalt cap. View of minor brown water staining observed on pavement to the north of the reconstructed cap. Cap in good condition. No NAPL observed at FE location. Facing west.<br>Lat: 29.7844<br>Long: -95.32099<br><br>WSP 2026 INSPECTION<br>Brown Water Staining FE1&3<br>04.08.2026 12:10 PM<br>29.78440 -95.32099 |

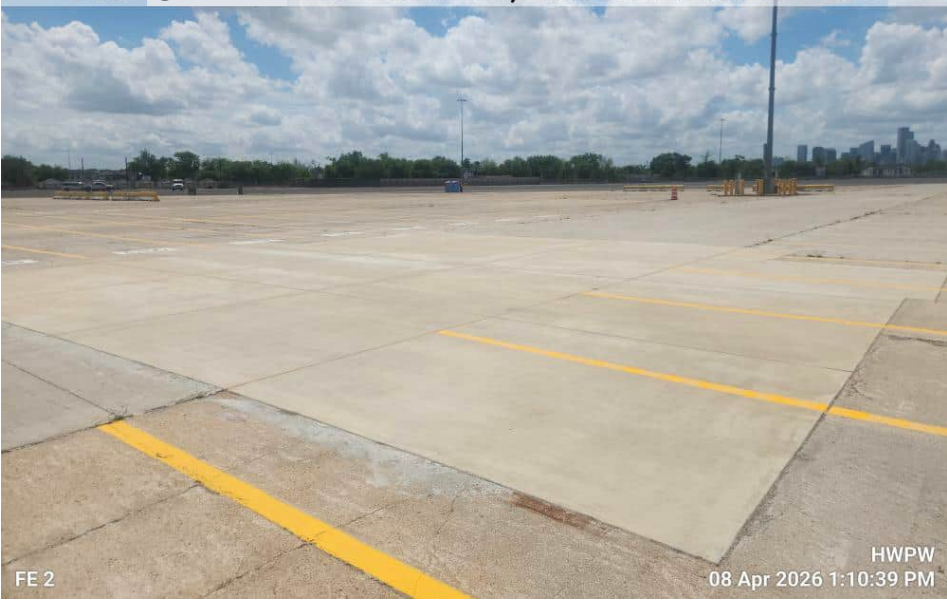
| <b>Description:</b><br>FE-2 weekly inspection of concrete cap.<br>Reconstructed cap in good condition. No NAPL observed at FE location. Facing southwest.<br><br>Lat: 29.78431<br>Long: -95.32077 | | | |

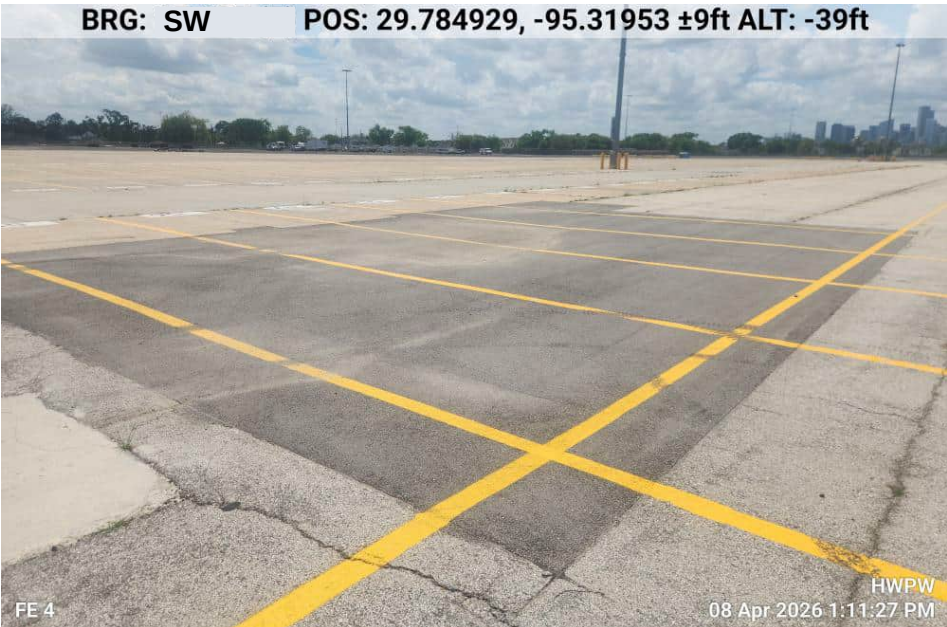
| <b>Description:</b><br>FE-4 weekly inspection of asphalt cap.<br>Reconstructed cap in good condition. No NAPL observed at FE location. Facing southwest.<br><br>Lat: 29.78493<br>Long: -95.31953 | | | |

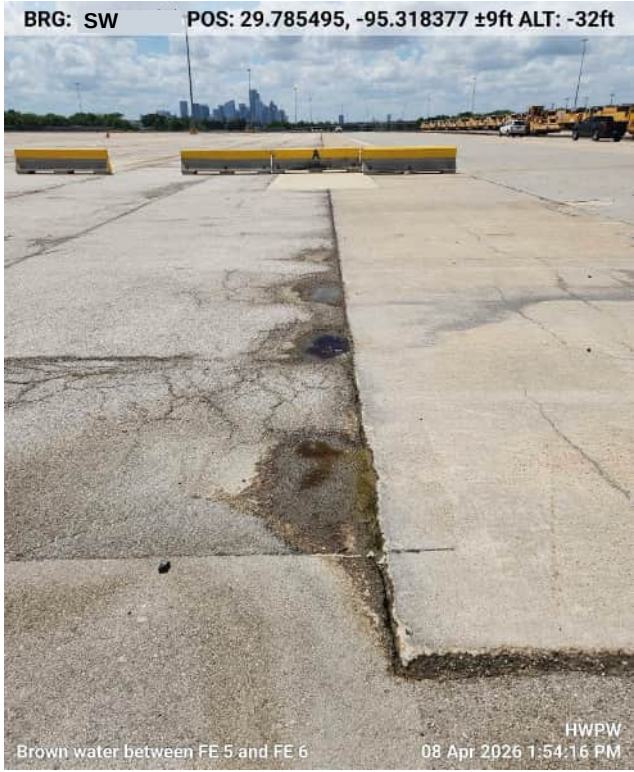
| <b>Photo No.</b><br>25 | <b>Inspection Date:</b><br>04/08/2026 | <div><div>BRG: SW      POS: 29.785495, -95.318377 ±9ft ALT: -32ft</div><div>Brown water between FE 5 and FE 6<br/>HWPW<br/>08 Apr 2026 1:54:16 PM</div></div> |
| <b>Description:</b><br>FE-6 weekly inspection of asphalt cap. Reconstructed cap in good condition. No NAPL observed at FE location. Brown standing water was along the joint perpendicular to western edge of FE-6. Facing southwest.<br><br>Lat: 29.7855<br>Long: -95.31838 | | |

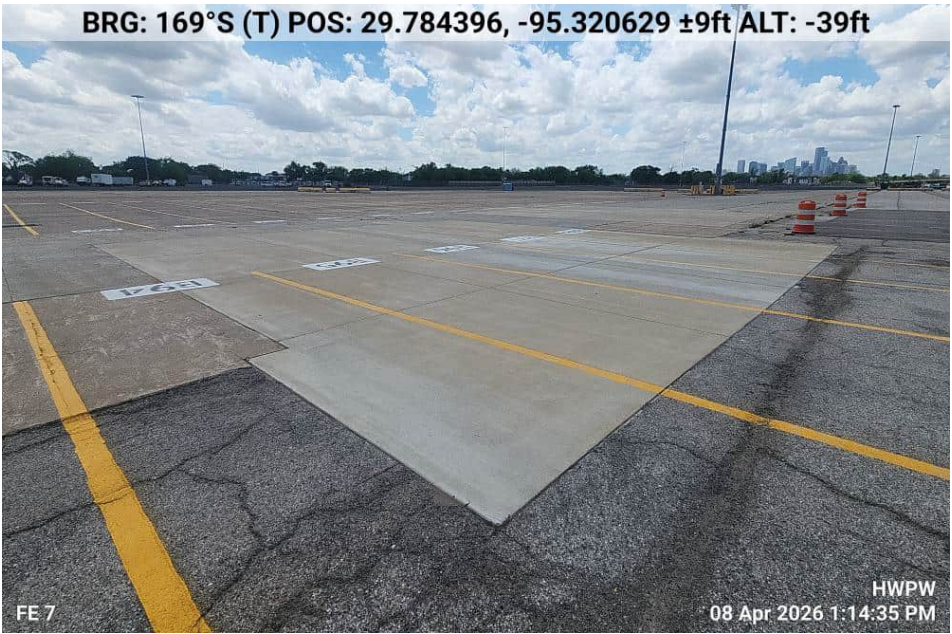
| <b>Description:</b><br>FE-7 weekly inspection of concrete cap. Reconstructed cap in good condition. No NAPL observed at FE location. Facing south.<br><br>Lat: 29.7844<br>Long: -95.32063 | | |

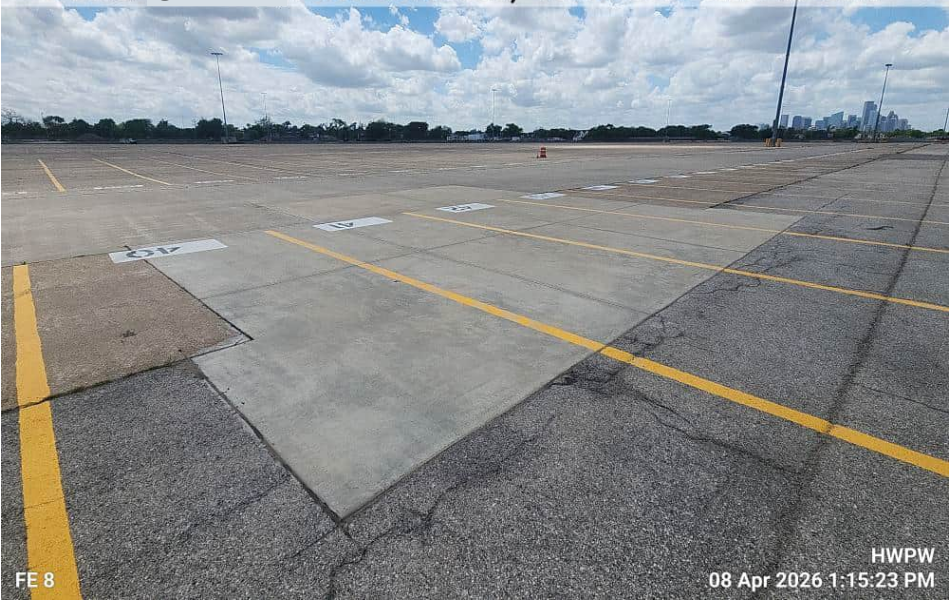
| <b>Description:</b><br>FE-8 weekly inspection of concrete cap.<br>Reconstructed cap in good condition. No NAPL observed at FE location. Facing south.<br><br>Lat: 29.78505<br>Long: -95.3191 | | <br>FE 8<br>HWPW<br>08 Apr 2026 1:15:23 PM | |

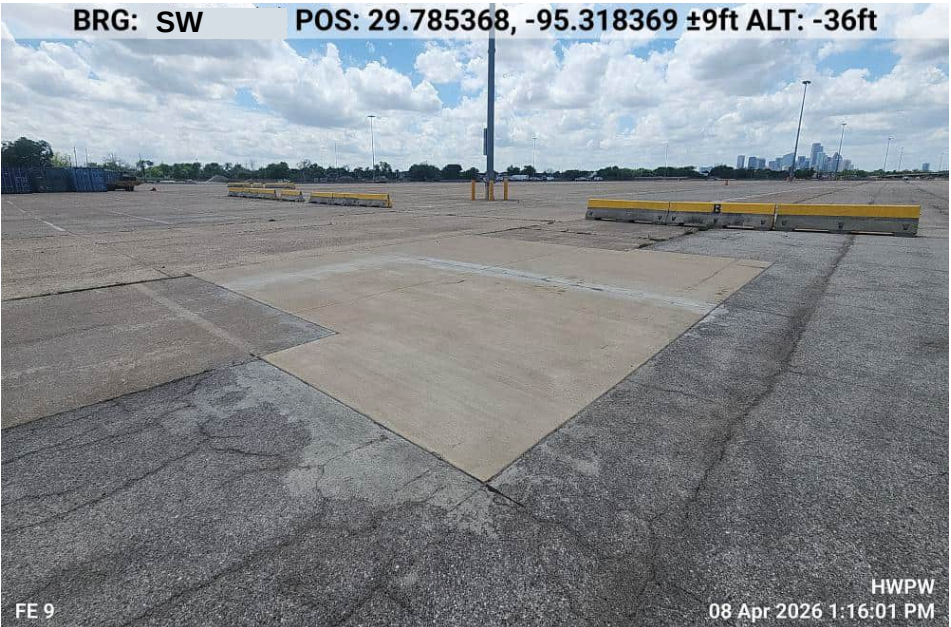
| <b>Description:</b><br>FE-9 weekly inspection of concrete cap.<br>Reconstructed cap in good condition. No NAPL observed at FE location. Facing southwest.<br><br>Lat: 29.78537<br>Long: -95.31837 | | <br>FE 9<br>HWPW<br>08 Apr 2026 1:16:01 PM | |

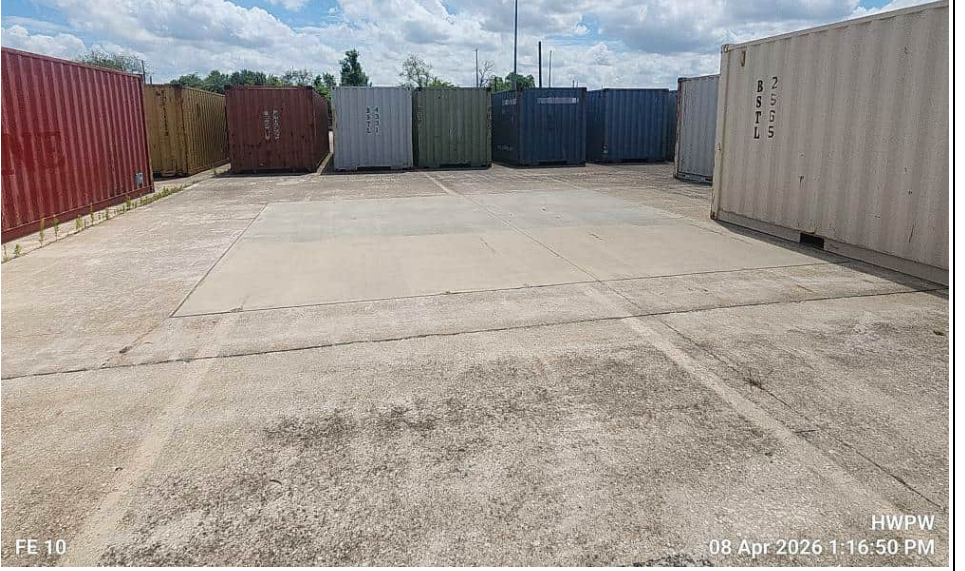
| <b>Description:</b><br>FE-10 weekly inspection of concrete cap.<br>Reconstructed cap in good condition. No NAPL observed at FE location. Facing southeast.<br><br>Lat: 29.785<br>Long: -95.31776 | | |

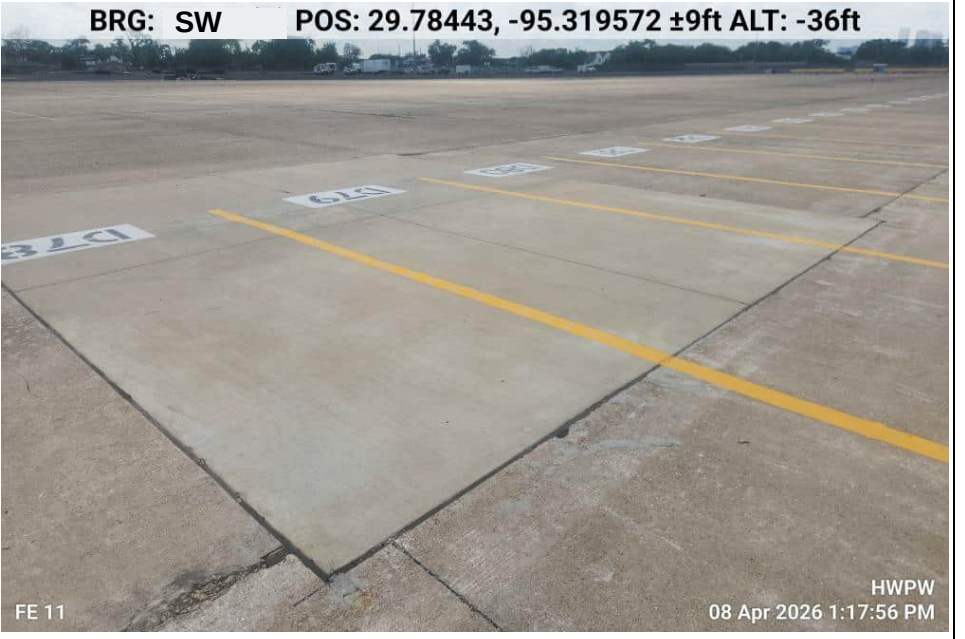
| <b>Description:</b><br>FE-11 weekly inspection of concrete cap.<br>Reconstructed cap in good condition. No NAPL observed at FE location. Facing southwest.<br><br>Lat: 29.78443<br>Long: -95.31957 | | |

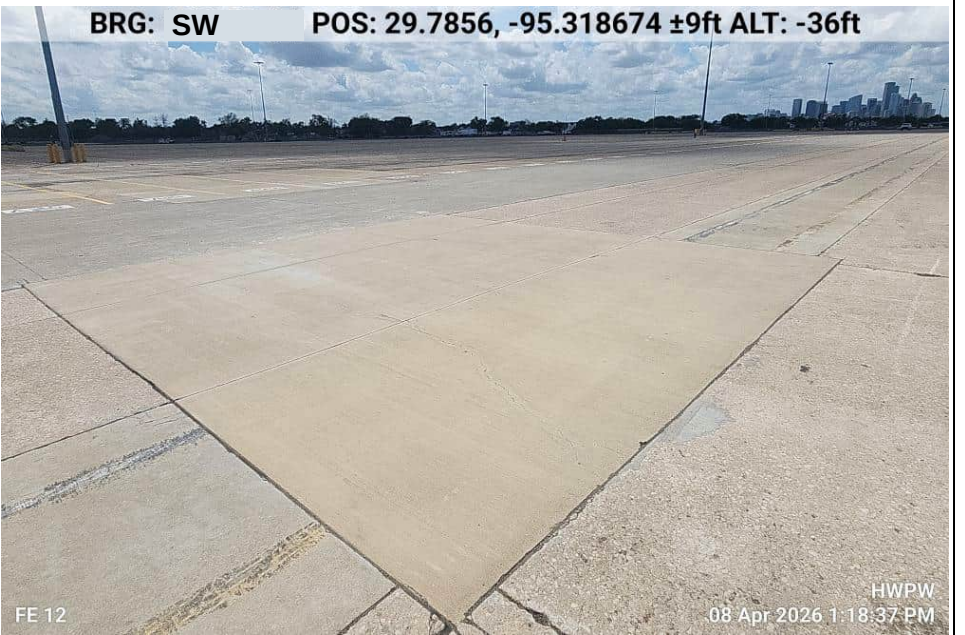
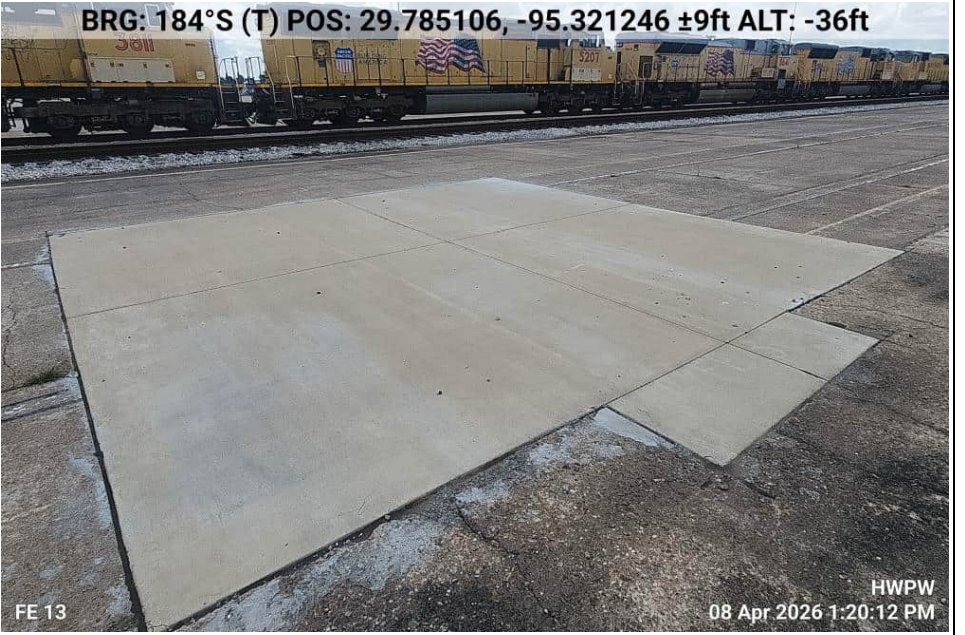
| <b>Description:</b><br>FE-12 weekly inspection of concrete cap.<br>Reconstructed cap in good condition. No NAPL observed at FE location. Facing southwest.<br><br>Lat: 29.7856<br>Long: -95.31867 | | <b>Description:</b><br>FE-13 weekly inspection of concrete cap.<br>Reconstructed cap in good condition. No NAPL observed at FE location. Facing south.<br><br>Lat: 29.78511<br>Long: -95.32125 | |

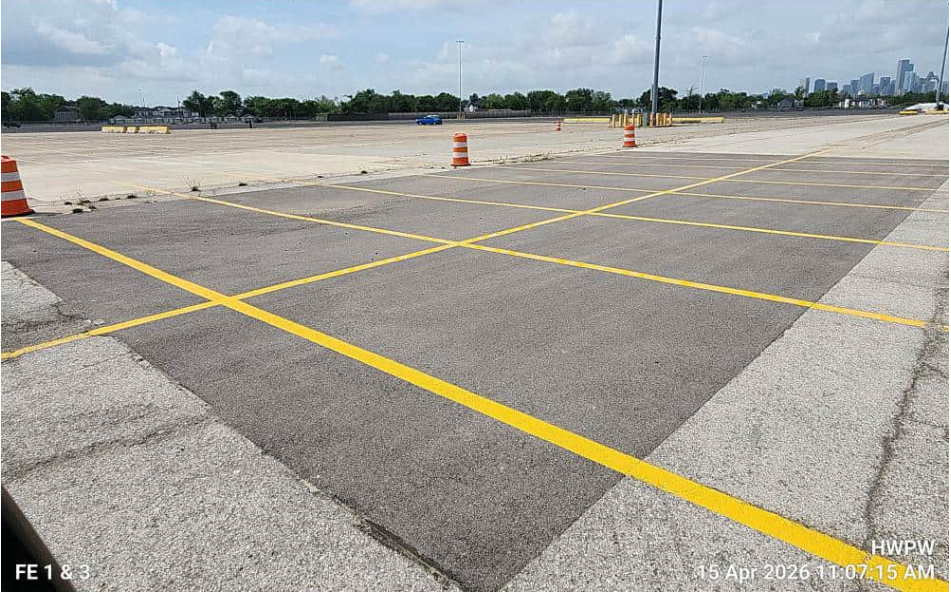
FE-1&3 weekly inspection of asphalt cap.  
Reconstructed cap in good condition. No NAPL  
observed at FE location. Facing southwest.

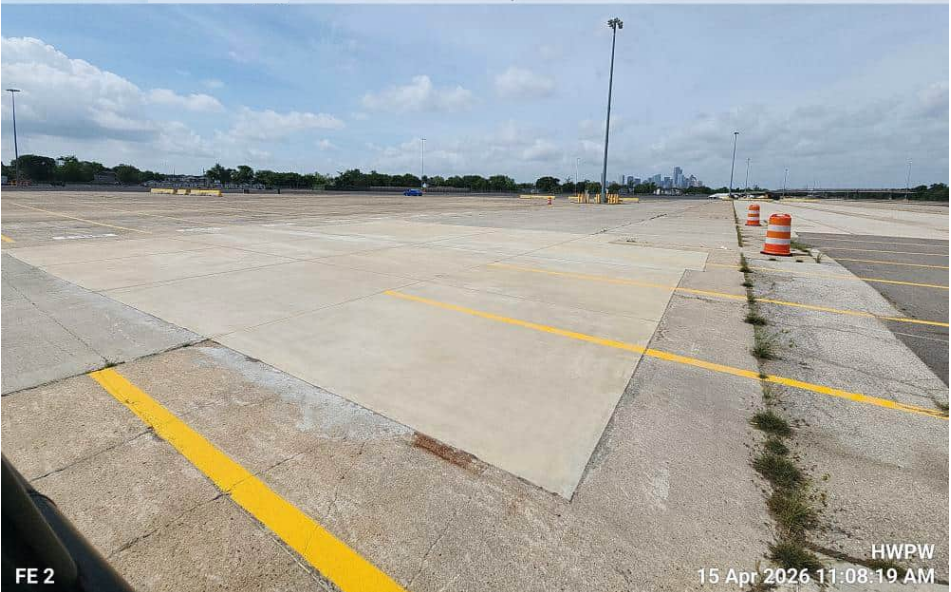
FE-2 weekly inspection of concrete cap.  
Reconstructed cap in good condition. No NAPL  
observed at FE location. Facing southwest.

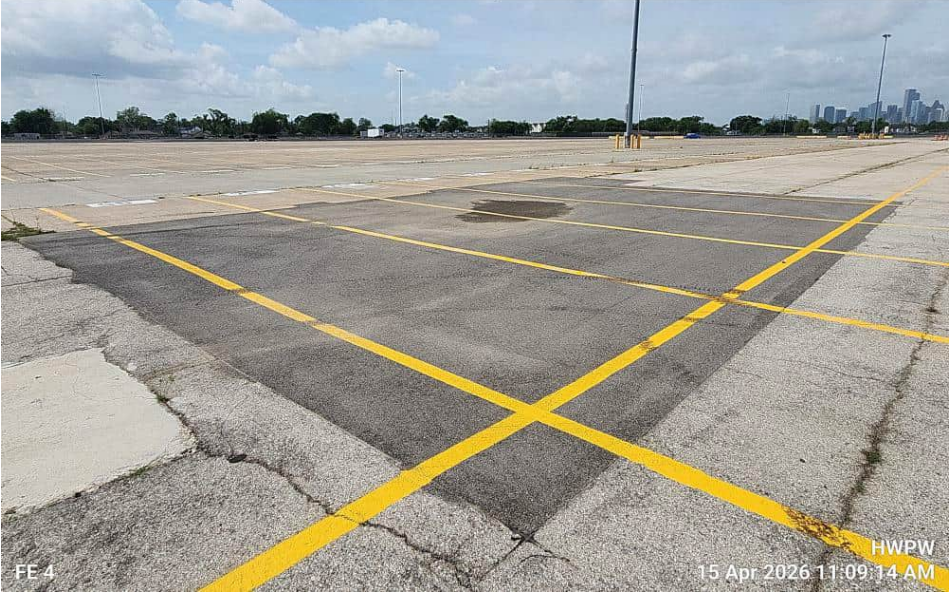
| wsp | | PHOTOGRAPH LOG |
|---|---|---|
| <b>Description:</b><br>FE-4 weekly inspection of asphalt cap. Reconstructed cap in good condition. No NAPL observed at FE location. Standing water from recent rain event. Facing southwest.<br><br>Lat: 29.78494<br>Long: -95.31955 | | <b>BRG: S      POS: 29.785432, -95.318725 ±9ft ALT: -42ft</b><br> <p>FE 5</p> <p>HWPW<br/>15 Apr 2026 11:10:33 AM</p> |

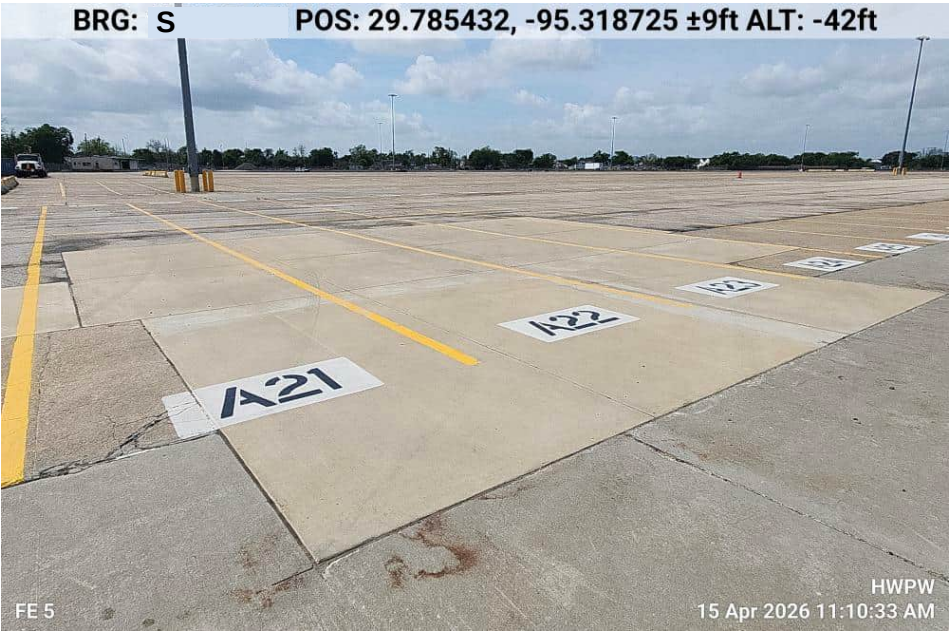
| wsp | | PHOTOGRAPH LOG |
|---|---|---|
| <b>Description:</b><br>FE-5 weekly inspection of concrete cap. Reconstructed cap in good condition. No NAPL observed at FE location. Brown water staining along the southern joint of FE-5 observed. Facing south.<br><br>Lat: 29.78429<br>Long: -95.31873 | | |

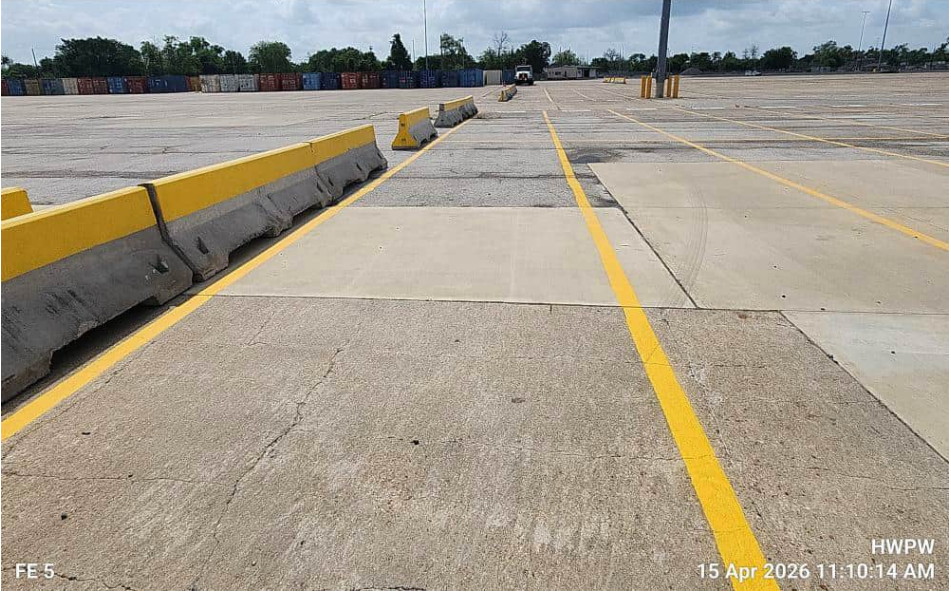
| <b>Description:</b><br>FE-5 weekly inspection of concrete cap.<br>Reconstructed cap in good condition. No NAPL observed at FE location. Brown water staining along the southern joint of FE-5 observed. Facing southeast.<br><br>Lat: 29.78543<br>Long: -95.31867 | | <b>Photo No.</b><br>38 | <b>Inspection Date:</b><br>04/15/2026 |

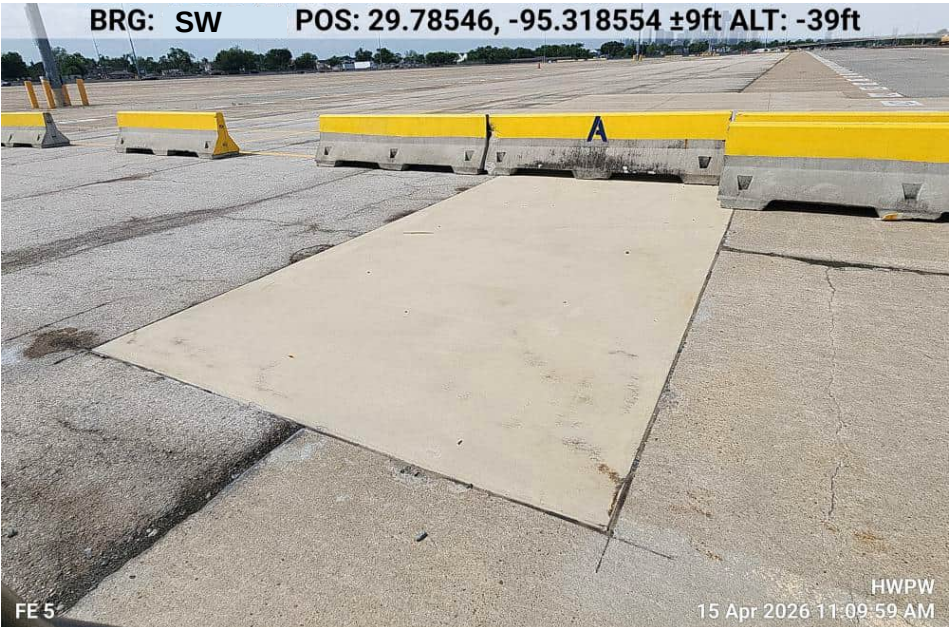
| <b>Description:</b><br>FE-5 weekly inspection of concrete cap.<br>Reconstructed cap in good condition. No NAPL observed at FE location. Brown water staining along the southern joint of FE-5 observed. Facing southwest.<br><br>Lat: 29.78546<br>Long: -95.31855 | | <b>BRG: SW      POS: 29.78546, -95.318554 ±9ft ALT: -39ft</b><br><br>FE 5<br>HWPW<br>15 Apr 2026 11:09:59 AM | |

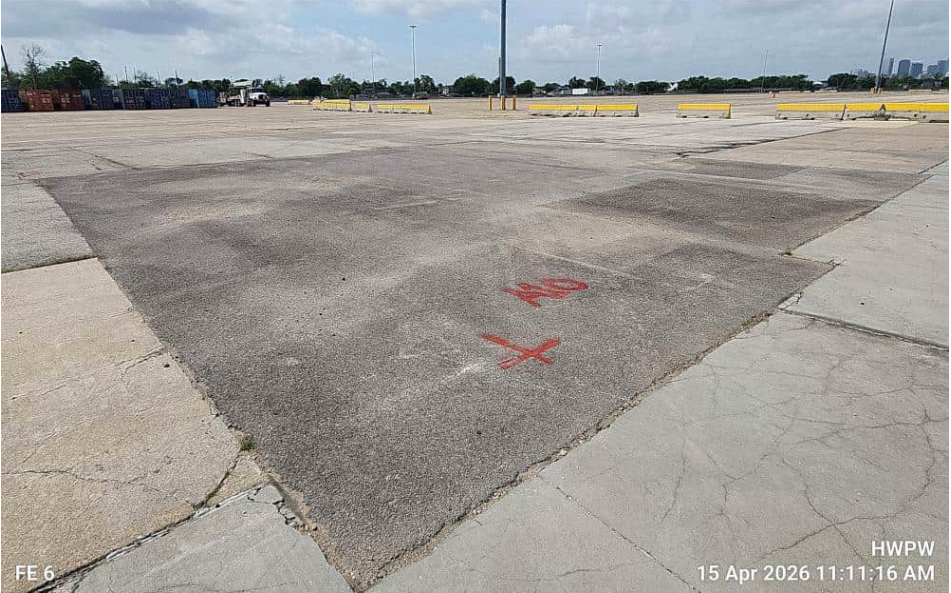
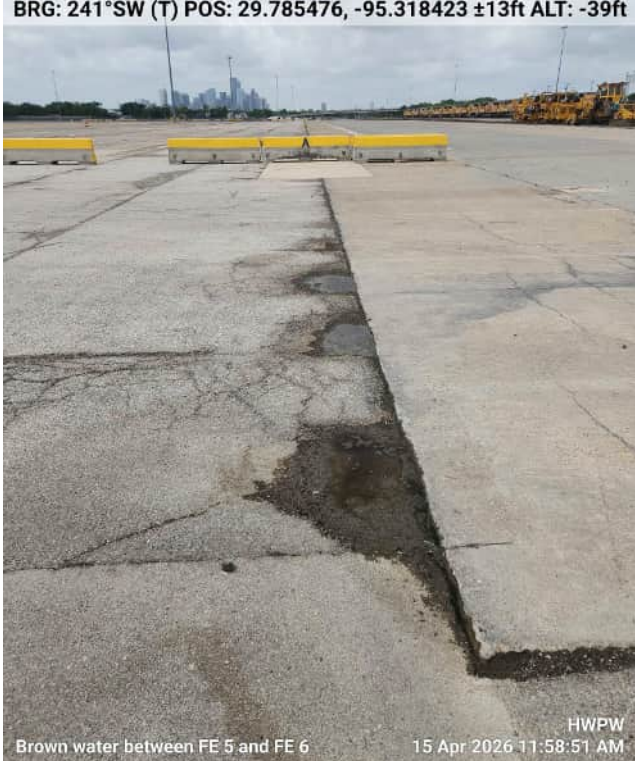
| <b>Description:</b><br>FE-6 weekly inspection of asphalt cap. Reconstructed cap in good condition. No NAPL observed at FE location. Brown standing water was along the joint perpendicular to western edge of FE-6. Facing south.<br>Lat: 29.7856<br>Long: -95.31835 | | <b>Description:</b><br>FE-6 weekly inspection of asphalt cap. Reconstructed cap in good condition. No NAPL observed at FE location. Brown standing water was along the joint perpendicular to western edge of FE-6. Facing southwest.<br>Lat: 29.78548<br>Long: -95.31842 | |

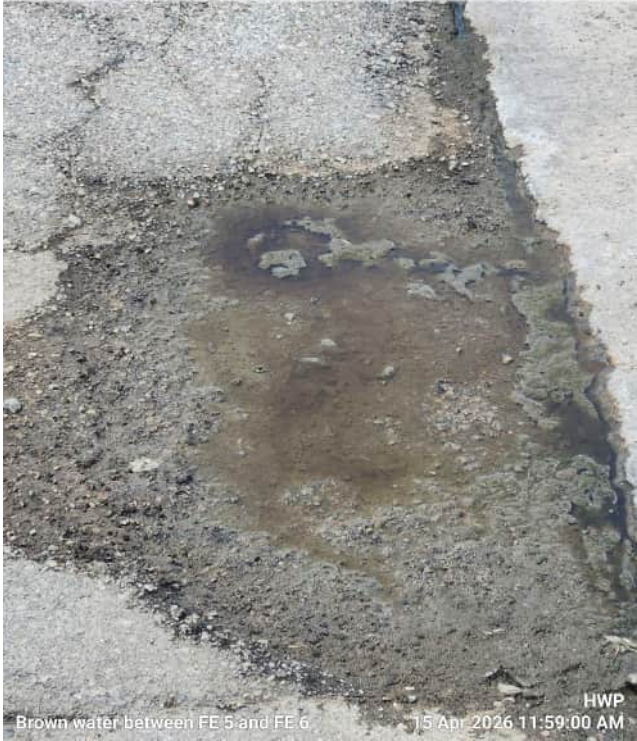
| <b>Description:</b><br>FE-6 weekly inspection of asphalt cap. Reconstructed cap in good condition. No NAPL observed at FE location. Brown standing water was along the joint perpendicular to western edge of FE-6. Facing southwest.<br><br>Lat: 29.78545<br>Long: -95.31841 | | <div> <b>BRG: S</b> <b>POS: 29.784395, -95.320651 ±13ft ALT: -36ft</b> </div> <div> FE 7 <span style="float: right;">HWPW<br/>15 Apr 2026 11:12:29 AM</span> </div> | |

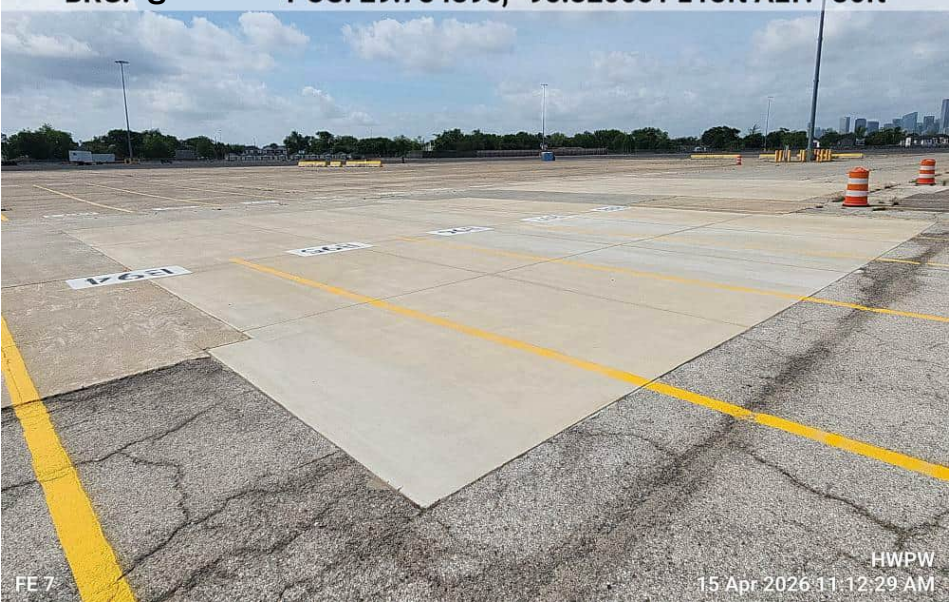
| <b>Photo No.</b><br>42 | <b>Inspection Date:</b><br>04/15/2026 | <b>Description:</b><br>FE-7 weekly inspection of concrete cap. Reconstructed cap in good condition. No NAPL observed at FE location. Facing south.<br><br>Lat: 29.7844<br>Long: -95.32065 | |

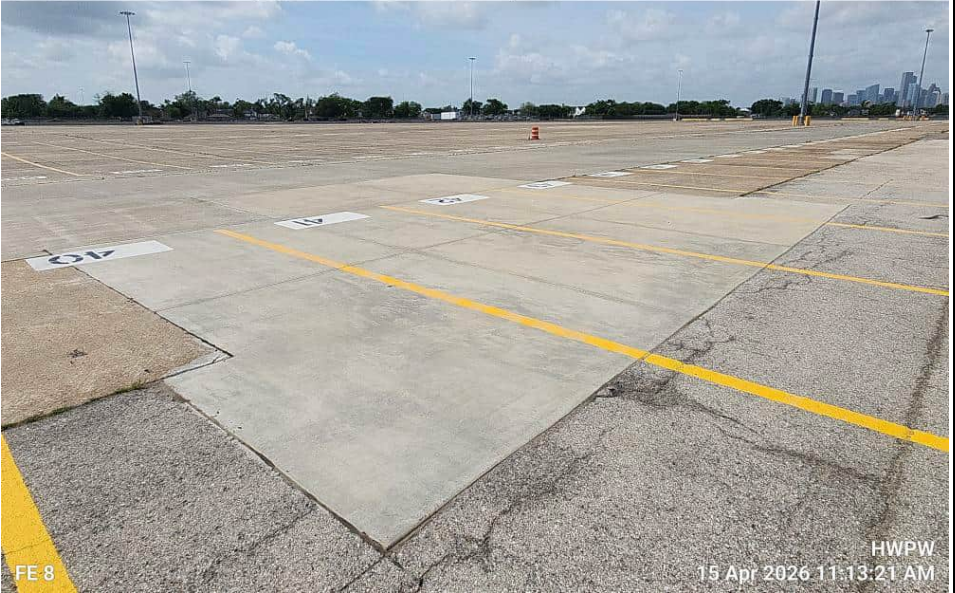
| <b>Description:</b><br>FE-8 weekly inspection of concrete cap.<br>Reconstructed cap in good condition. No NAPL observed at FE location. Facing south.<br><br>Lat: 29.78506<br>Long: -95.31911 | | <p>FE 8</p> <p>HWPW<br/>15 Apr 2026 11:13:21 AM</p> | |

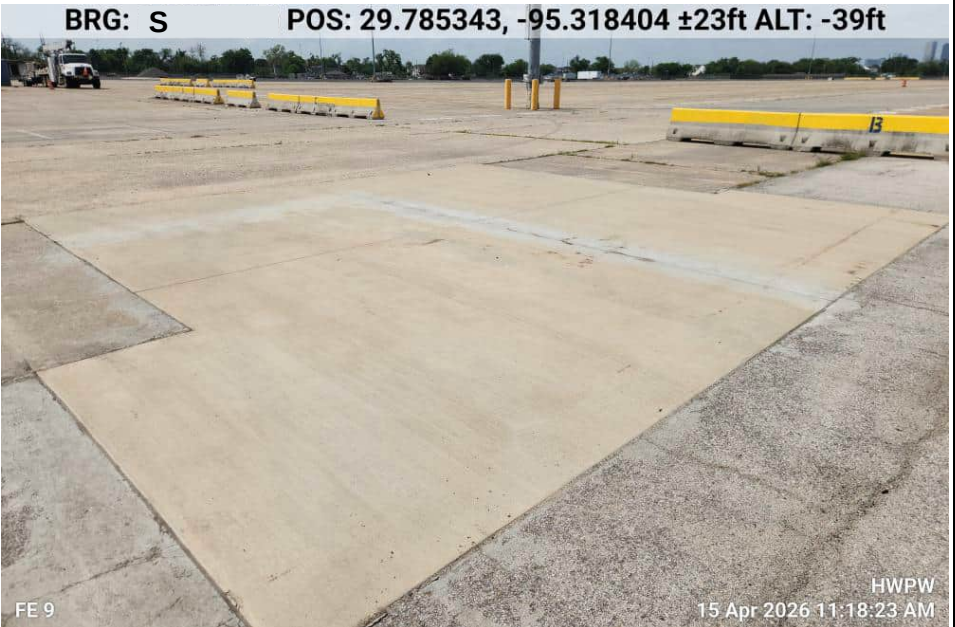
| <b>Description:</b><br>FE-9 weekly inspection of concrete cap.<br>Reconstructed cap in good condition. No NAPL observed at FE location. Facing south.<br><br>Lat: 29.78534<br>Long: -95.3184 | | <p>FE 9</p> <p>HWPW<br/>15 Apr 2026 11:18:23 AM</p> | |

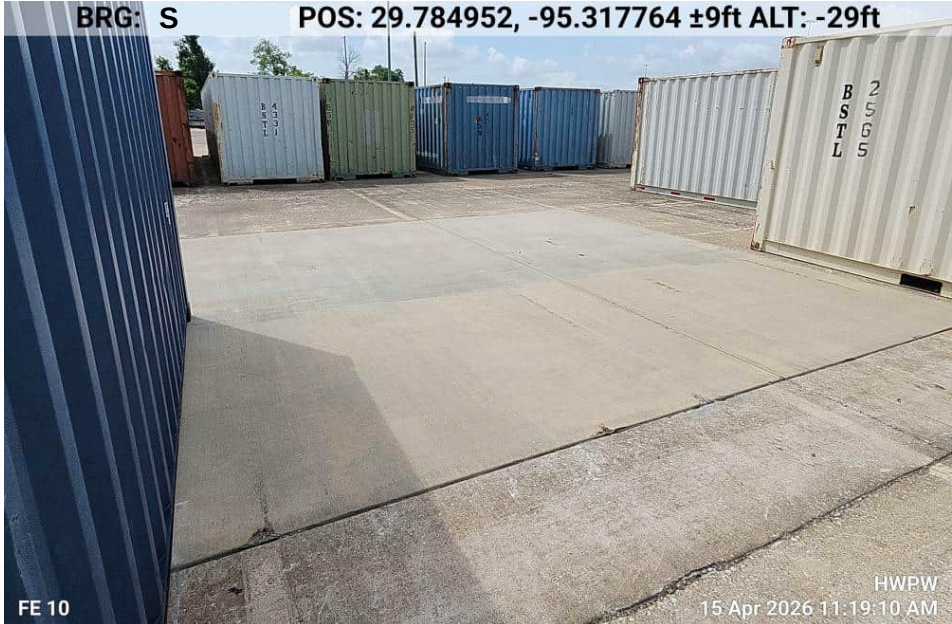
| <b>Description:</b><br>FE-10 weekly inspection of concrete cap.<br>Reconstructed cap in good condition. No NAPL observed at FE location. Facing south.<br><br>Lat: 29.78495<br>Long: -95.31776 | | | |

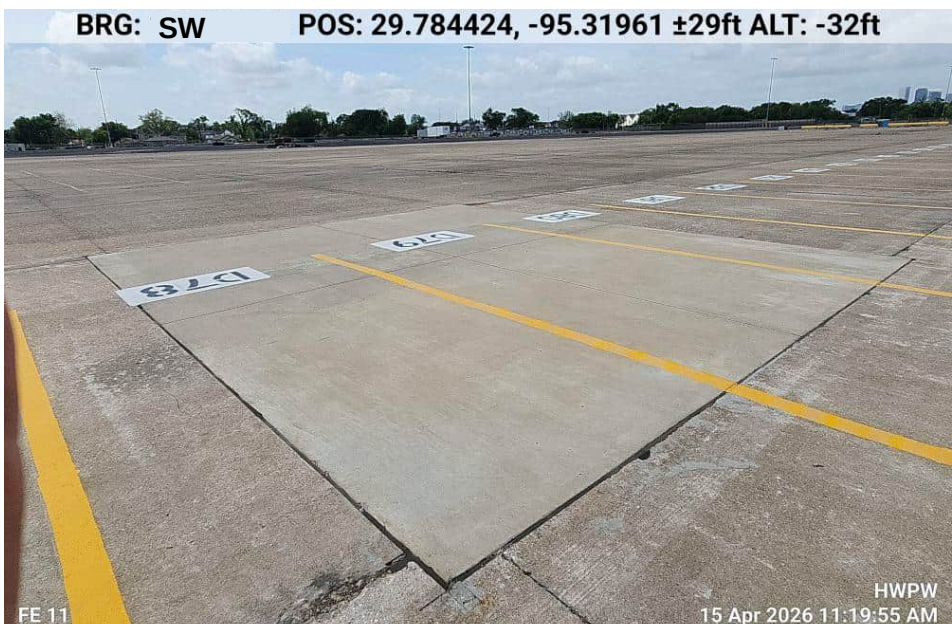
| <b>Description:</b><br>FE-11 weekly inspection of concrete cap.<br>Reconstructed cap in good condition. No NAPL observed at FE location. Facing southwest.<br><br>Lat: 29.78442<br>Long: -95.31961 | | | |

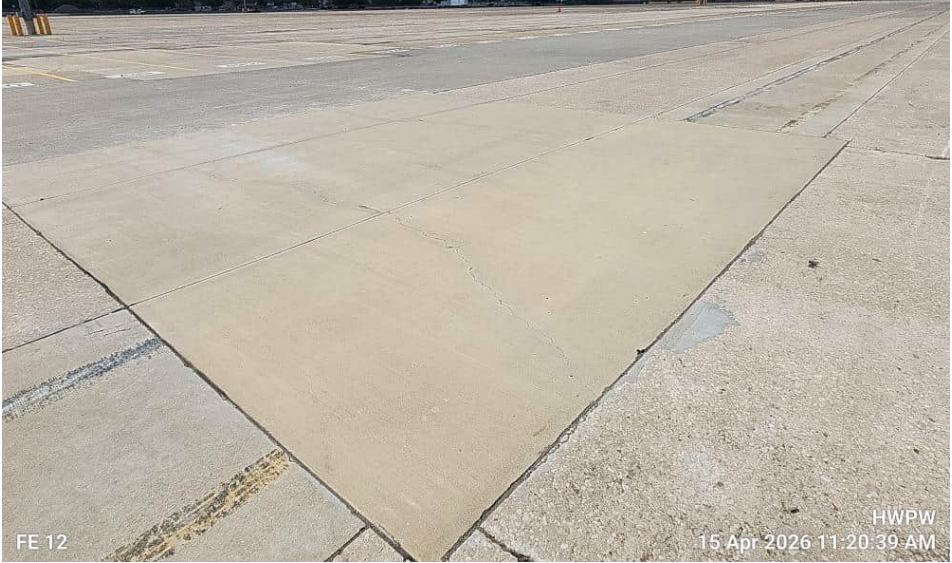
| <b>Description:</b><br>FE-12 weekly inspection of concrete cap.<br>Reconstructed cap in good condition. No NAPL observed at FE location. Facing southwest.<br><br>Lat: 29.78559<br>Long: -95.3187 | | |

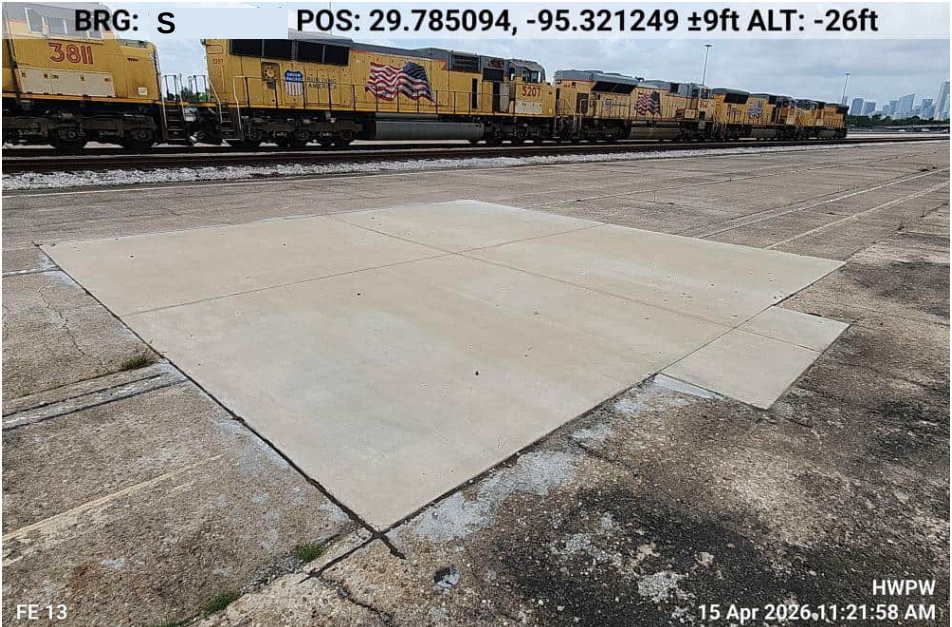
| <b>Description:</b><br>FE-13 weekly inspection of concrete cap.<br>Reconstructed cap in good condition. No NAPL observed at FE location. Facing south.<br><br>Lat: 29.78509<br>Long: -95.32125 | | |

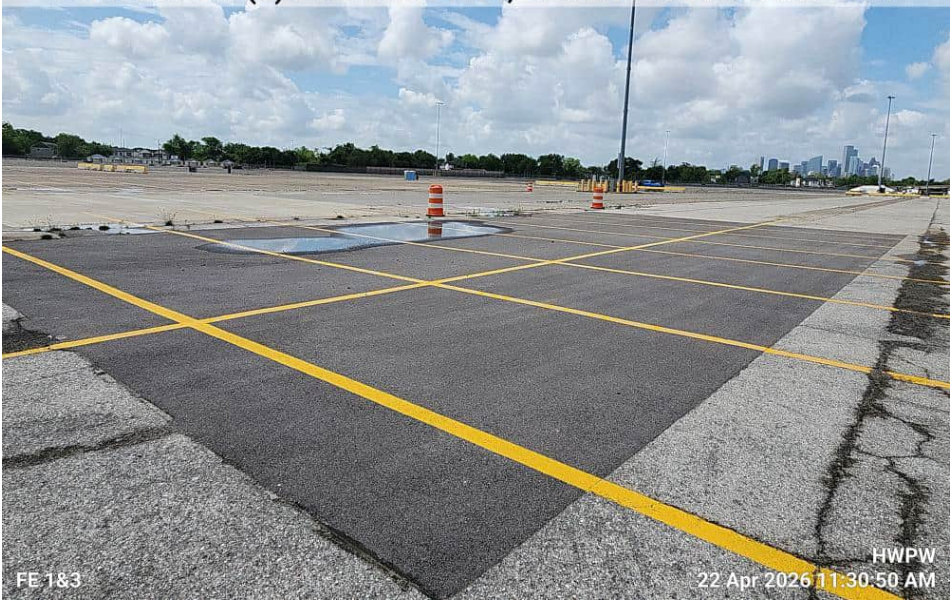
| <b>Description:</b><br>FE-1&3 weekly inspection of asphalt cap. Reconstructed cap in good condition. No NAPL observed at FE location. Standing water from recent rain event. Facing southwest.<br>Lat: 29.7844<br>Long: -95.32081 | | |

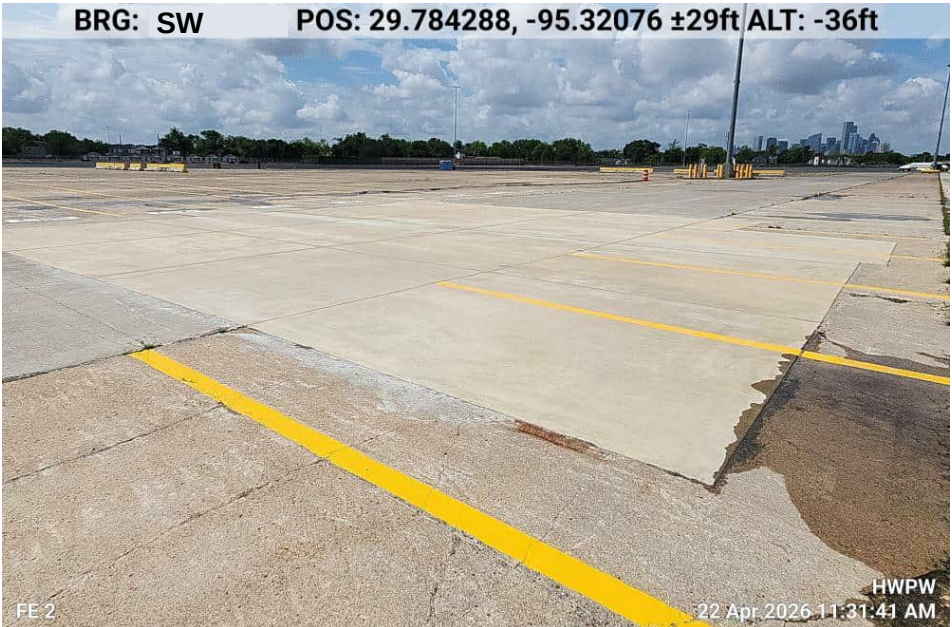
| <b>Description:</b><br>FE-2 weekly inspection of concrete cap. Reconstructed cap in good condition. No NAPL observed at FE location. Standing water from recent rain event. Facing southwest.<br>Lat: 29.78429<br>Long: -95.32076 | | |

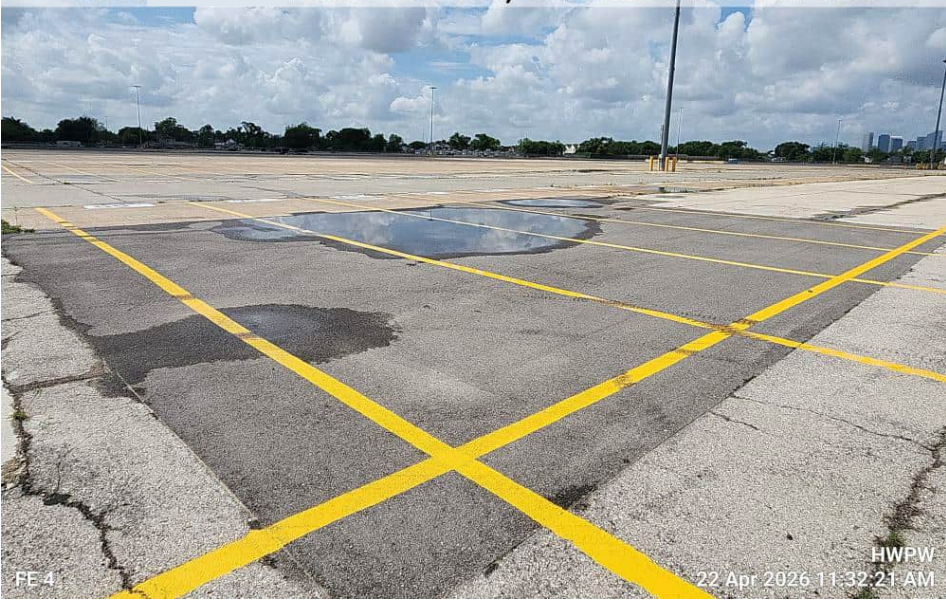
| <b>Description:</b><br>FE-4 weekly inspection of asphalt cap. Reconstructed cap in good condition. No NAPL observed at FE location. Standing water from recent rain event. Facing southwest.<br><br>Lat: 29.78494<br>Long: -95.31954 | | |

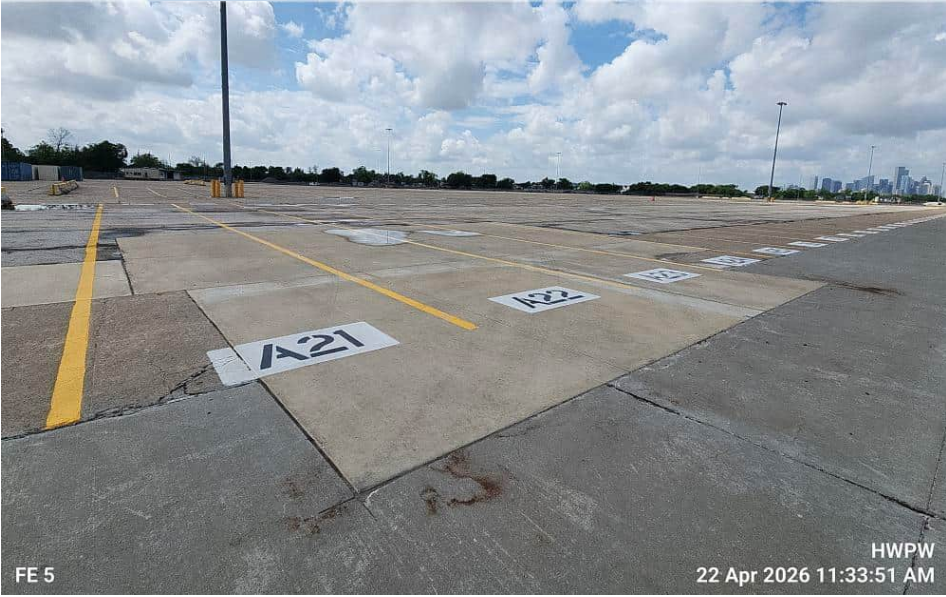
| <b>Description:</b><br>FE-5 weekly inspection of concrete cap. Reconstructed cap in good condition. No NAPL observed at FE location. Brown water staining along the southern joint of FE-5 observed. Standing water from recent rain event. Facing south.<br><br>Lat: 29.78544<br>Long: -95.31866 | | |

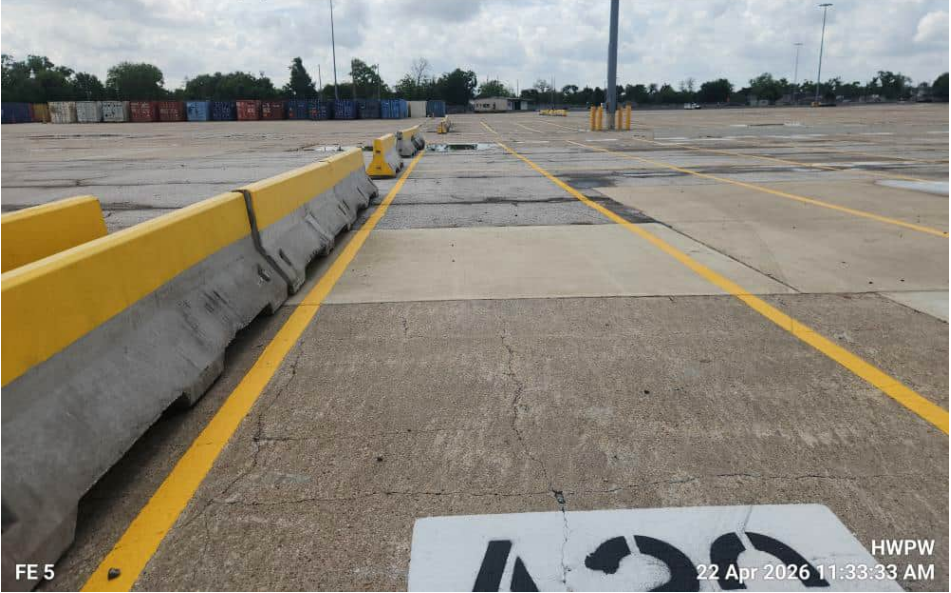
| <b>Description:</b><br>FE-5 weekly inspection of concrete cap.<br>Reconstructed cap in good condition. No NAPL observed at FE location. Brown water staining along the southern joint of FE-5 observed. Standing water from recent rain event. Facing southeast.<br><br>Lat: 29.78544<br>Long: -95.31861 | | <br>FE 5<br>HWPW<br>22 Apr 2026 11:33:33 AM | |

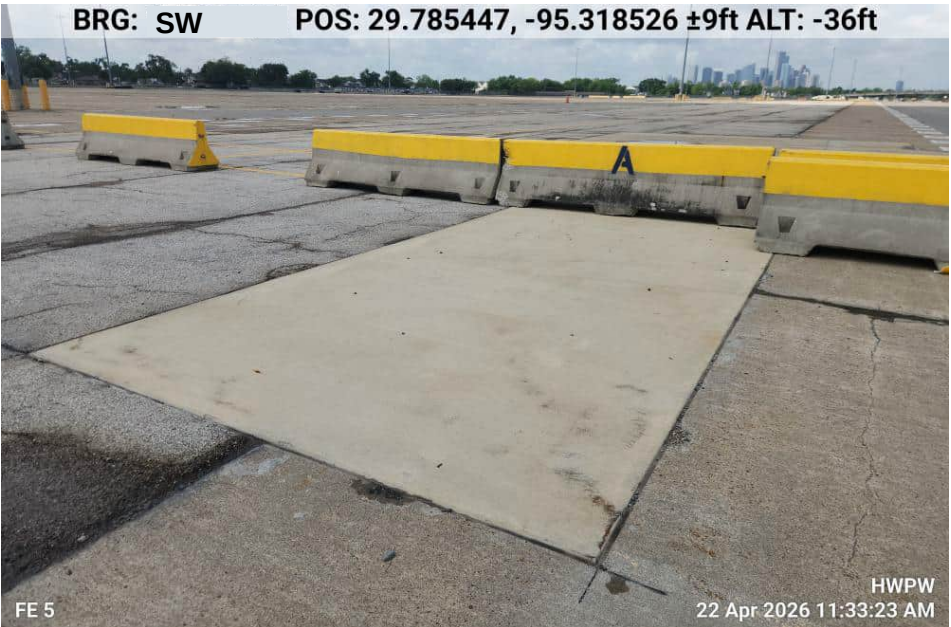
| <b>Description:</b><br>FE-5 weekly inspection of concrete cap.<br>Reconstructed cap in good condition. No NAPL observed at FE location. Brown water staining along the southern joint of FE-5 observed. Standing water from recent rain event. Facing southwest.<br><br>Lat: 29.78545<br>Long: -95.31853 | | <br>FE 5<br>HWPW<br>22 Apr 2026 11:33:23 AM | |
