May 14, 2026

Project No. US0039040.3990

**Re: MONTHLY STATUS UPDATE – ENGLEWOOD INTERMODAL YARD – REVISED INTERIM MEASURES  
WORK PLAN POST-CONSTRUCTION AND NAPL COLLECTION SYSTEM/CONCRETE CAP REPAIR  
INSPECTIONS  
UNION PACIFIC RAILROAD HOUSTON WOOD PRESERVING WORKS FACILITY  
4910 LIBERTY ROAD FACILITY, HOUSTON, TEXAS  
POST-CLOSURE CARE PERMIT NO. HW-50343; INDUSTRIAL SWR NO. 31547**

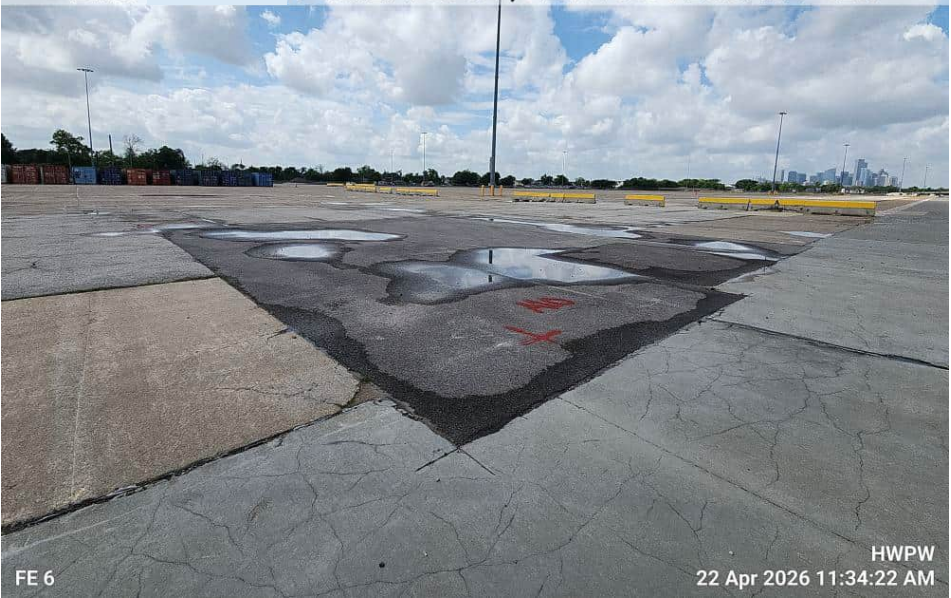
| <b>Description:</b><br>FE-6 weekly inspection of asphalt cap.<br>Reconstructed cap in good condition. No NAPL observed at FE location. Brown standing water was along the joint perpendicular to western edge of FE-6. Other standing water from recent rain event. Facing south.<br><br>Lat: 29.7856<br>Long: -95.31833 | | <br>FE 6<br>HWPW<br>22 Apr 2026 11:34:22 AM | |

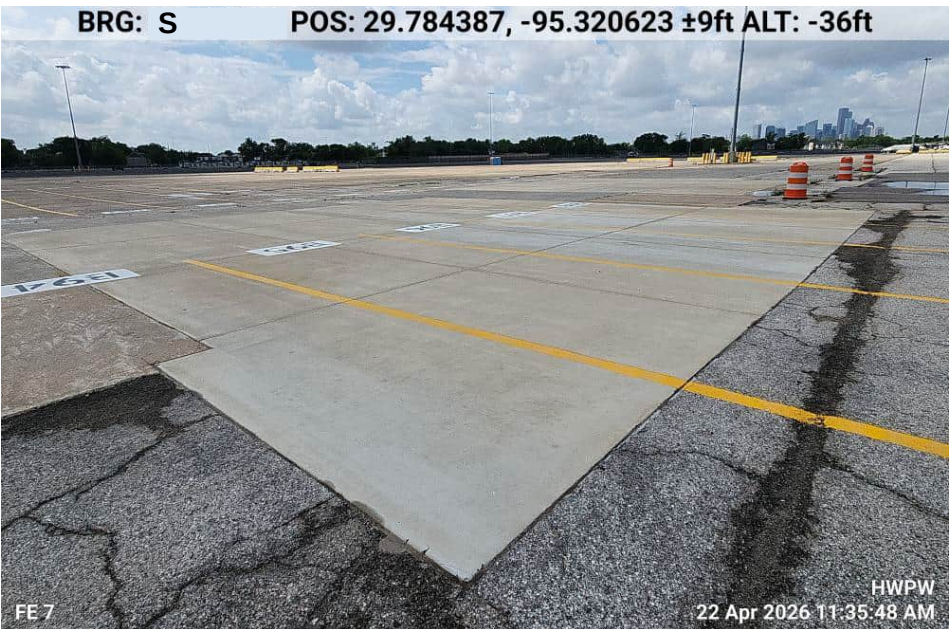
| <b>Description:</b><br>FE-7 weekly inspection of concrete cap.<br>Reconstructed cap in good condition. No NAPL observed at FE location. Standing water from recent rain event. Facing south.<br><br>Lat: 29.78439<br>Long: -95.32062 | | <br>FE 7<br>HWPW<br>22 Apr 2026 11:35:48 AM | |

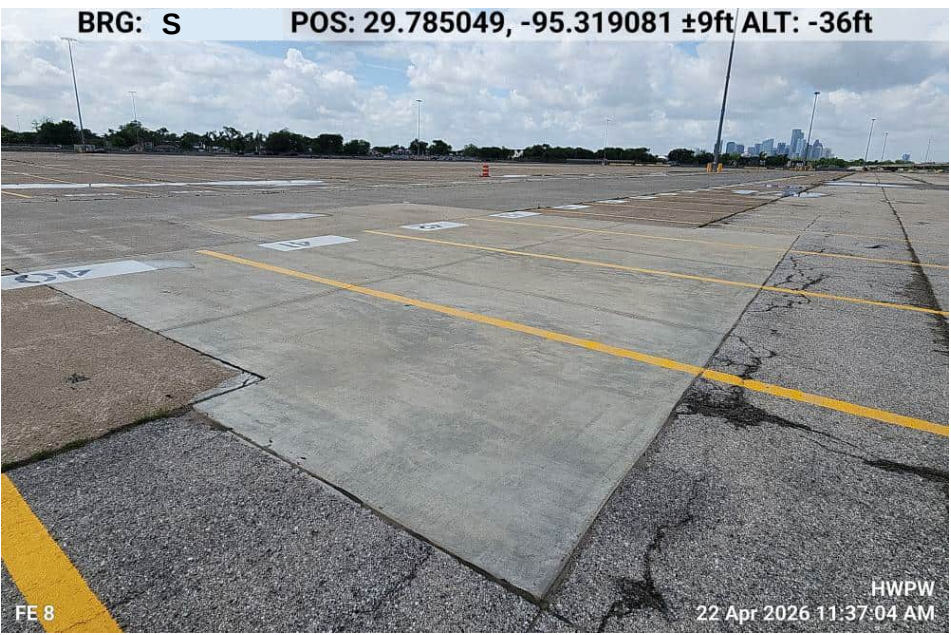
| <b>Description:</b><br>FE-8 weekly inspection of concrete cap.<br>Reconstructed cap in good condition. No NAPL observed at FE location. Standing water from recent rain event. Facing south.<br><br>Lat: 29.78505<br>Long: -95.31908 | | |

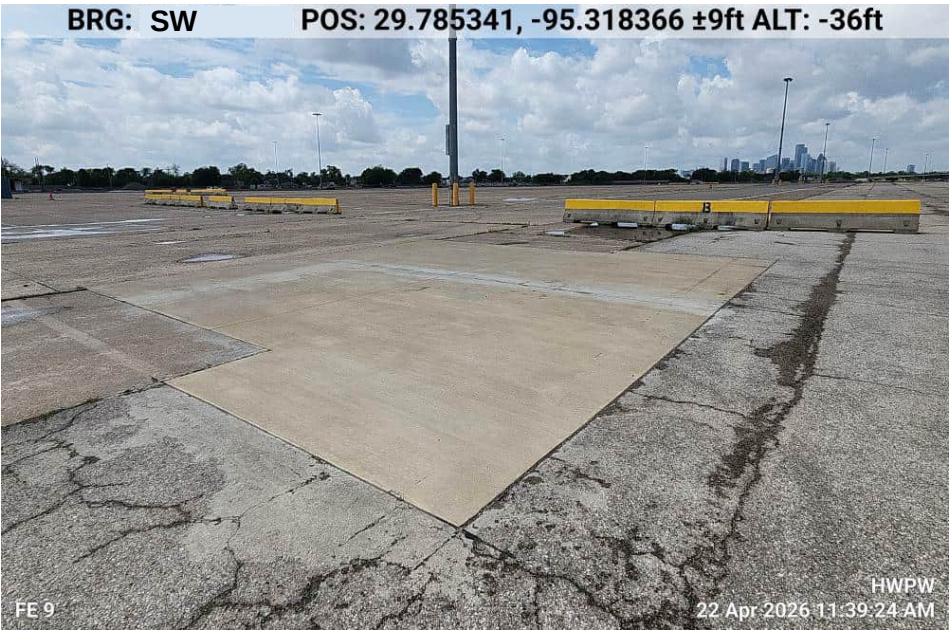
| <b>Description:</b><br>FE-9 weekly inspection of concrete cap.<br>Reconstructed cap in good condition. No NAPL observed at FE location. Standing water from recent rain event. Facing southwest.<br><br>Lat: 29.78534<br>Long: -95.31837 | | |

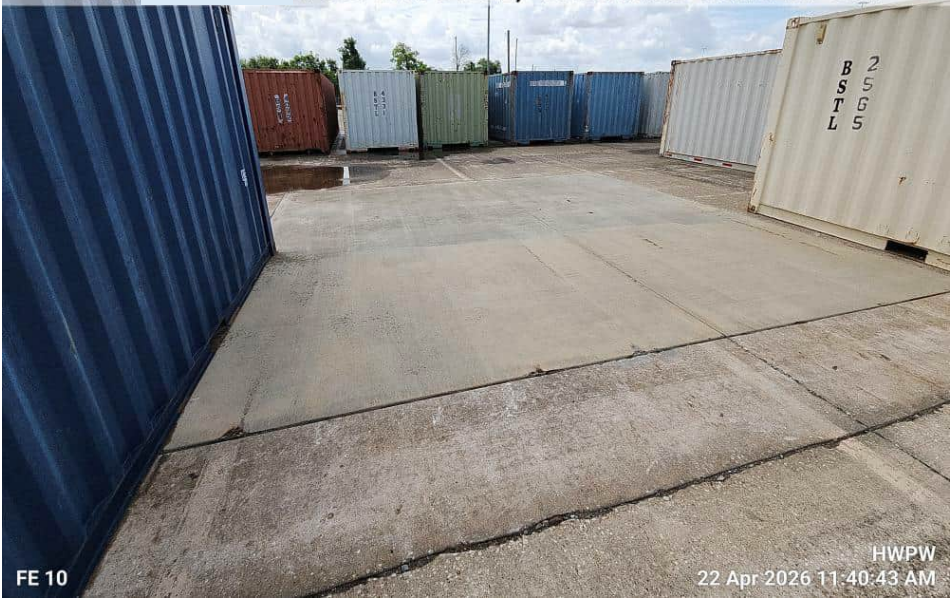
| <b>Description:</b><br>FE-10 weekly inspection of concrete cap.<br>Reconstructed cap in good condition. No NAPL observed at FE location. Standing water from recent rain event. Facing south.<br><br>Lat: 29.78496<br>Long: -95.31776 | | |

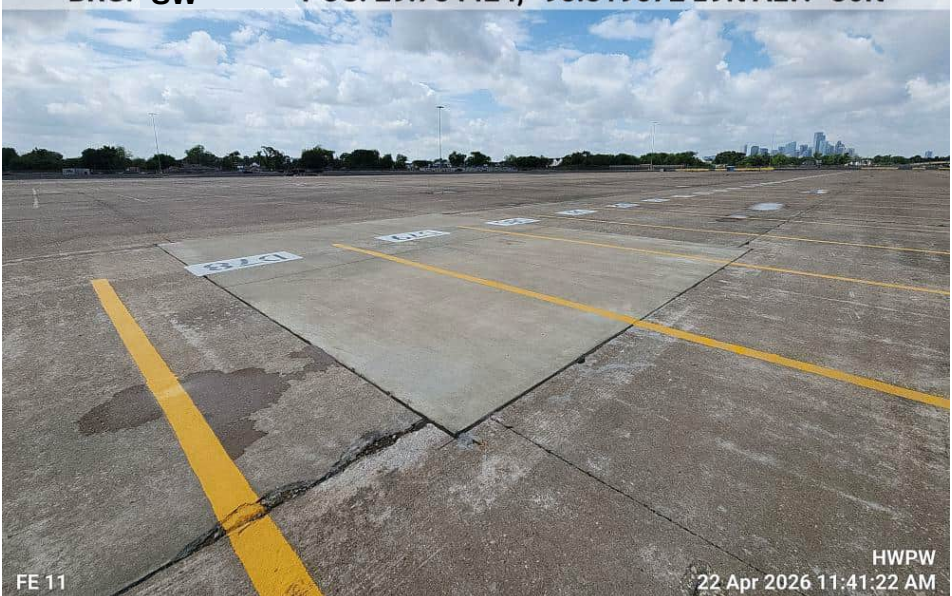
| <b>Description:</b><br>FE-11 weekly inspection of concrete cap.<br>Reconstructed cap in good condition. No NAPL observed at FE location. Standing water from recent rain event. Facing southwest.<br><br>Lat: 29.78442<br>Long: -95.31957 | | |

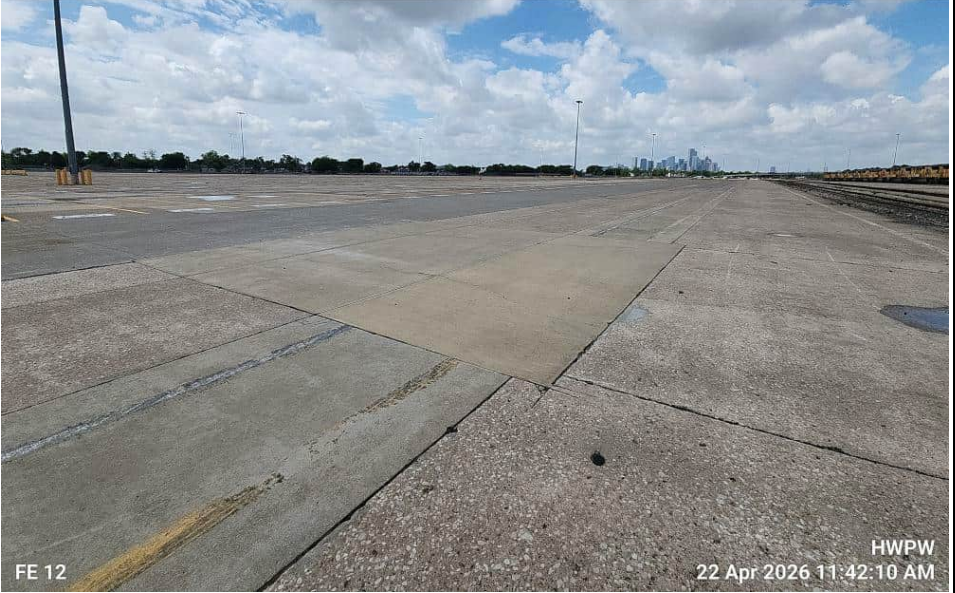
| <b>Description:</b><br>FE-12 weekly inspection of concrete cap.<br>Reconstructed cap in good condition. No NAPL observed at FE location. Standing water from recent rain event. Facing southwest.<br><br>Lat: 29.7856<br>Long: -95.31869 | | |

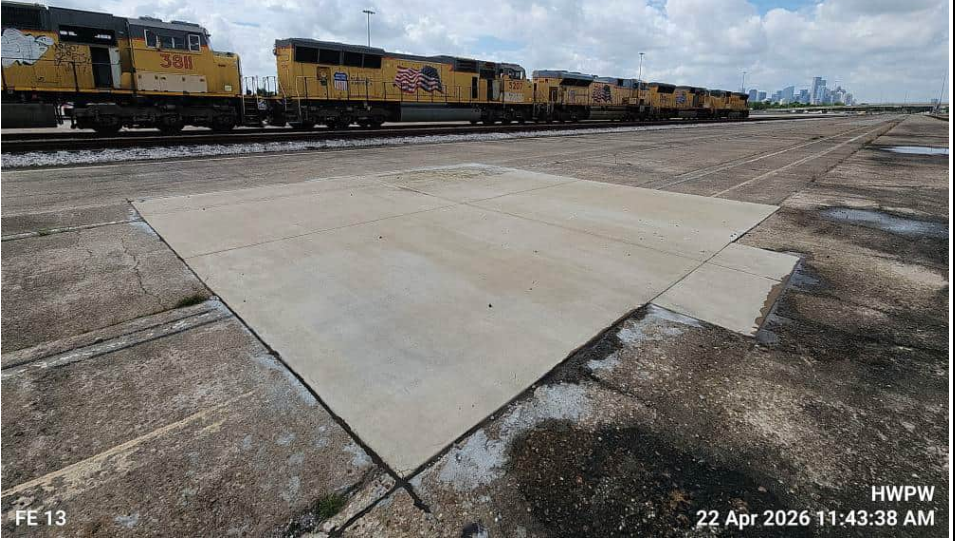
| <b>Description:</b><br>FE-13 weekly inspection of concrete cap.<br>Reconstructed cap in good condition. No NAPL observed at FE location. Standing water from recent rain event. Facing south.<br><br>Lat: 29.7851<br>Long: -95.32124 | | |

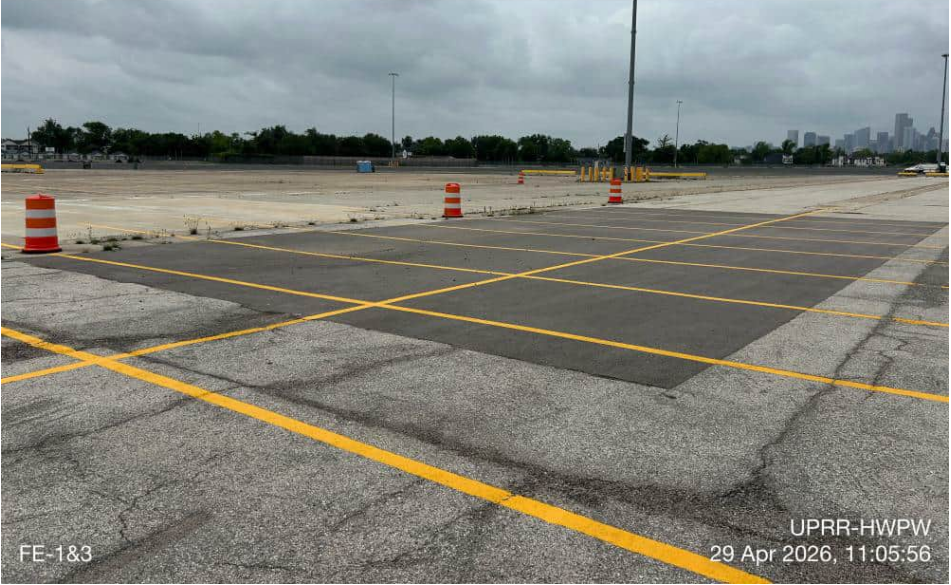
| <b>Description:</b><br>FE-1&3 weekly inspection of asphalt cap.<br>Reconstructed cap in good condition. No NAPL observed at FE location. Facing southwest.<br><br>Lat: 29.78441<br>Long: -95.32081 | | <div> <div> SE S SW W </div> <div> 120 150 180 210 240 270 </div> <div> ☀ 189°S (T) LAT: 29.784288 LON: -95.320811 ±13ft ▲ 58ft </div> <div> FE-2 UPRR-HWPW<br/>29 Apr 2026, 11:05:35 </div> </div> | |

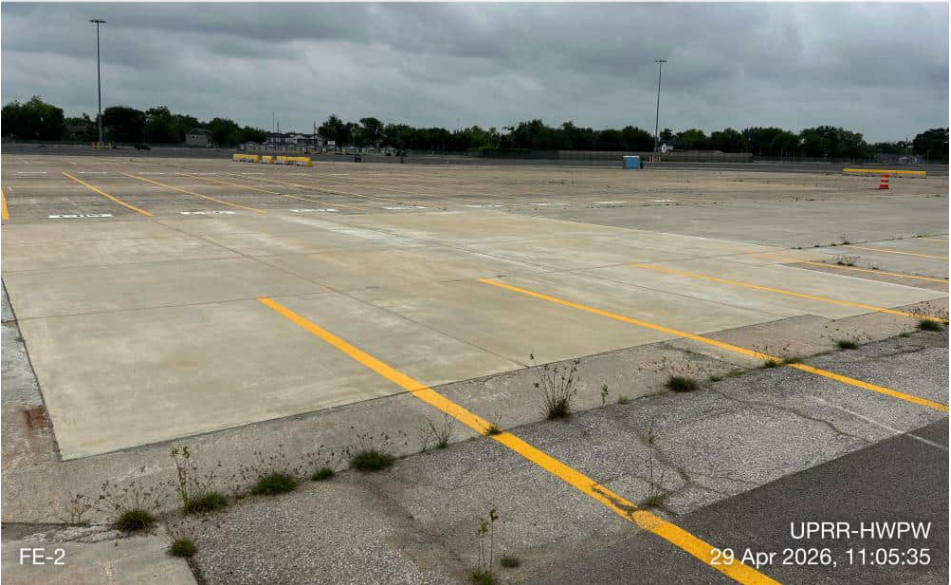
| <b>Photo No.</b><br>64 | <b>Inspection Date:</b><br>04/29/2026 | <b>Description:</b><br>FE-2 weekly inspection of concrete cap.<br>Reconstructed cap in good condition. No NAPL observed at FE location. Facing south.<br><br>Lat: 29.78429<br>Long: -95.32081 | |

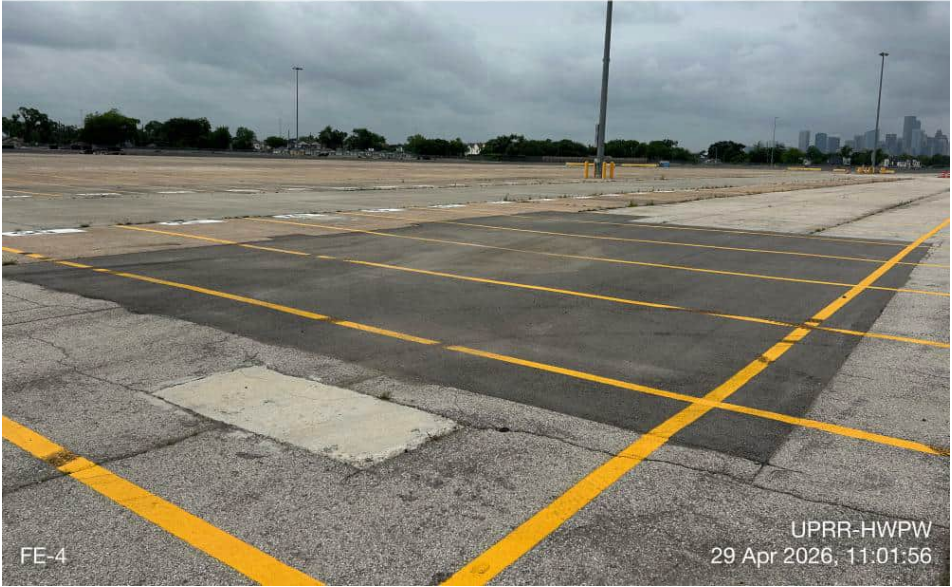
FE-4 weekly inspection of asphalt cap.  
Reconstructed cap in good condition. No NAPL  
observed at FE location. Facing southwest.

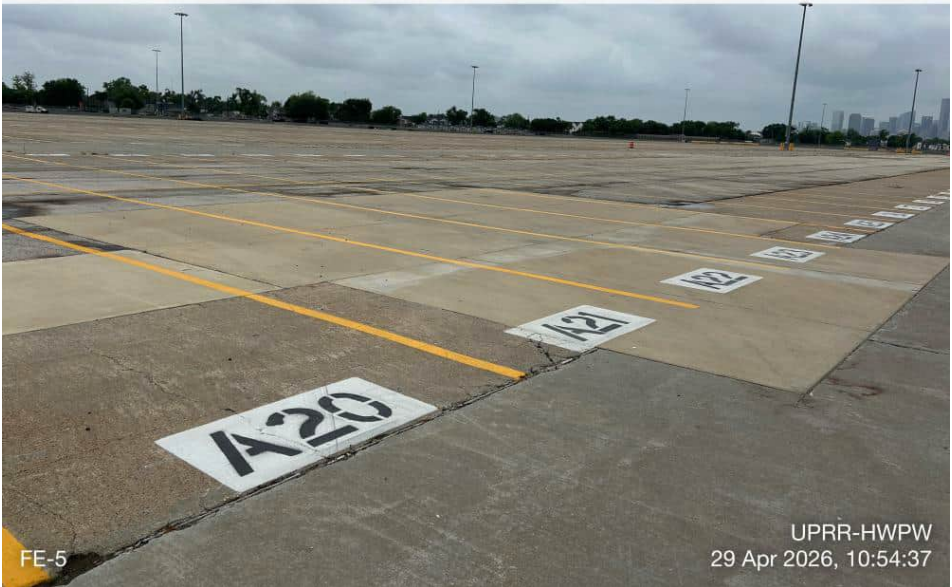
FE-5 weekly inspection of concrete cap.  
Reconstructed cap in good condition. No NAPL  
observed at FE location. Facing southwest.

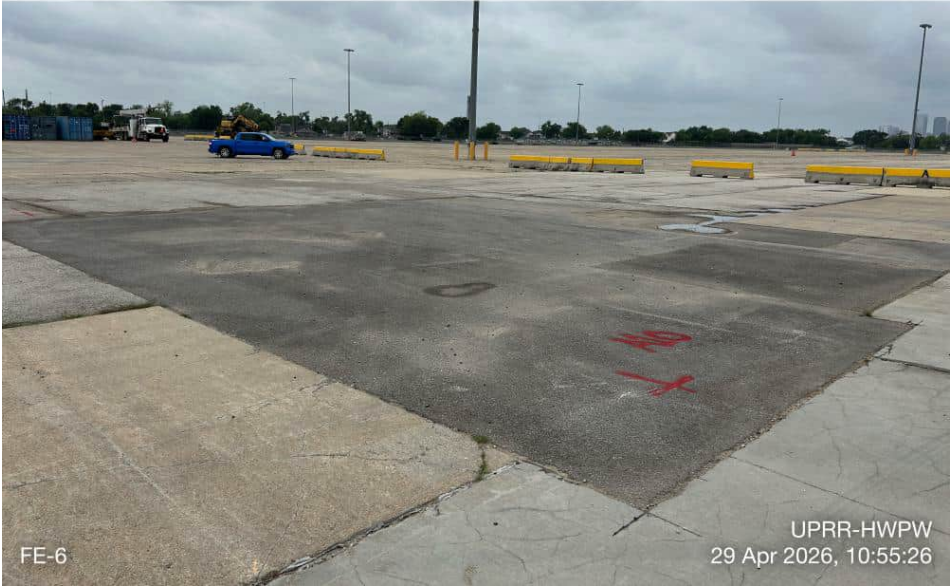
FE-6 weekly inspection of asphalt cap.  
Reconstructed cap in good condition. No NAPL  
observed at FE location. Facing south.

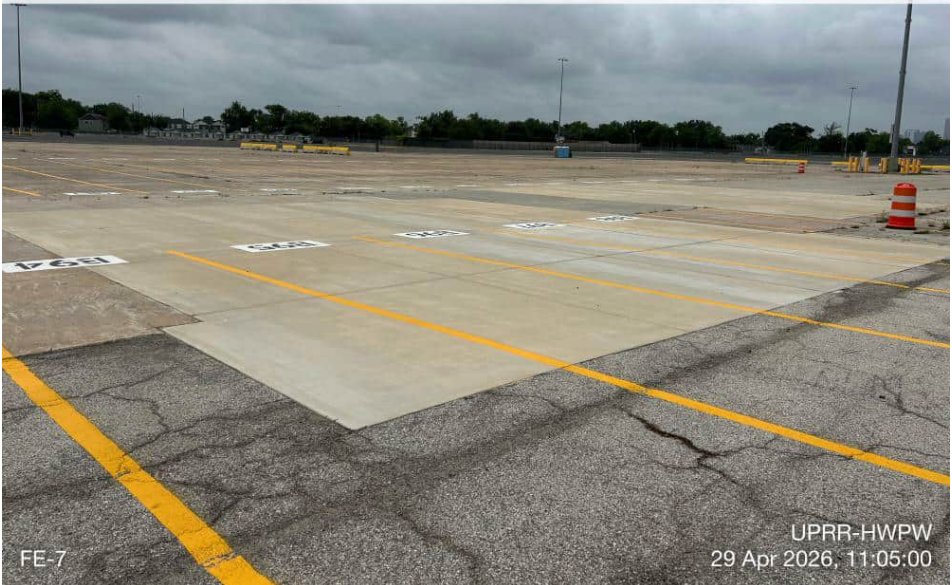
FE-7 weekly inspection of concrete cap.  
Reconstructed cap in good condition. No NAPL  
observed at FE location. Facing south.

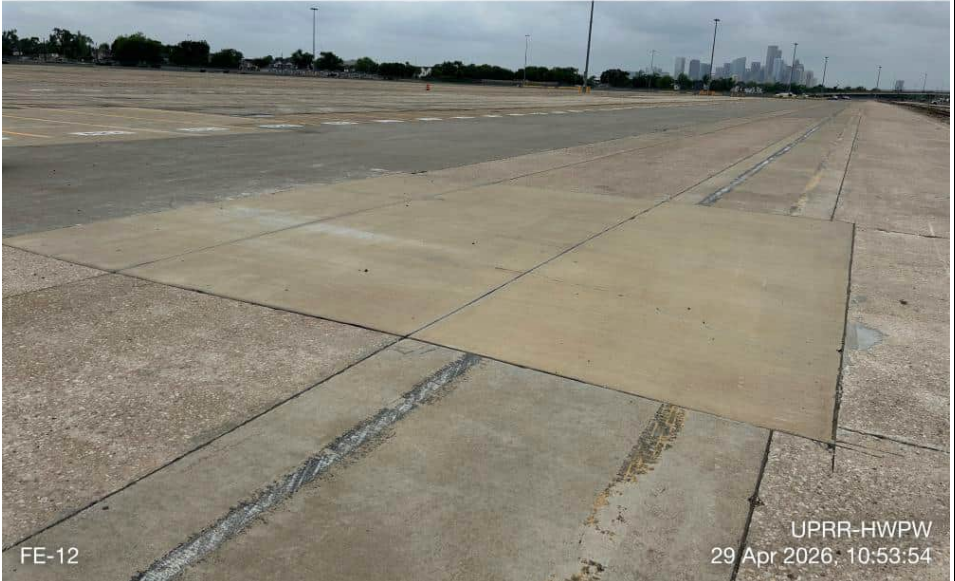
FE-12 weekly inspection of concrete cap.  
Reconstructed cap in good condition. No NAPL  
observed at FE location. Facing southwest.

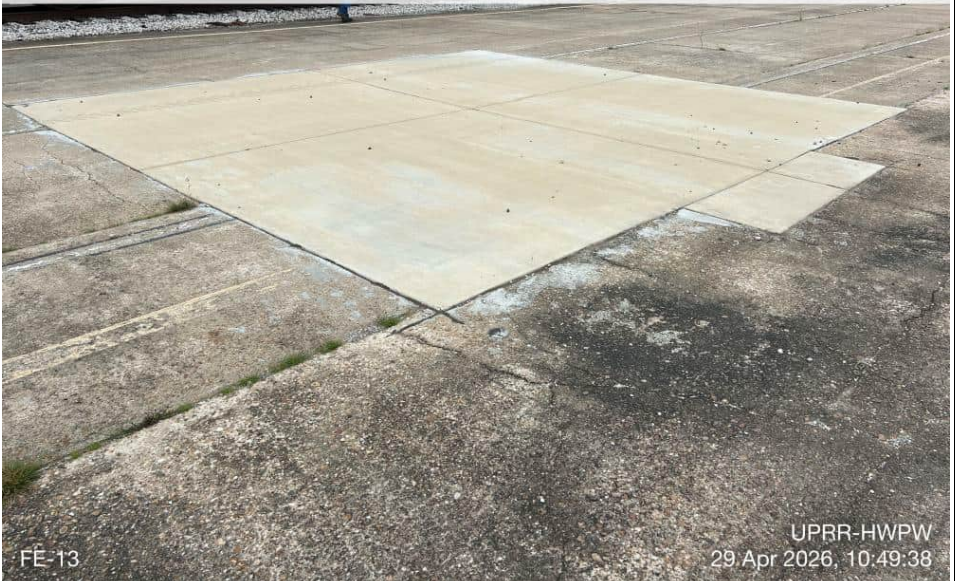
FE-13 weekly inspection of concrete cap.  
Reconstructed cap in good condition. No NAPL  
observed at FE location. Facing south.

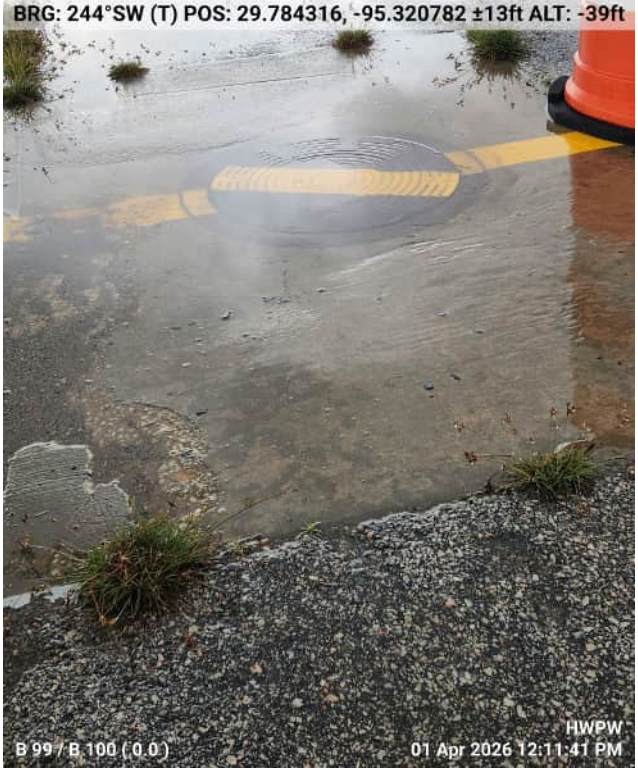
Sump 1 (B99/B100), freeboard could not be measured due to ponding. Standing water from recent and on-going rain event.

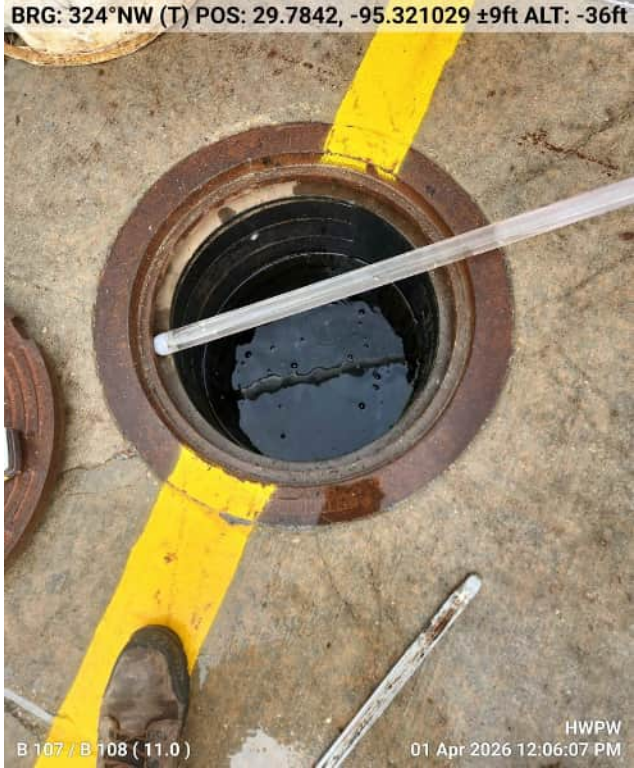
Sump 3 (B107/B108), 11.0 inches of freeboard in sump. Color is clear, and no sheen or odor was reported.

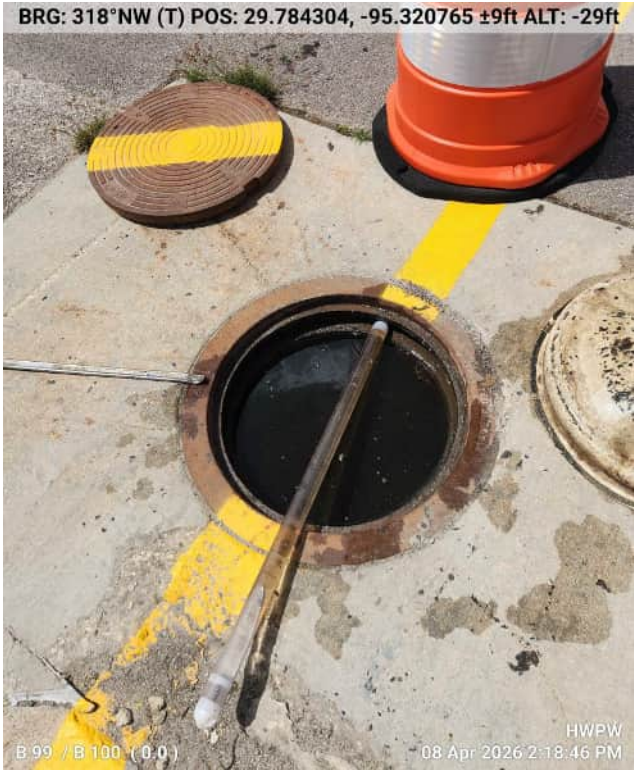
Sump 1 (B99/B100), 0.0 inches of freeboard in sump. Color is light brown, and a sheen was observed. No odor was reported.

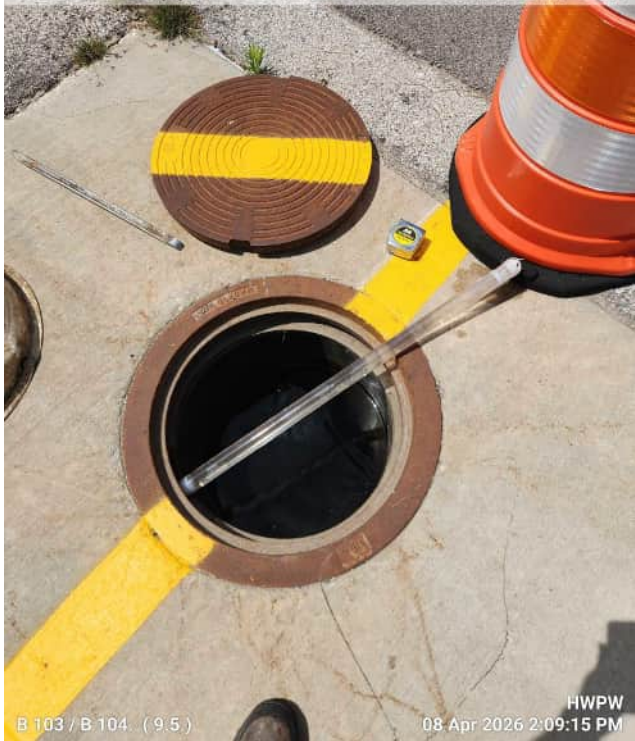
| <b>Description:</b><br>Sump 2 (B103/B104), 9.5 inches of freeboard in sump. Color is clear, and no sheen or odor was reported.<br><br>Lat: 29.78426<br>Long: -95.32089 | | | |

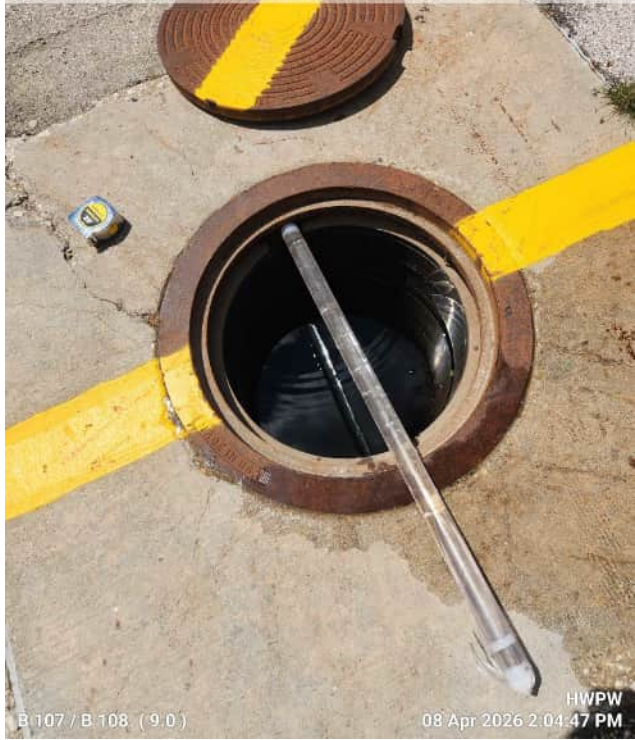
| <b>Description:</b><br>Sump 3 (B107/B108), 9.0 inches of freeboard in sump. Color is clear, and no sheen or odor was reported.<br><br>Lat: 29.78421<br>Long: -95.321 | | | |

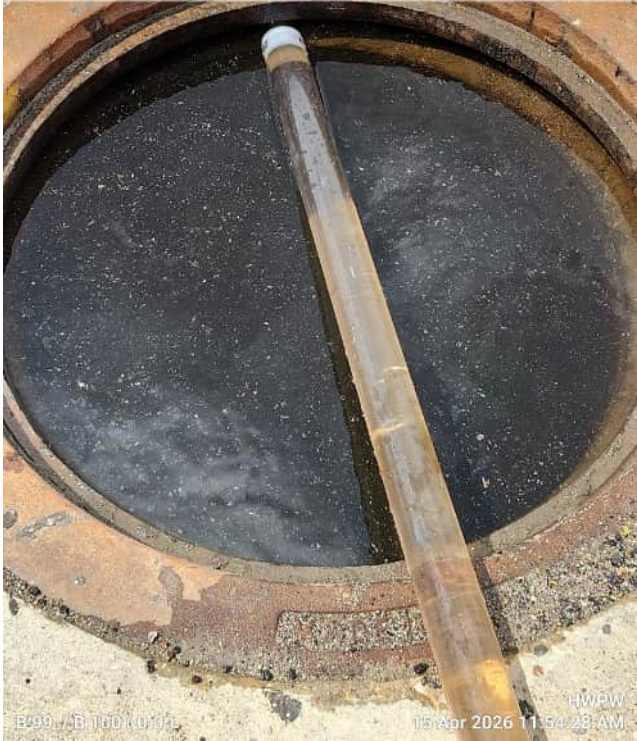
Sump 1 (B99/B100), 0.0 inches of freeboard in sump. Color is brown, and a sheen was observed. No odor was reported.

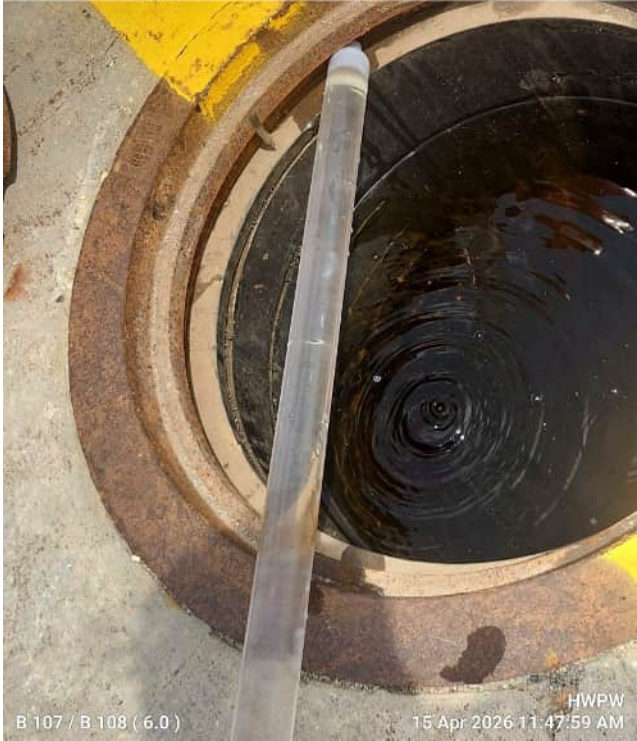
| <b>Description:</b><br>Sump 3 (B107/B108), 6.0 inches of freeboard in sump. Color is clear, and no sheen or odor was reported.<br><br>Lat: 29.78418<br>Long: -95.32102 | | |

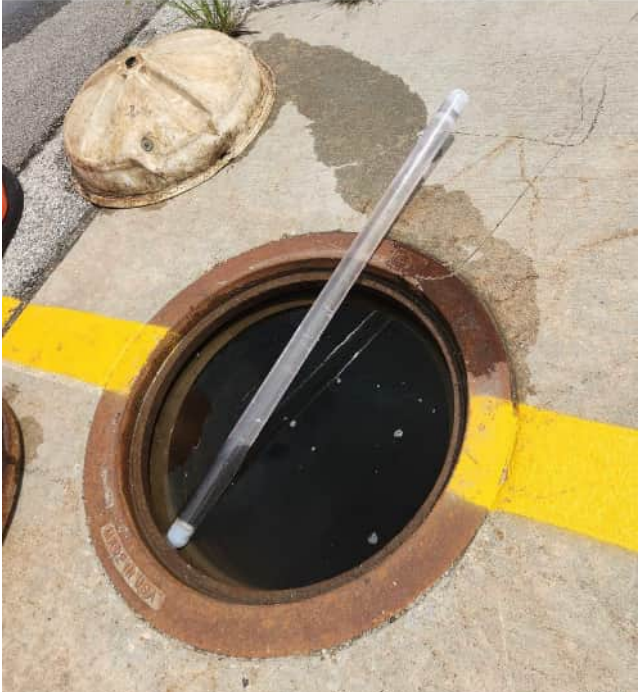
Sump 2 (B103/B104), 0.0 inches of freeboard in sump. Color is clear, and no sheen or odor was reported.

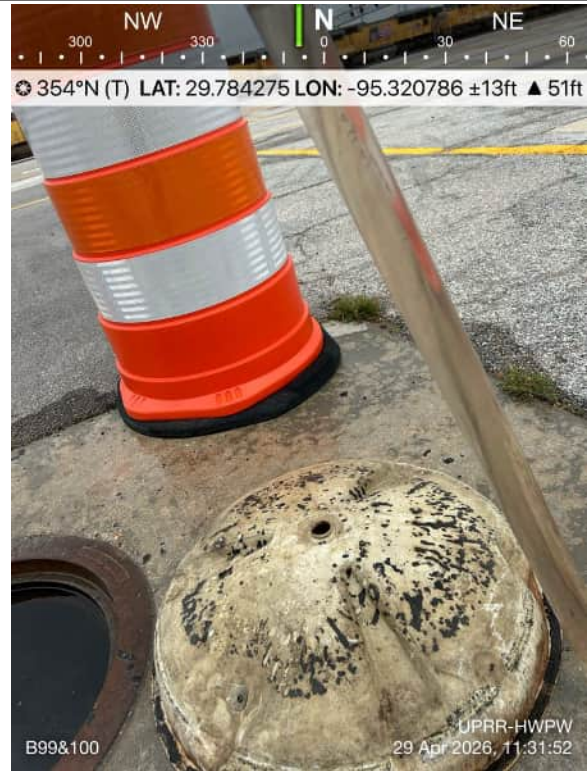
Sump 1 (B99/B100), 0.0 inches of freeboard in sump. Color is light brown, and a sheen was observed. No odor was reported.

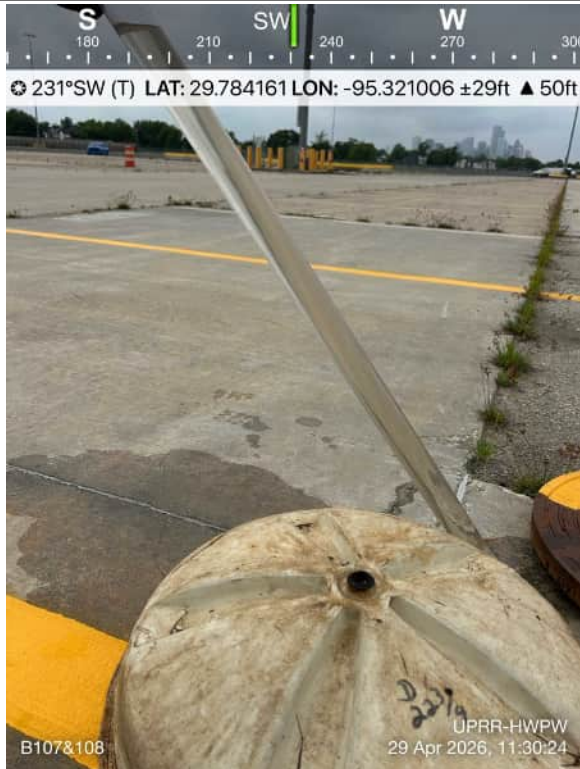
| <b>Description:</b><br>Sump 3 (B107/B108), 9.3 inches of freeboard in sump. Color is light brown, and no sheen or odor was reported.<br><br>Lat: 29.78416<br>Long: -95.32101 | | | |

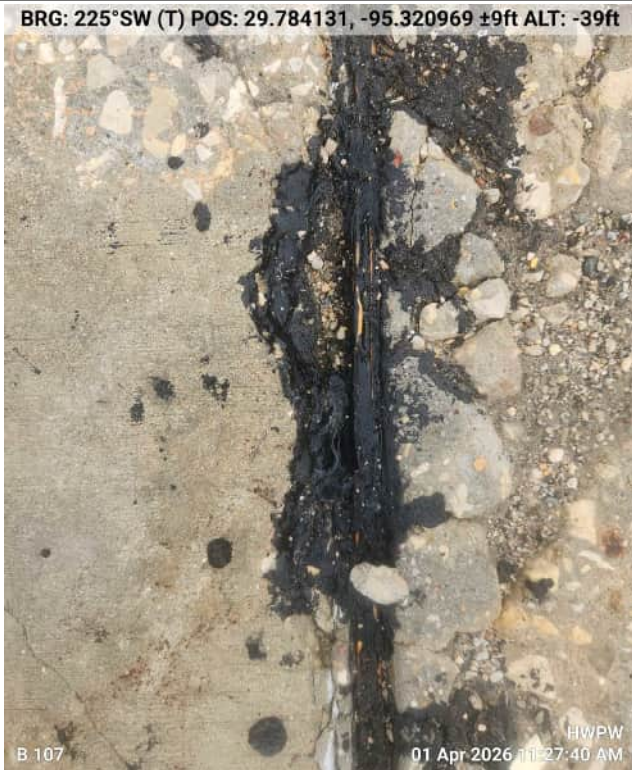
| <b>Description:</b><br>B107 weekly inspection of joint. Surrounding concrete in good condition. Approximately 2 cubic inches of NAPL observed at seep location.<br><br>Lat: 29.78413<br>Long: -95.32097 | | | |

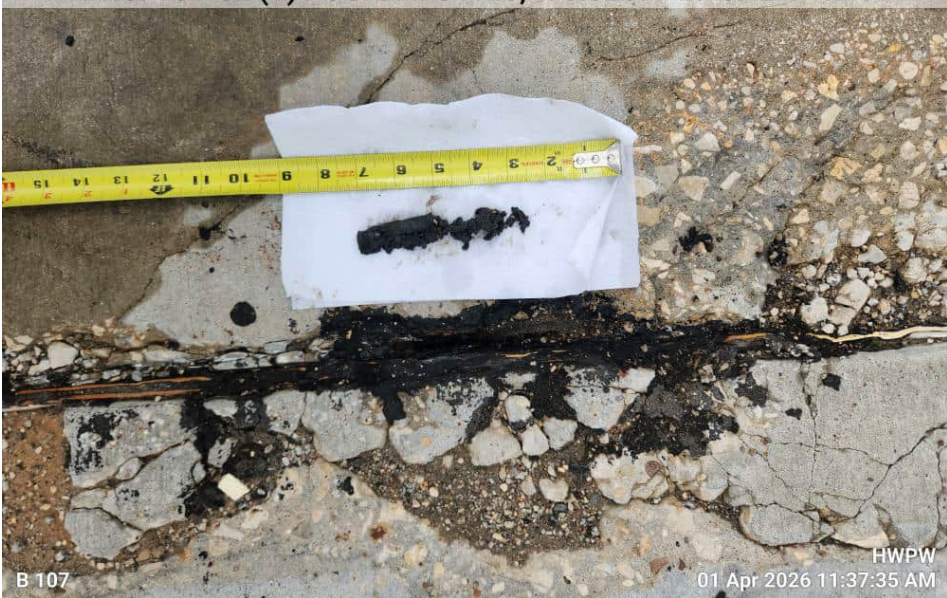
| <b>Description:</b><br>B107 weekly inspection of joint. Surrounding concrete in good condition. Approximately 2 cubic inches of NAPL observed at seep location.<br><br>Lat: 29.78415<br>Long: -95.32097 | | |

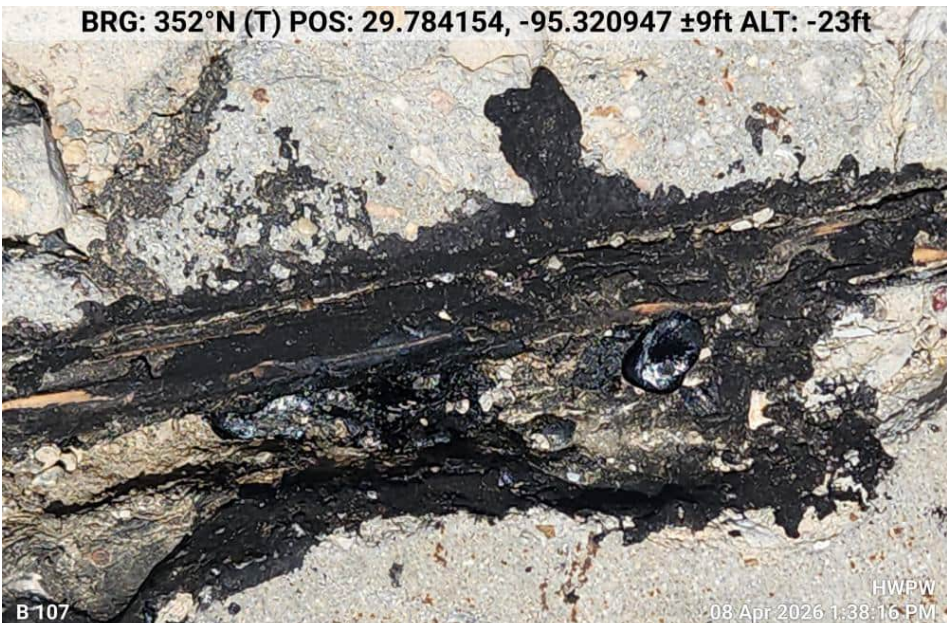
| <b>Description:</b><br>B107 weekly inspection of joint. Surrounding concrete in good condition. Approximately 1.5 cubic inches of NAPL observed at seep location.<br><br>Lat: 29.78415<br>Long: -95.32095 | | |

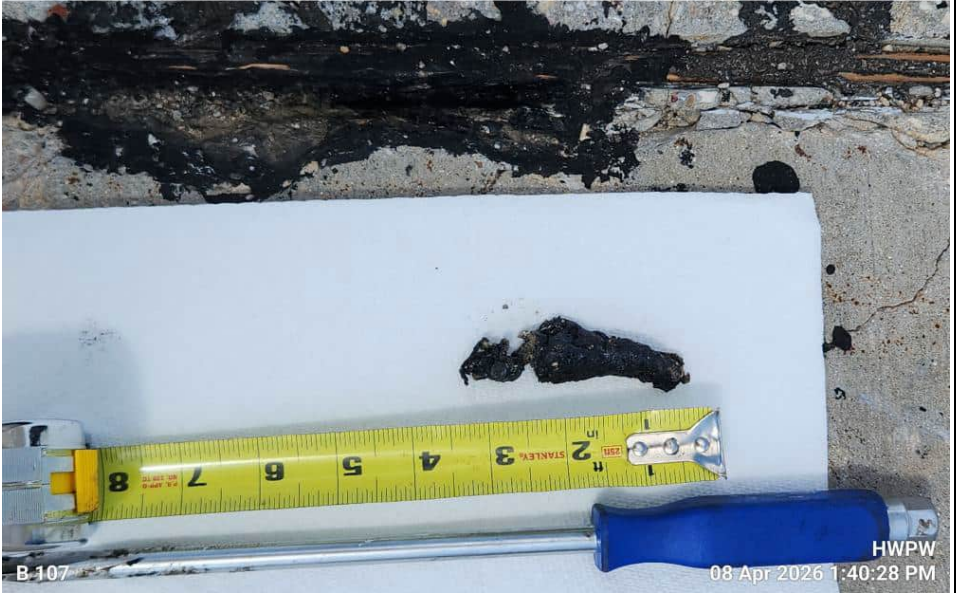
| <b>Description:</b><br>B107 weekly inspection of joint. Surrounding concrete in good condition. Approximately 1.5 cubic inches of NAPL observed at seep location.<br><br>Lat: 29.78416<br>Long: -95.32095 | | |

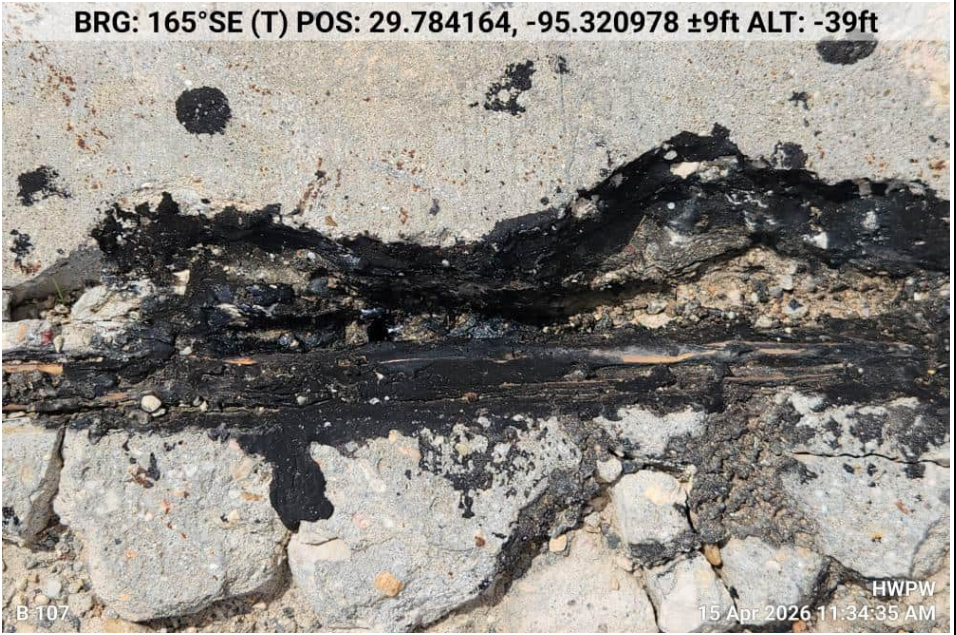
| <b>Description:</b><br>B107 weekly inspection of joint. Surrounding concrete in good condition. Approximately 1.5 cubic inches of NAPL observed at seep location.<br><br>Lat: 29.78416<br>Long: -95.32098 | | |

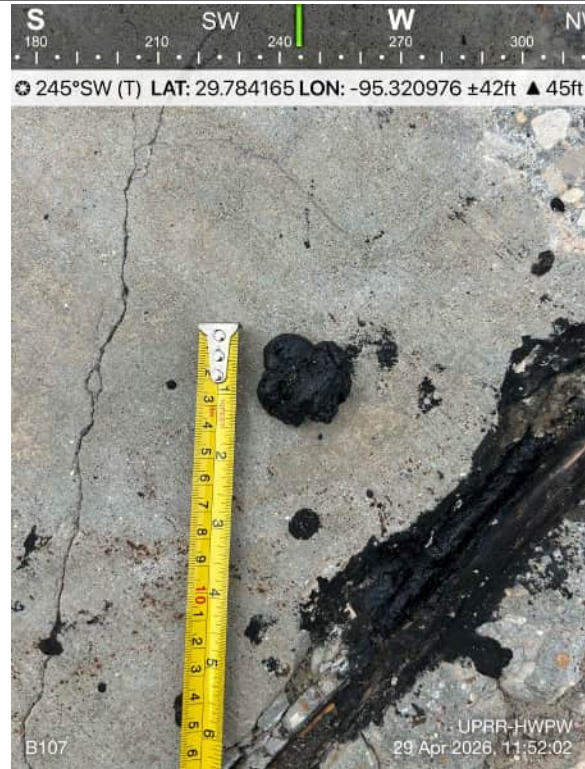
B107 weekly inspection of joint. Surrounding concrete in good condition. Approximately 1.5 cubic inches of NAPL observed at seep location.

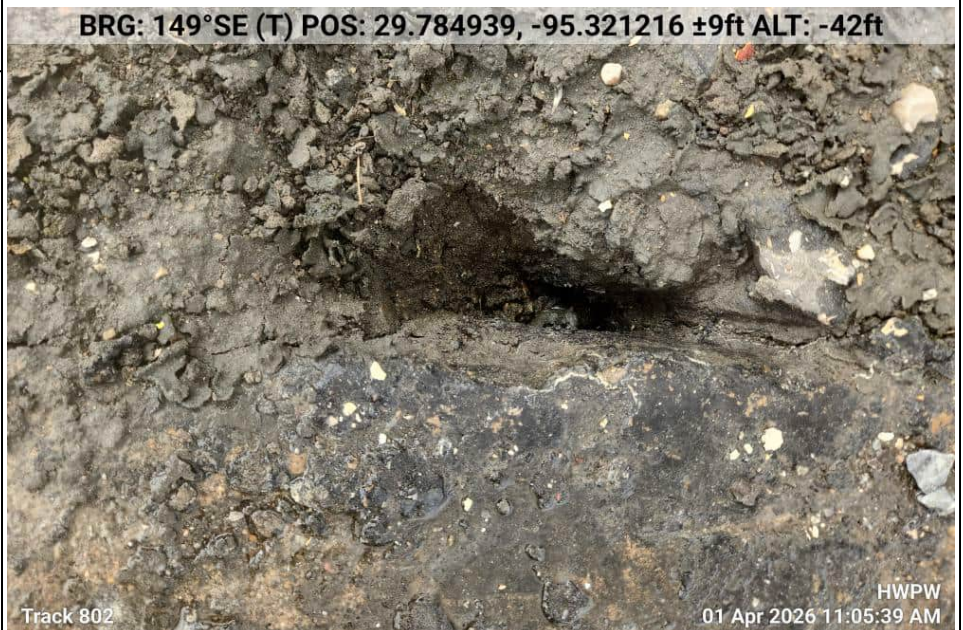
**Photo No.** 98  
**Inspection Date:** 04/01/2026

Track 802 weekly inspection of track. Surrounding concrete and ballast in good condition. No active NAPL seep observed along joint.

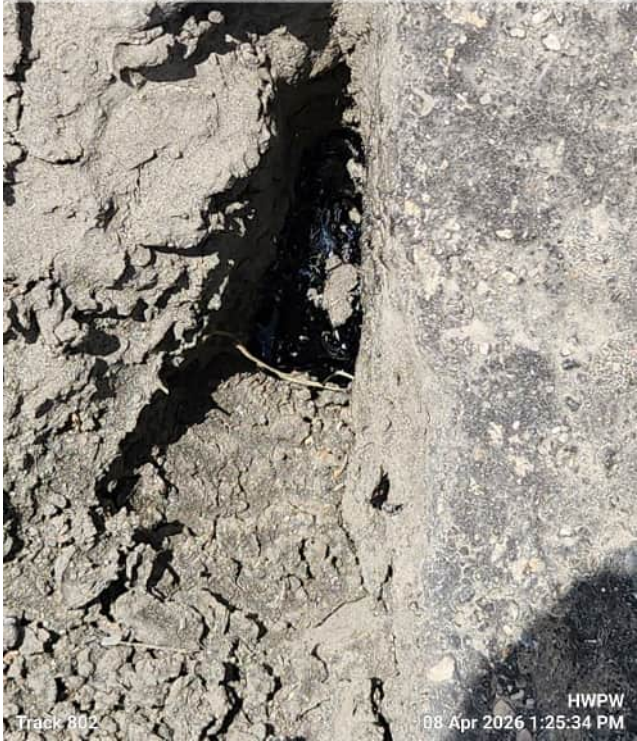
Track 802 weekly inspection of track. Surrounding concrete and ballast in good condition. Approximately 3 cubic inches of NAPL observed at seep location.

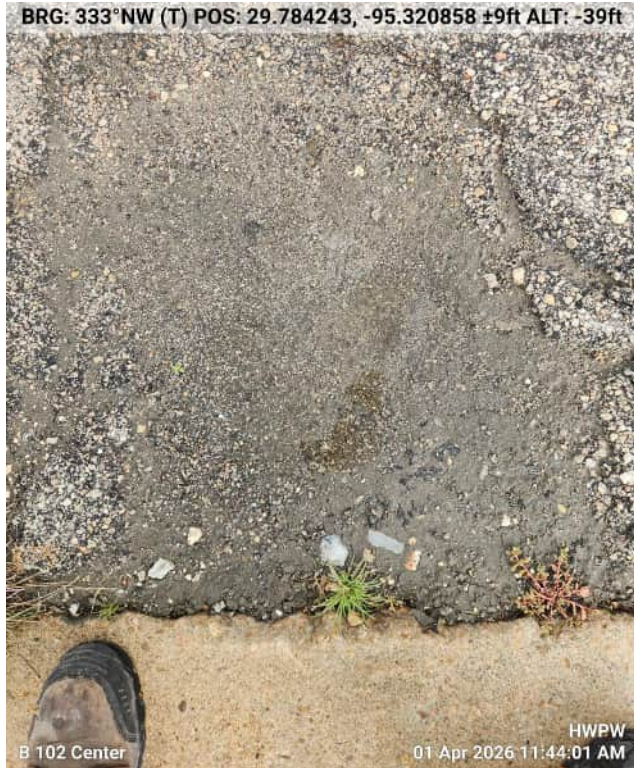
| <b>Description:</b><br>B102 Center weekly inspection of previously identified seep. Surrounding asphalt in good condition. No active NAPL seep observed along joint.<br><br>Lat: 29.78424<br>Long: -95.32086 | | | |

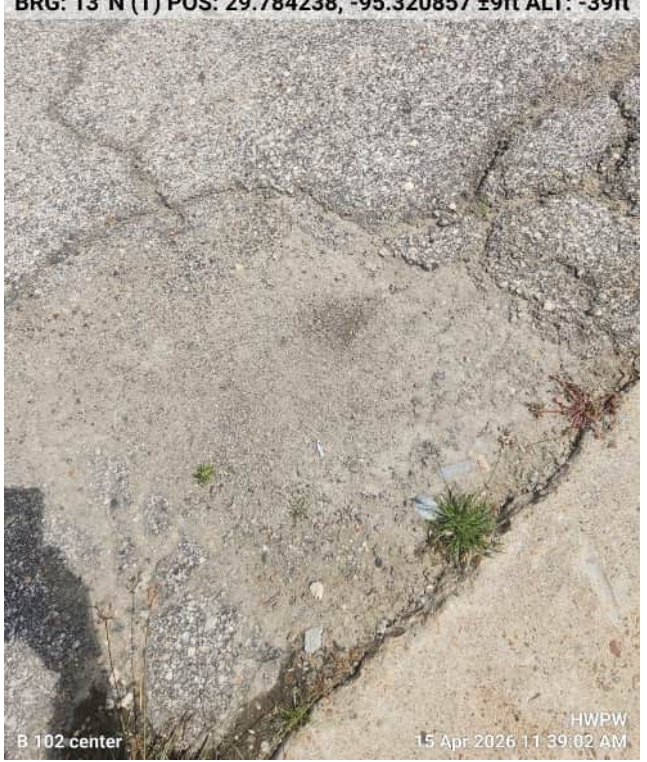
| <b>Description:</b><br>B102 Center weekly inspection of previously identified seep. Surrounding asphalt in good condition. No active NAPL seep observed along joint. | <b>Description:</b><br>B102 Center weekly inspection of previously identified seep. Surrounding asphalt in good condition. No active NAPL seep observed along joint. | |

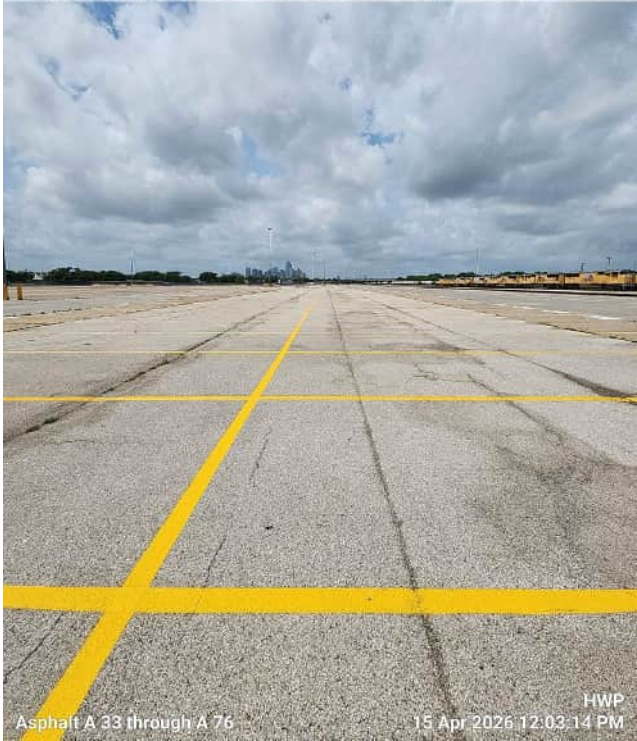
| <b>Photo No.</b><br>109 | <b>Inspection Date:</b><br>04/15/2026 | <div>BRG: SW POS: 29.784809, -95.319778 ±9ft ALT: -39ft</div> <div>Asphalt A 33 through A 76 HWP<br/>15 Apr 2026 12:03:14 PM</div> |

Brown water staining along the joint that runs from A033 through A076. Facing southwest.

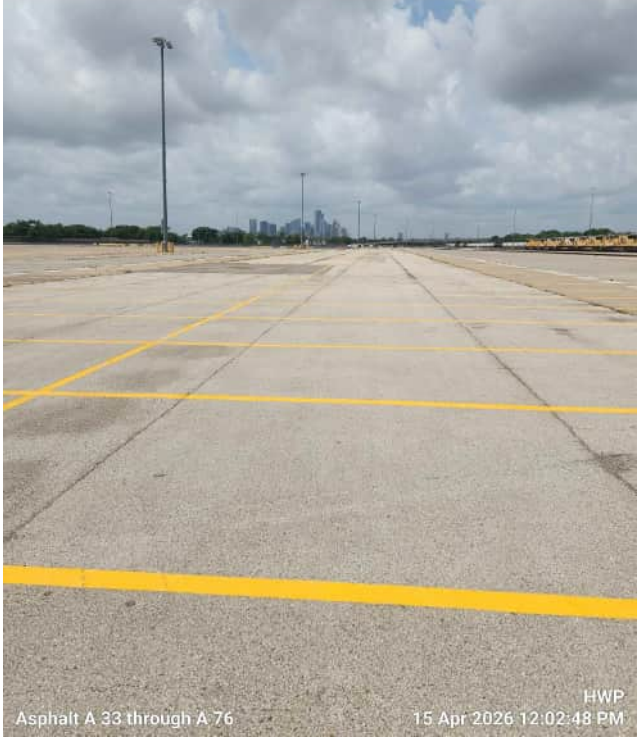
| <b>Photo No.</b><br>110 | <b>Inspection Date:</b><br>04/15/2026 | <div>BRG: SW POS: 29.785041, -95.319303 ±9ft ALT: -39ft</div> <div>Asphalt A 33 through A 76 HWP<br/>15 Apr 2026 12:02:48 PM</div> |

Brown water staining along the joint that runs from A033 through A076. Facing southwest.

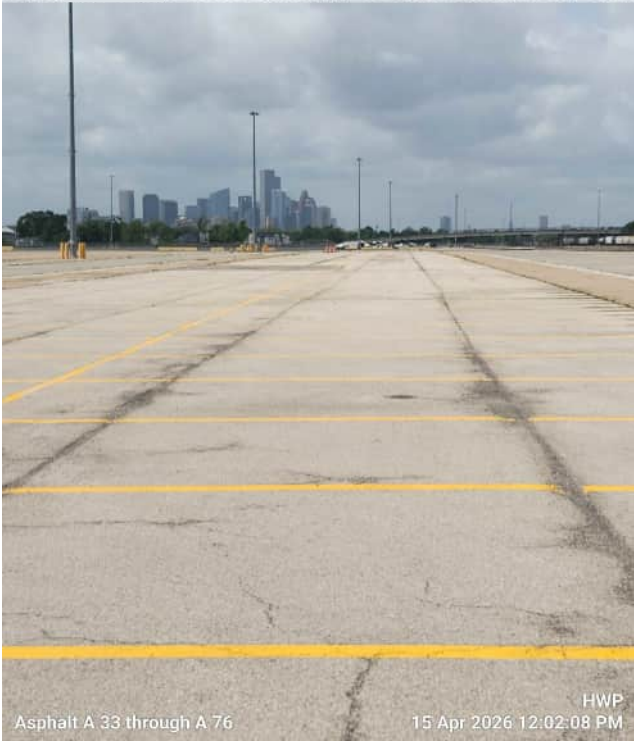
| <b>Description:</b><br>Brown water staining along the joint that runs from A033 through A076. Facing southwest.<br><br>Lat: 29.7852<br>Long: -95.31893 | | |
