June 15, 2026

Project No. US0039040.3990

**Re: MONTHLY STATUS UPDATE – ENGLEWOOD INTERMODAL YARD – REVISED INTERIM MEASURES  
WORK PLAN POST-CONSTRUCTION AND NAPL COLLECTION SYSTEM/CONCRETE CAP REPAIR  
INSPECTIONS  
UNION PACIFIC RAILROAD HOUSTON WOOD PRESERVING WORKS FACILITY  
4910 LIBERTY ROAD FACILITY, HOUSTON, TEXAS  
POST-CLOSURE CARE PERMIT NO. HW-50343; INDUSTRIAL SWR NO. 31547**

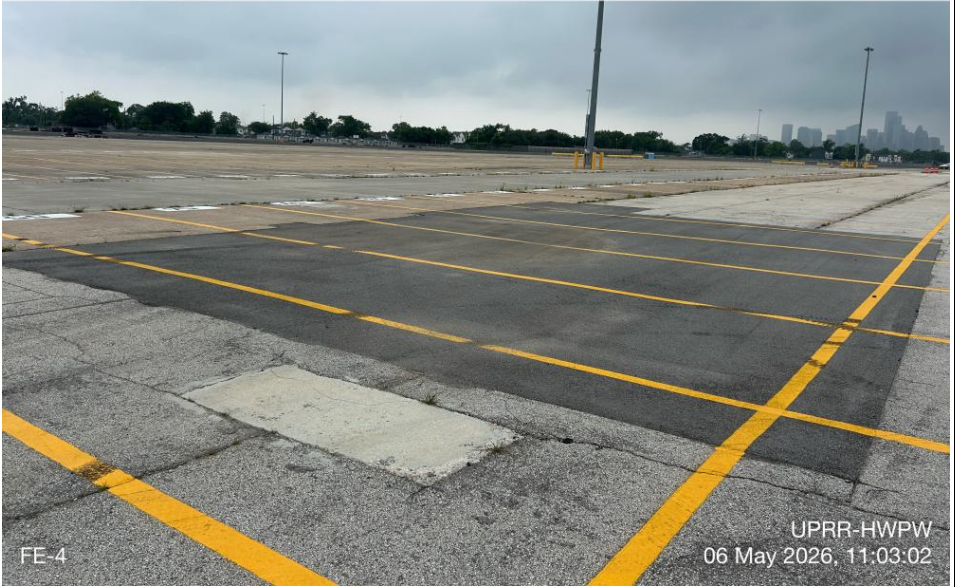
| <b>Description:</b><br>FE-4 weekly inspection of asphalt cap.<br>Reconstructed cap in good condition. No NAPL observed at FE location. Facing southwest.<br><br>Lat: 29.78492<br>Long: -95.31951 | | <b>Description:</b><br>FE-5 weekly inspection of concrete cap.<br>Reconstructed cap in good condition. No NAPL observed at FE location. Brown water staining along the southern joint of FE-5 observed. Facing southwest.<br><br>Lat: 29.78547<br>Long: -95.3186 | |

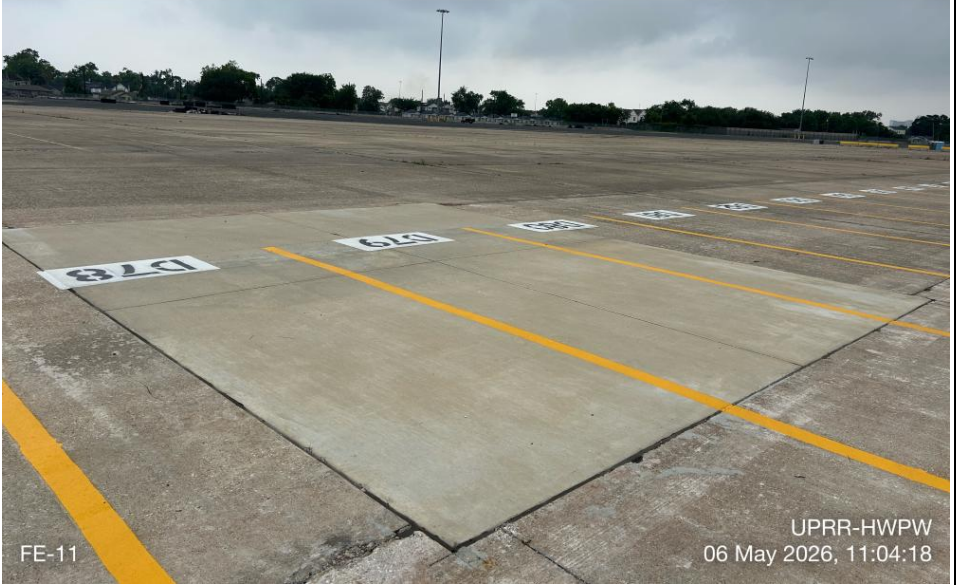
FE-11 weekly inspection of concrete cap.  
Reconstructed cap in good condition. No NAPL  
observed at FE location. Facing south.

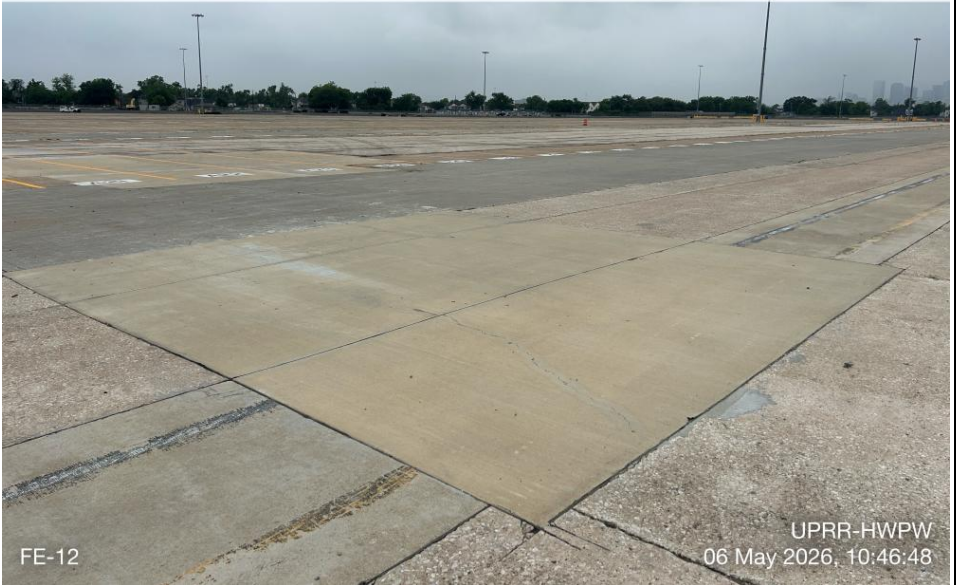
FE-12 weekly inspection of concrete cap.  
Reconstructed cap in good condition. No NAPL  
observed at FE location. Facing south.

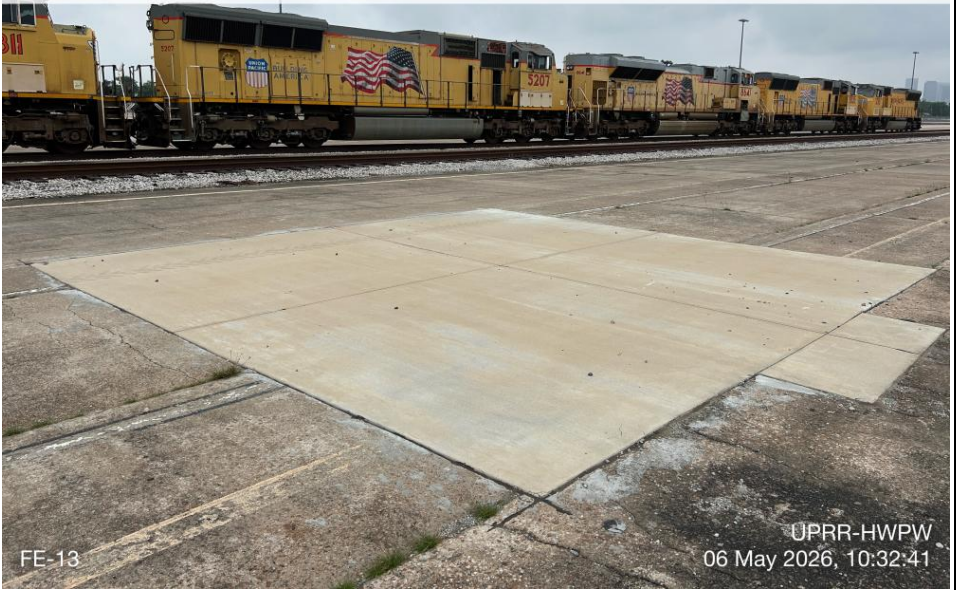
| <b>Description:</b><br>FE-13 weekly inspection of concrete cap.<br>Reconstructed cap in good condition. No NAPL observed at FE location. Facing south.<br><br>Lat: 29.78505<br>Long: -95.32121 | | <b>Description:</b><br>FE-1&3 weekly inspection of asphalt cap.<br>Reconstructed cap in good condition. No NAPL observed at FE location. Facing southwest.<br><br>Lat: 29.7844<br>Long: -95.3208 | |

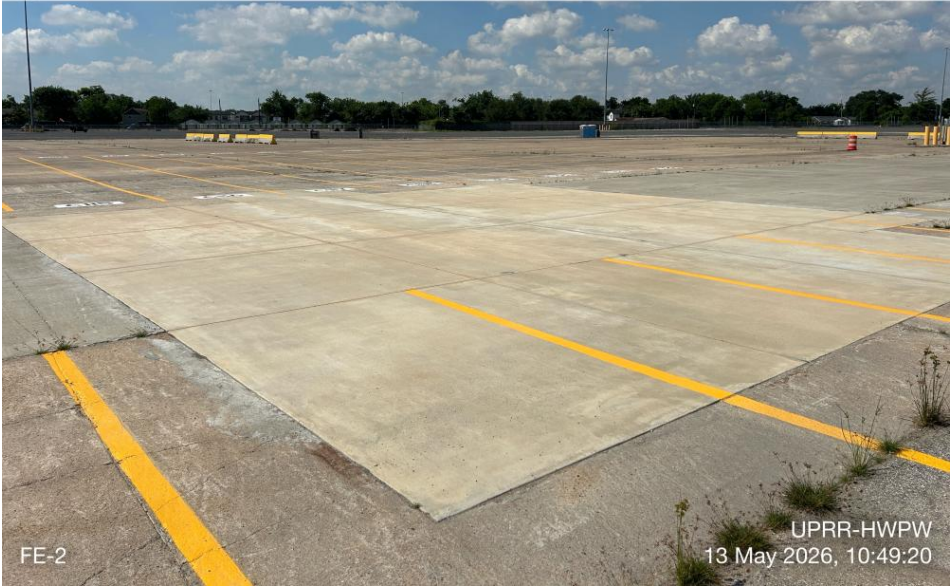
| <b>Description:</b><br>FE-2 weekly inspection of concrete cap.<br>Reconstructed cap in good condition. No NAPL observed at FE location. Facing south.<br><br>Lat: 29.78429<br>Long: -95.32076 | | <b>Description:</b><br>FE-4 weekly inspection of asphalt cap.<br>Reconstructed cap in good condition. No NAPL observed at FE location. Facing south.<br><br>Lat: 29.78492<br>Long: -95.31953 | |

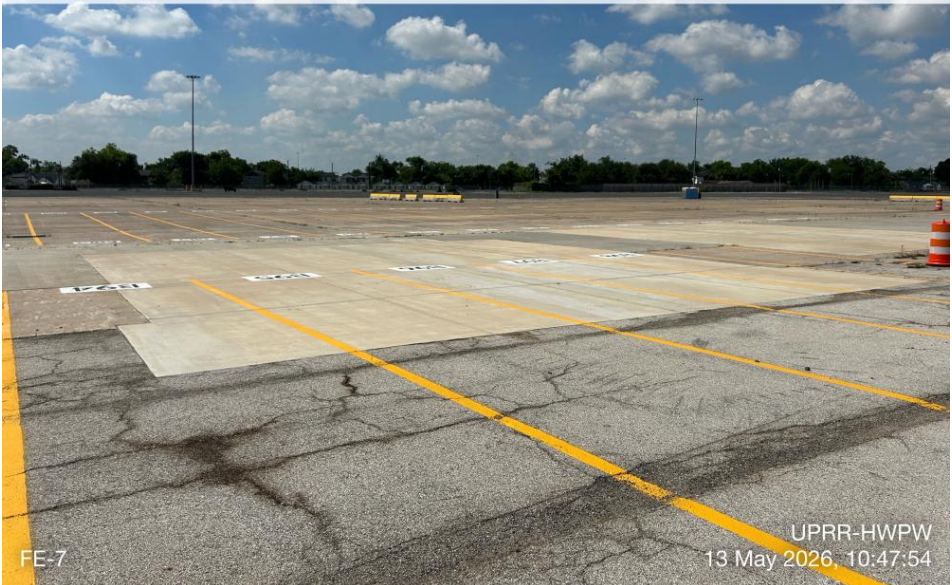
| <b>Description:</b><br>FE-6 weekly inspection of asphalt cap. Reconstructed cap in good condition. No NAPL observed at FE location. Brown water staining was observed along the southern joint of the reconstructed asphalt cap of FE-6, located with the red arrow is Photo No. 18. Facing northeast.<br><br>Lat: 29.78539<br>Long: -95.31831 | | <b>Description:</b><br>FE-7 weekly inspection of concrete cap. Reconstructed cap in good condition. No NAPL observed at FE location. Facing south.<br><br>Lat: 29.78442<br>Long: -95.32065 | |

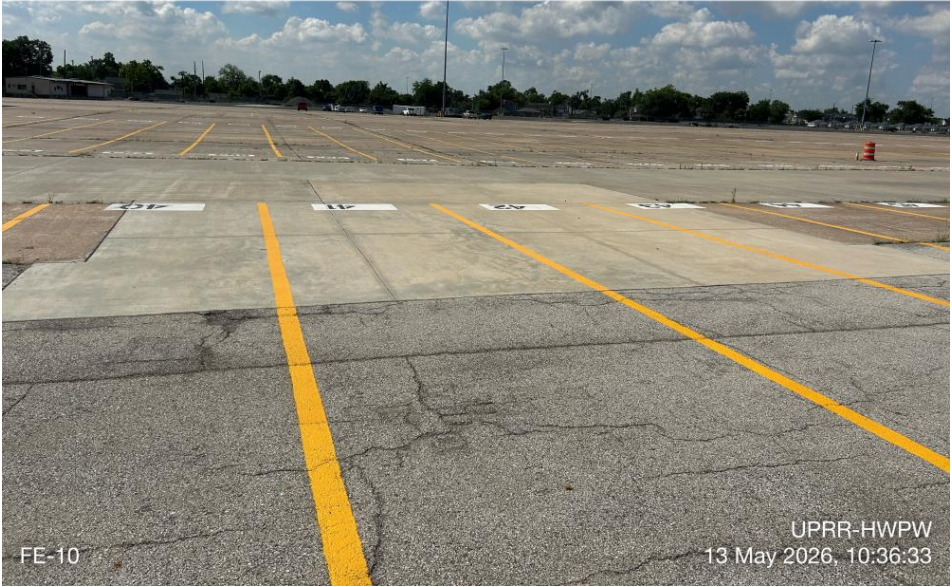
| <b>Description:</b><br>FE-8 weekly inspection of concrete cap.<br>Reconstructed cap in good condition. No NAPL observed at FE location. Mislabeled FE-10. Facing south.<br><br>Lat: 29.78505<br>Long: -95.31914 | | | |

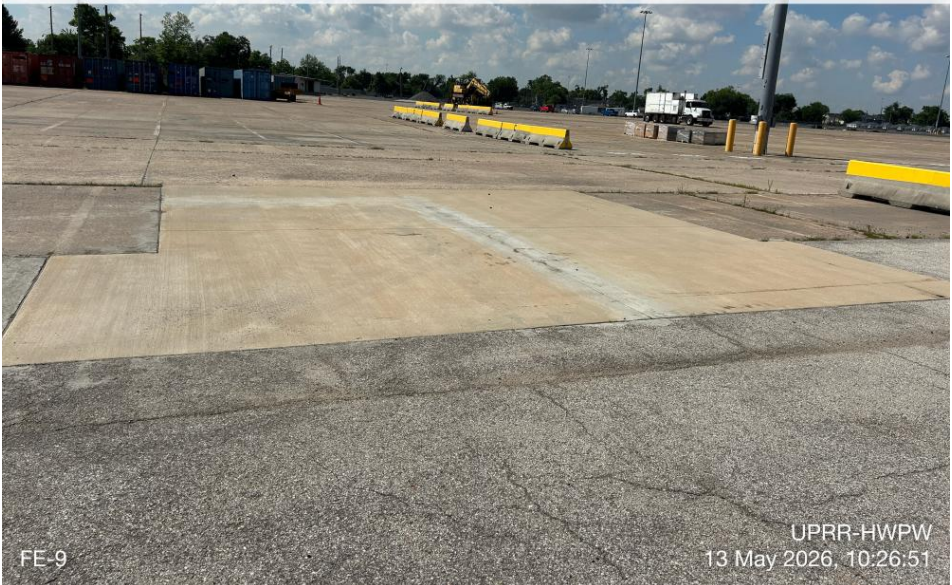
| <b>Description:</b><br>FE-9 weekly inspection of concrete cap.<br>Reconstructed cap in good condition. No NAPL observed at FE location. Facing south.<br><br>Lat: 29.78533<br>Long: -95.3184 | | | |

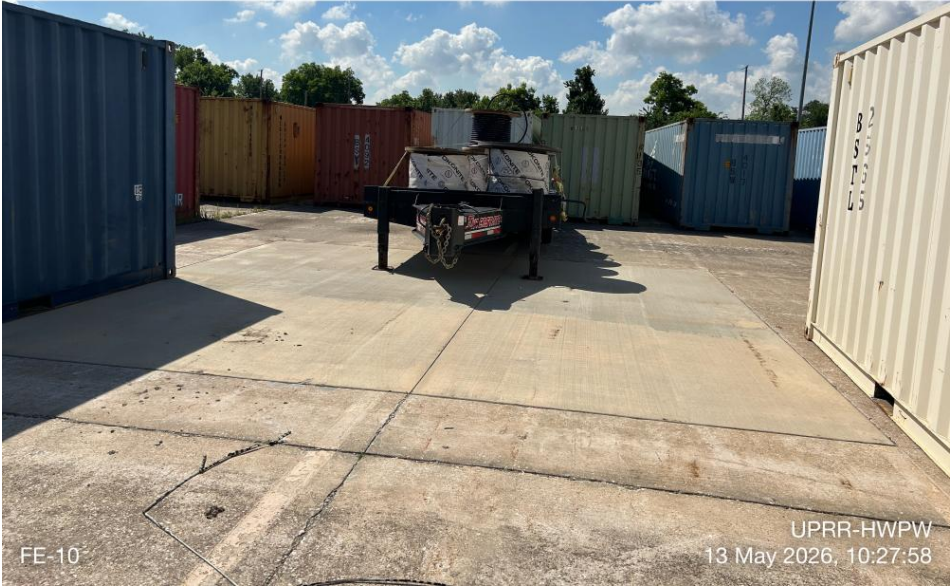
| <b>Description:</b><br>FE-10 weekly inspection of concrete cap.<br>Reconstructed cap in good condition. No NAPL observed at FE location. Facing southeast.<br><br>Lat: 29.78501<br>Long: -95.31778 | | <b>Description:</b><br>FE-11 weekly inspection of concrete cap.<br>Reconstructed cap in good condition. No NAPL observed at FE location. Facing south.<br><br>Lat: 29.78441<br>Long: -95.31957 | |

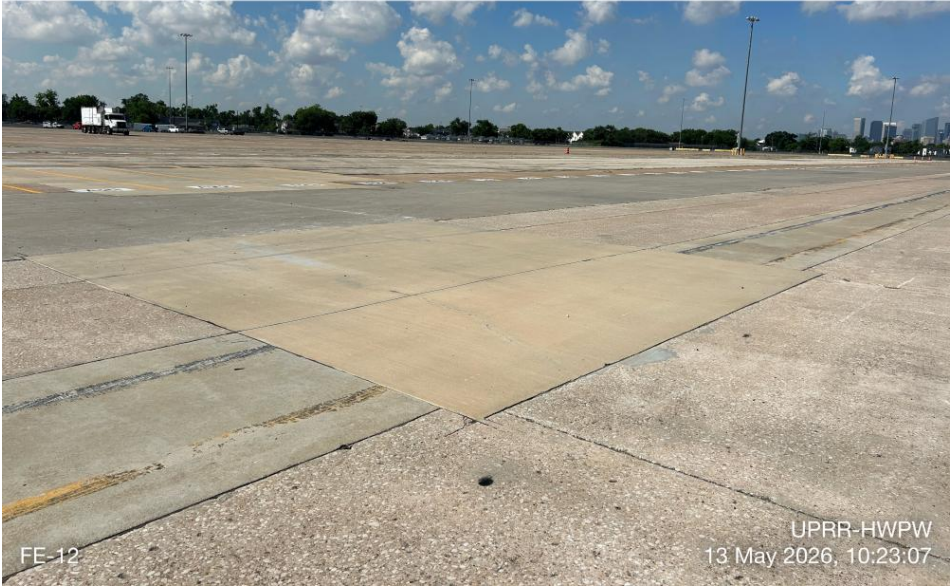
FE-12 weekly inspection of concrete cap.  
Reconstructed cap in good condition. No NAPL  
observed at FE location. Facing south.

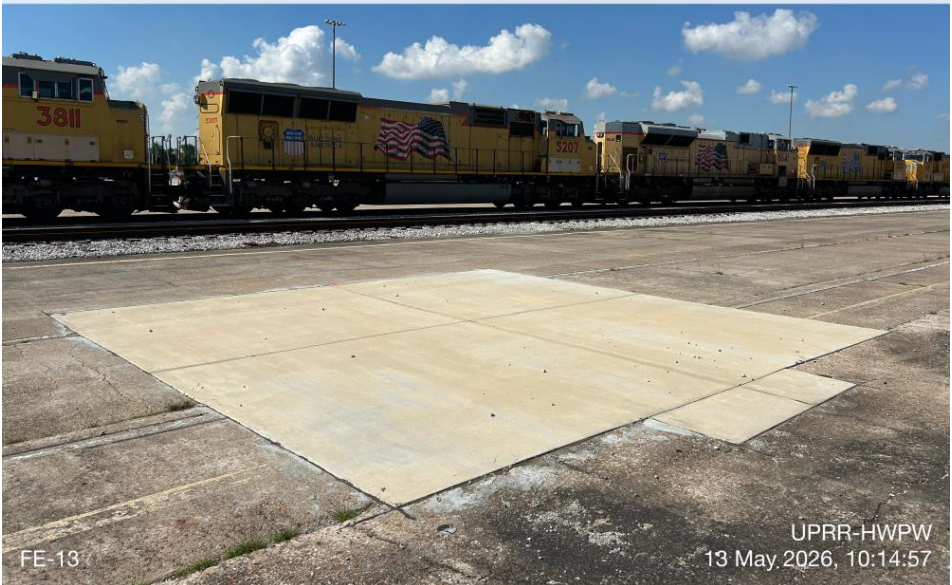
FE-13 weekly inspection of concrete cap.  
Reconstructed cap in good condition. No NAPL  
observed at FE location. Facing south.

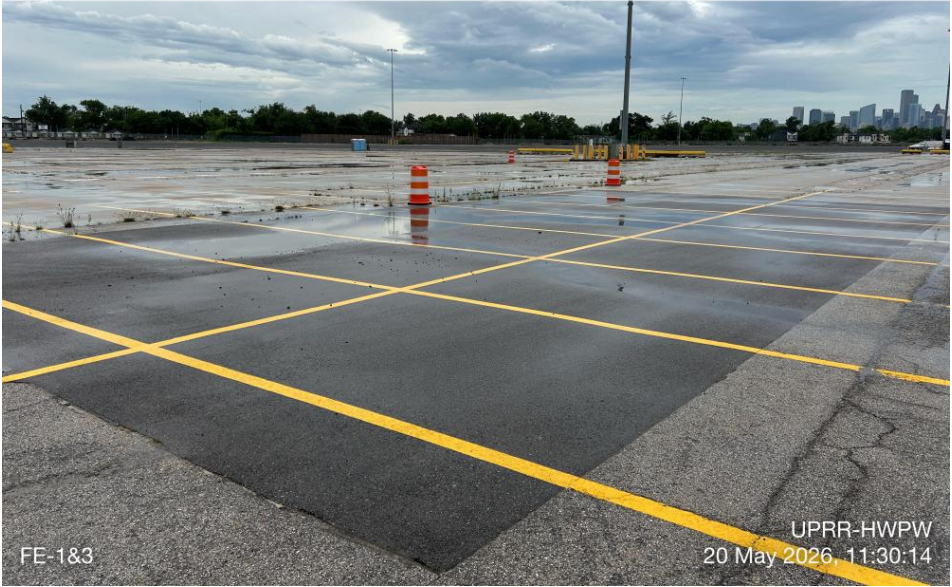
| <b>Description:</b><br>FE-1&3 weekly inspection of asphalt cap.<br>Reconstructed cap in good condition. No NAPL observed at FE location. Standing water from recent rain event. Facing southwest.<br><br>Lat: 29.78442<br>Long: -95.3208 | | <b>Description:</b><br>FE-2 weekly inspection of concrete cap.<br>Reconstructed cap in good condition. No NAPL observed at FE location. Standing water from recent rain event. Facing south.<br><br>Lat: 29.78429<br>Long: -95.32076 | |

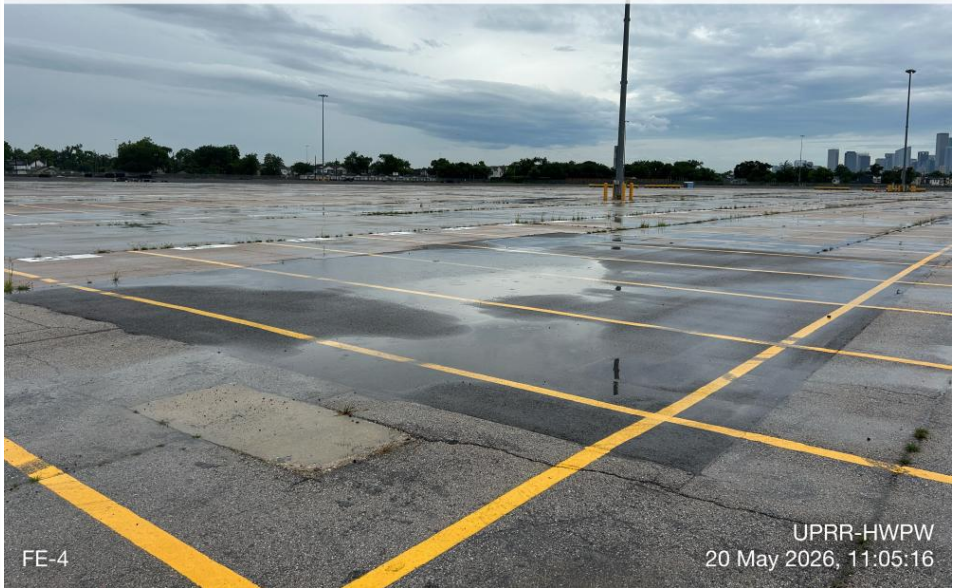
| <b>Description:</b><br>FE-4 weekly inspection of asphalt cap. Reconstructed cap in good condition. No NAPL observed at FE location. Standing water from recent rain event. Facing southwest.<br><br>Lat: 29.78492<br>Long: -95.31949 | | | | | |

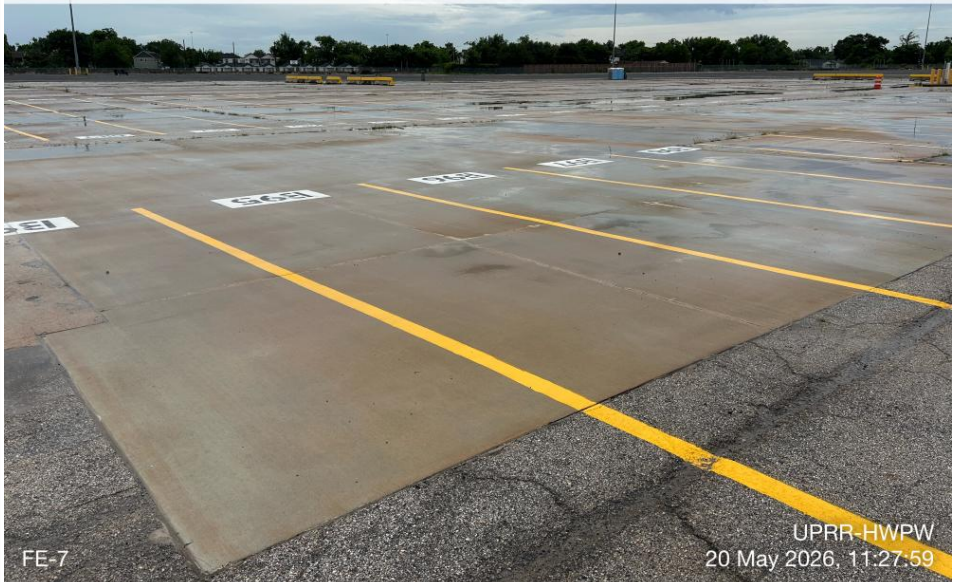
| <b>Description:</b><br>FE-7 weekly inspection of concrete cap.<br>Reconstructed cap in good condition. No NAPL observed at FE location. Standing water from recent rain event. Facing south.<br><br>Lat: 29.78439<br>Long: -95.32061 | | | | | |

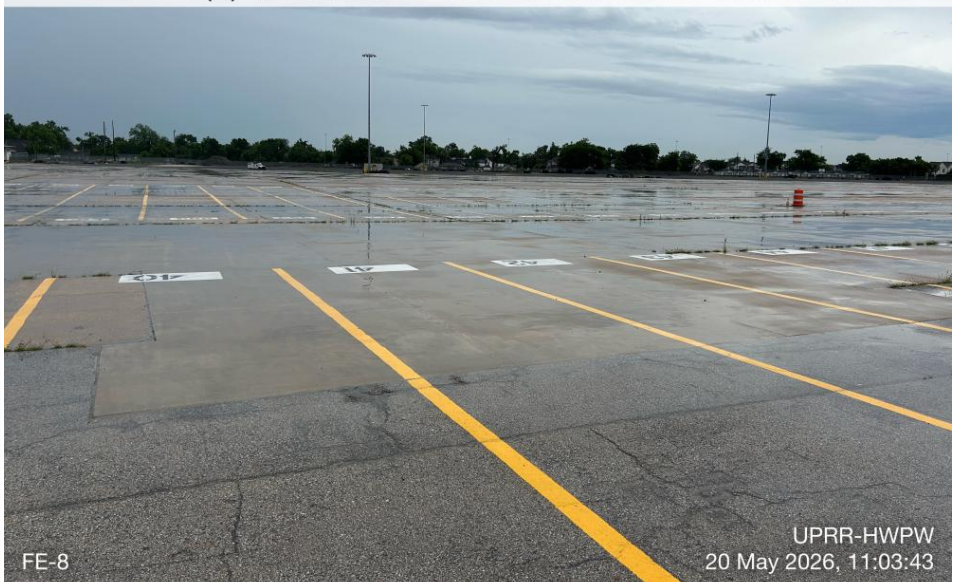
| <b>Description:</b><br>FE-8 weekly inspection of concrete cap.<br>Reconstructed cap in good condition. No NAPL observed at FE location. Standing water from recent rain event. Facing south.<br><br>Lat: 29.78505<br>Long: -95.31911 | | | | | |

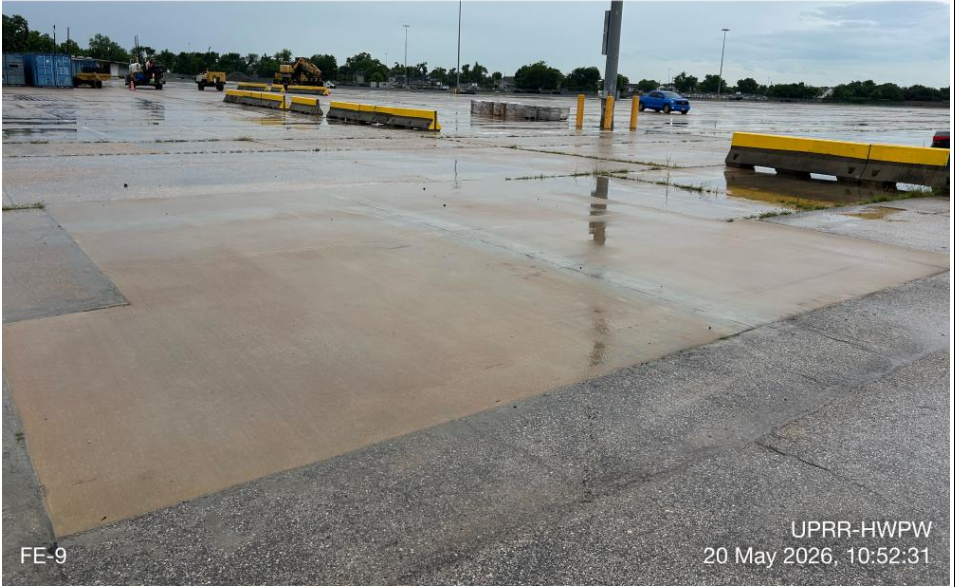
| <b>Description:</b><br>FE-9 weekly inspection of concrete cap. Reconstructed cap in good condition. No NAPL observed at FE location. Standing water from recent rain event. Facing south.<br><br>Lat: 29.78534<br>Long: -95.31838 | | <b>Description:</b><br>FE-10 weekly inspection of concrete cap. Reconstructed cap in good condition. No NAPL observed at FE location. Standing water from recent rain event. Facing southeast.<br><br>Lat: 29.78497<br>Long: -95.31776 | |

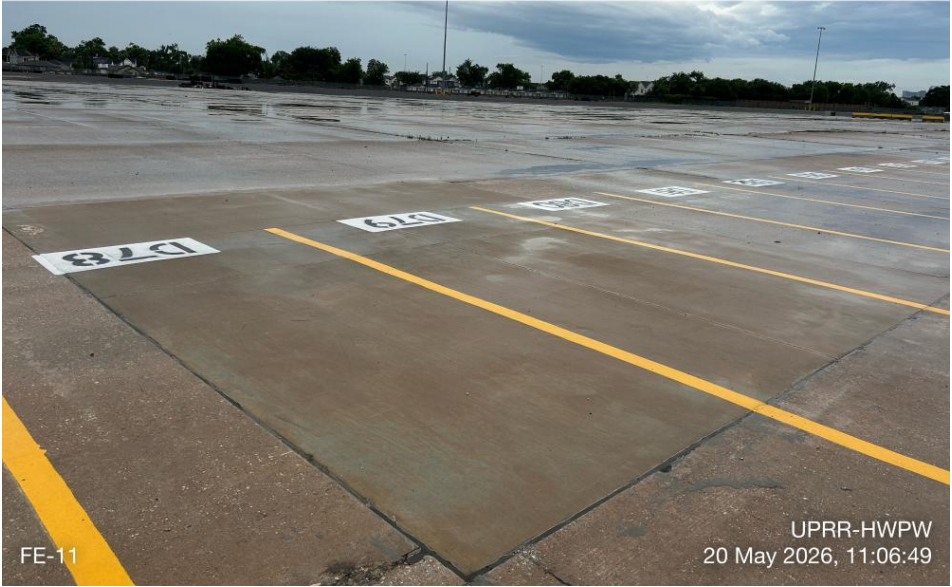
| <b>Description:</b><br>FE-11 weekly inspection of concrete cap.<br>Reconstructed cap in good condition. No NAPL observed at FE location. Standing water from recent rain event. Facing south.<br><br>Lat: 29.78441<br>Long: -95.31954 | | <b>Description:</b><br>FE-12 weekly inspection of concrete cap.<br>Reconstructed cap in good condition. No NAPL observed at FE location. Standing water from recent rain event. Facing southwest.<br><br>Lat: 29.78559<br>Long: -95.31867 | |

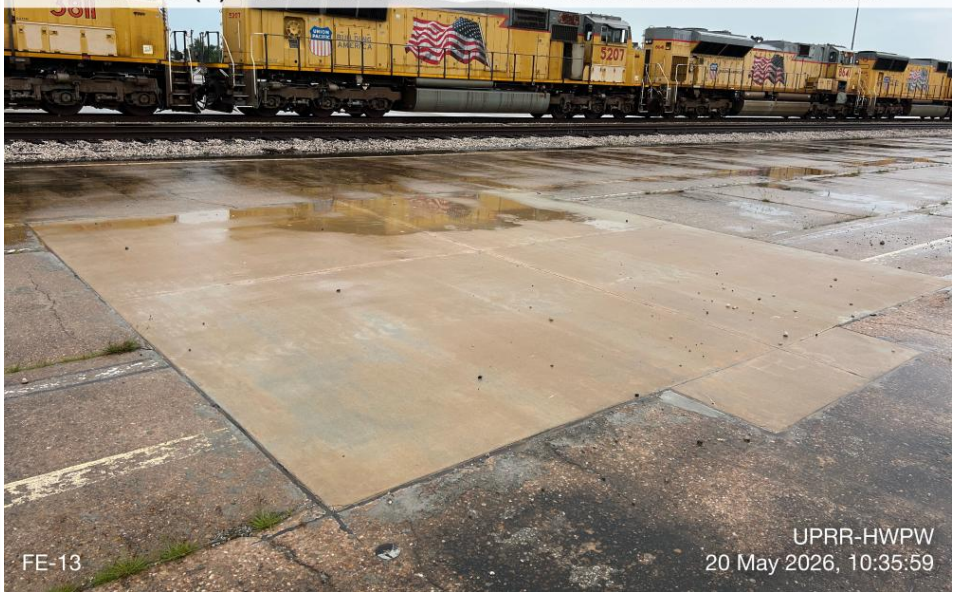
| <b>Description:</b><br>FE-13 weekly inspection of concrete cap. Reconstructed cap in good condition. No NAPL observed at FE location. Standing water from recent rain event. Facing south.<br><br>Lat: 29.78507<br>Long: -95.3212 | | | | | |

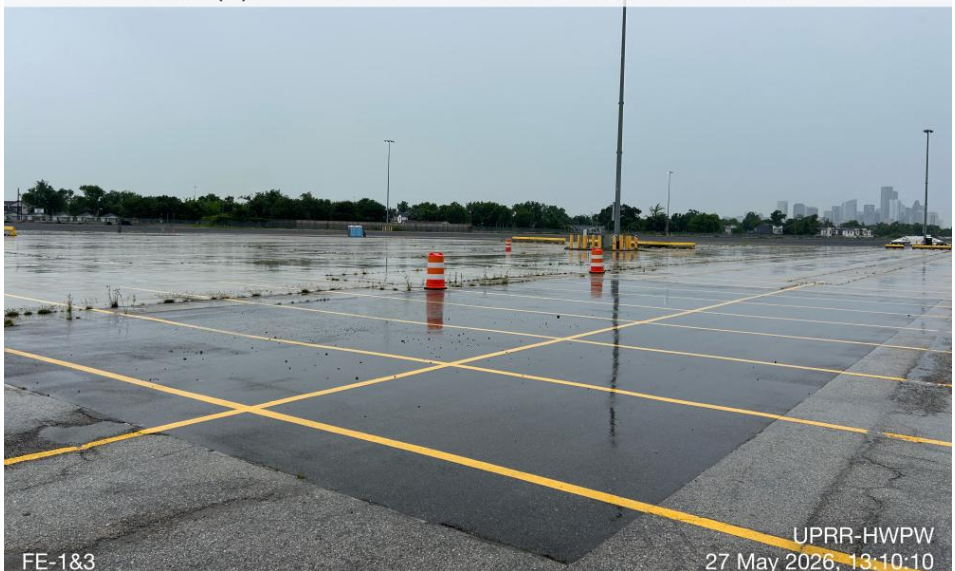
| <b>Description:</b><br>FE-1&3 weekly inspection of asphalt cap. Reconstructed cap in good condition. No NAPL observed at FE location. Standing water from recent rain event. Facing southwest.<br><br>Lat: 29.78442<br>Long: -95.3208 | | | | | |

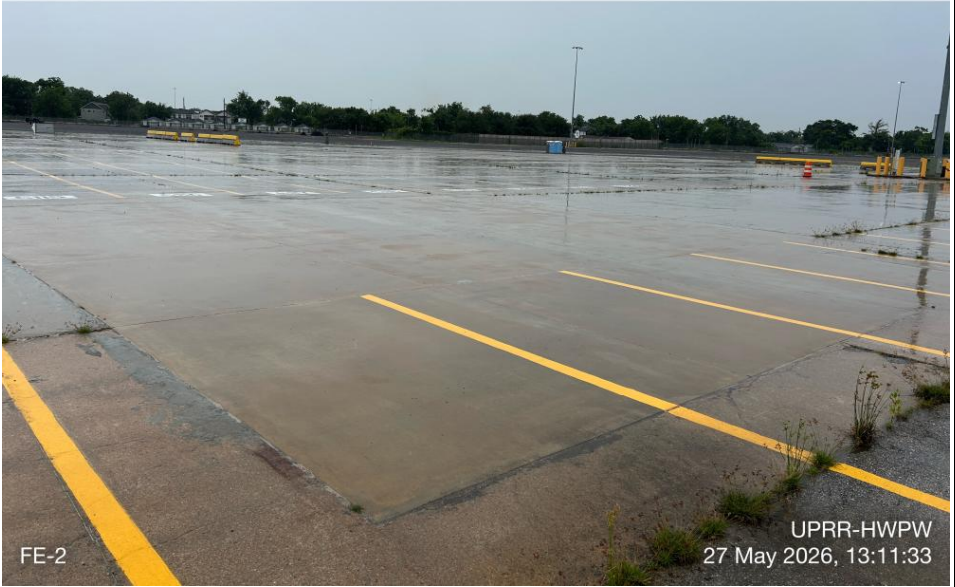
| <b>Description:</b><br>FE-2 weekly inspection of concrete cap.<br>Reconstructed cap in good condition. No NAPL observed at FE location. Standing water from recent rain event. Facing south.<br><br>Lat: 29.7843<br>Long: -95.32078 | | <b>Description:</b><br>FE-4 weekly inspection of asphalt cap.<br>Reconstructed cap in good condition. No NAPL observed at FE location. Standing water from recent rain event. Facing southwest.<br><br>Lat: 29.78493<br>Long: -95.3195 | |

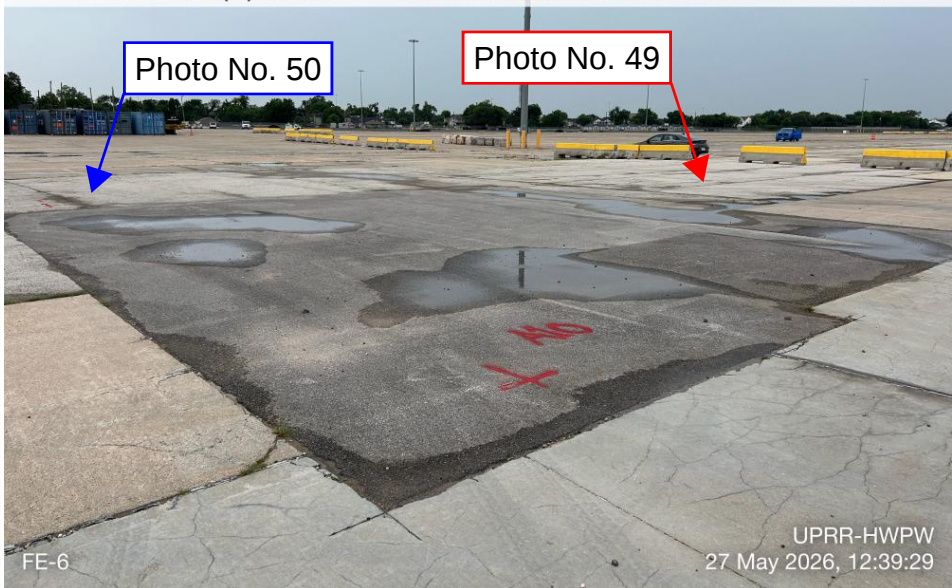
| <b>Description:</b><br>FE-6 weekly inspection of asphalt cap. Reconstructed cap in good condition. No NAPL observed at FE location. Brown water staining and a small amount of standing water were observed along the western joint perpendicular to the reconstructed asphalt cap of FE-6. Brown water staining was observed along the southern joint of the reconstructed asphalt cap of FE-6. Other standing water from recent rain event. Facing southwest.<br><br>Lat: 29.78557<br>Long: -95.31833 | | | |

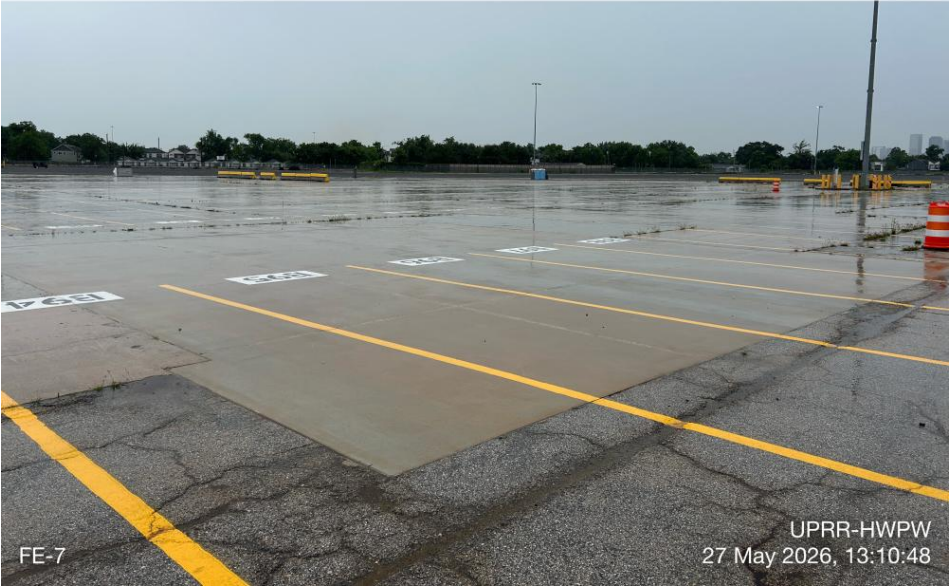
| <b>Description:</b><br>FE-7 weekly inspection of concrete cap. Reconstructed cap in good condition. No NAPL observed at FE location. Standing water from recent rain event. Facing south.<br><br>Lat: 29.7844<br>Long: -95.32062 | | <b>Description:</b><br>FE-8 weekly inspection of concrete cap. Reconstructed cap in good condition. No NAPL observed at FE location. Standing water from recent rain event. Facing south.<br><br>Lat: 29.78505<br>Long: -95.31914 | |

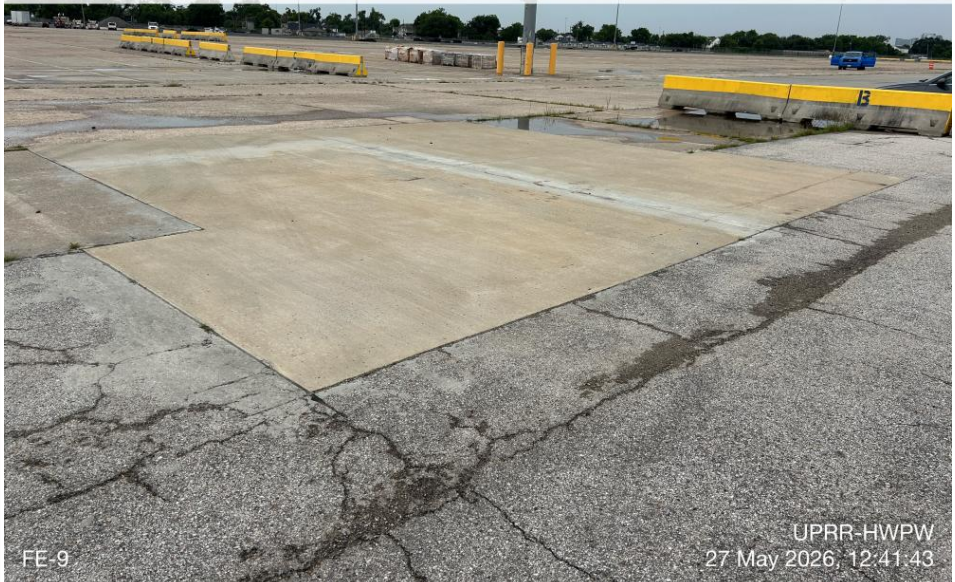
| <b>Description:</b><br>FE-9 weekly inspection of concrete cap. Reconstructed cap in good condition. No NAPL observed at FE location. Standing water from recent rain event. Facing south.<br><br>Lat: 29.78532<br>Long: -95.31836 | | | |

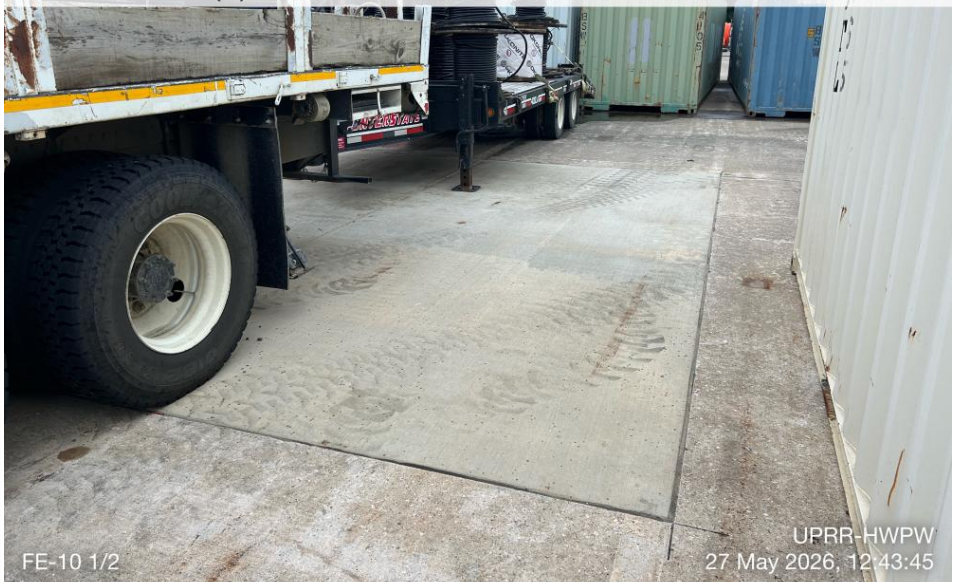
| <b>Description:</b><br>FE-10 weekly inspection of concrete cap. Reconstructed cap in good condition. No NAPL observed at FE location. Standing water from recent rain event. Facing southeast.<br><br>Lat: 29.78494<br>Long: -95.31778 | | | |

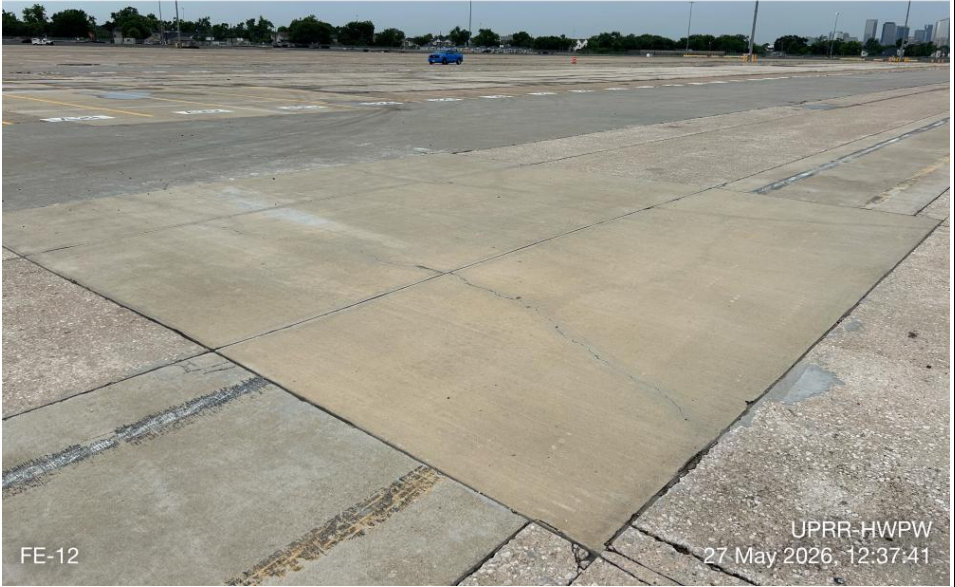
FE-12 weekly inspection of concrete cap. Reconstructed cap in good condition. No NAPL observed at FE location. Standing water from recent rain event. Facing southwest.

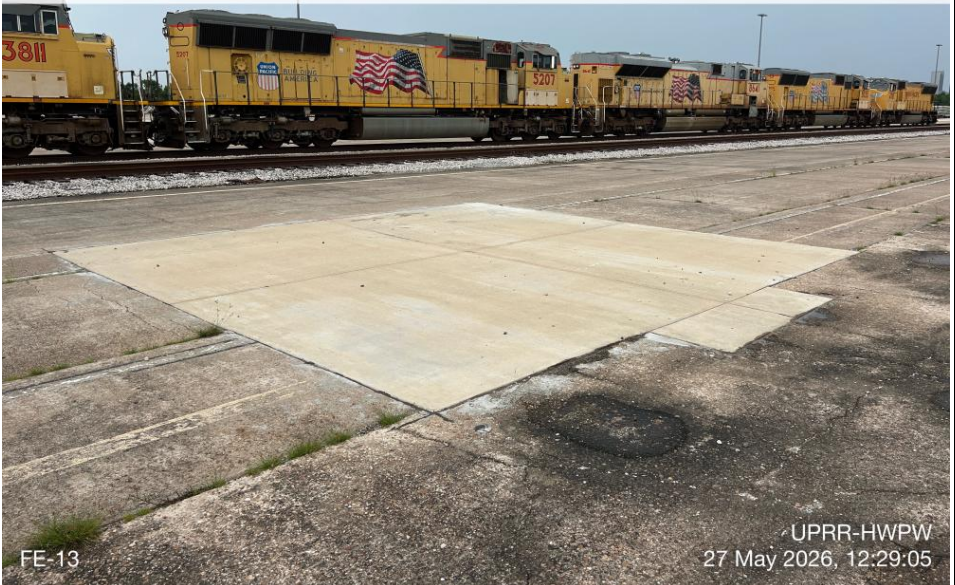
FE-13 weekly inspection of concrete cap. Reconstructed cap in good condition. No NAPL observed at FE location. Standing water from recent rain event. Facing south.

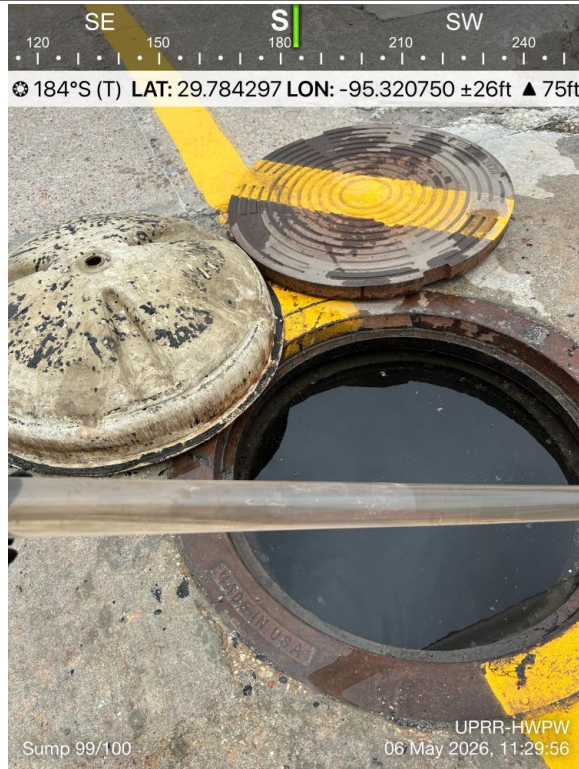
| <b>Description:</b><br>Sump 1 (B99/B100), 0.0 inches of freeboard in sump. Color is brown, and a sheen was observed. No odor was reported.<br><br>Lat: 29.7843<br>Long: -95.32075 | | <br>Sump 99/100<br>UPRR-HWPW<br>06 May 2026, 11:29:56 | |

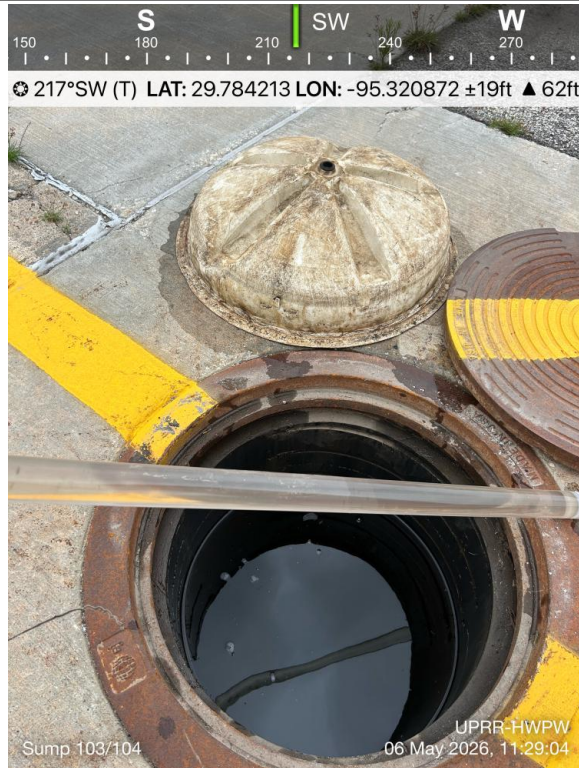
| <b>Description:</b><br>Sump 2 (B103/B104), 9.3 inches of freeboard in sump. Color is light brown, and no sheen or odor was reported.<br><br>Lat: 29.78421<br>Long: -95.32087 | | <br>Sump 103/104<br>UPRR-HWPW<br>06 May 2026, 11:29:04 | |

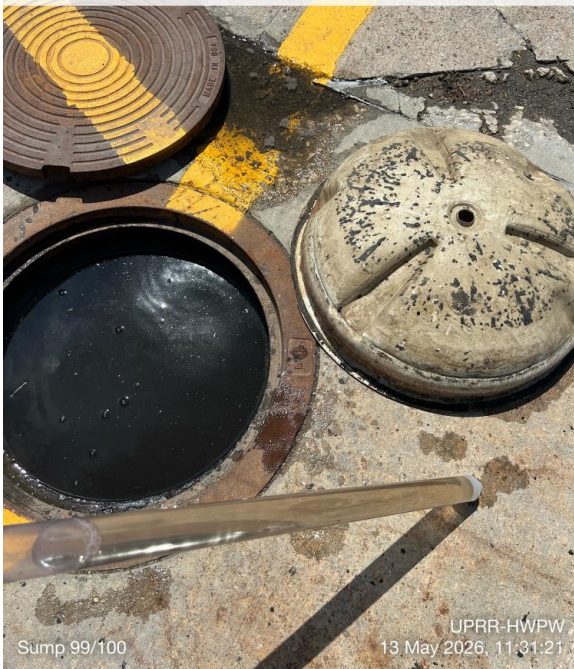
| <b>Description:</b><br>Sump 1 (B99/B100), 0.0 inches of freeboard in sump. Color is light brown, and no sheen or odor was reported.<br><br>Lat: 29.78429<br>Long: -95.32076 | | <div><div><div>E90120150180SESW</div><div>132°SE (T) LAT: 29.784289 LON: -95.320760 ±19ft ▲ 50ft</div><div></div><div>Sump 99/100UPRR-HWPW13 May 2026, 11:31:21</div></div></div> | |

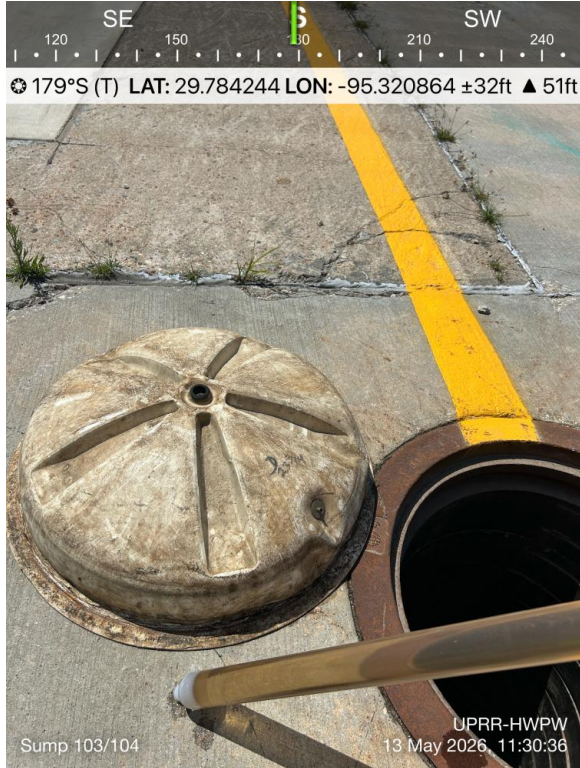
| <b>Description:</b><br>Sump 2 (B103/B104), 37.7 inches of freeboard in sump. Color is light brown, and no sheen or odor was reported.<br><br>Lat: 29.78424<br>Long: -95.32086 | | | |

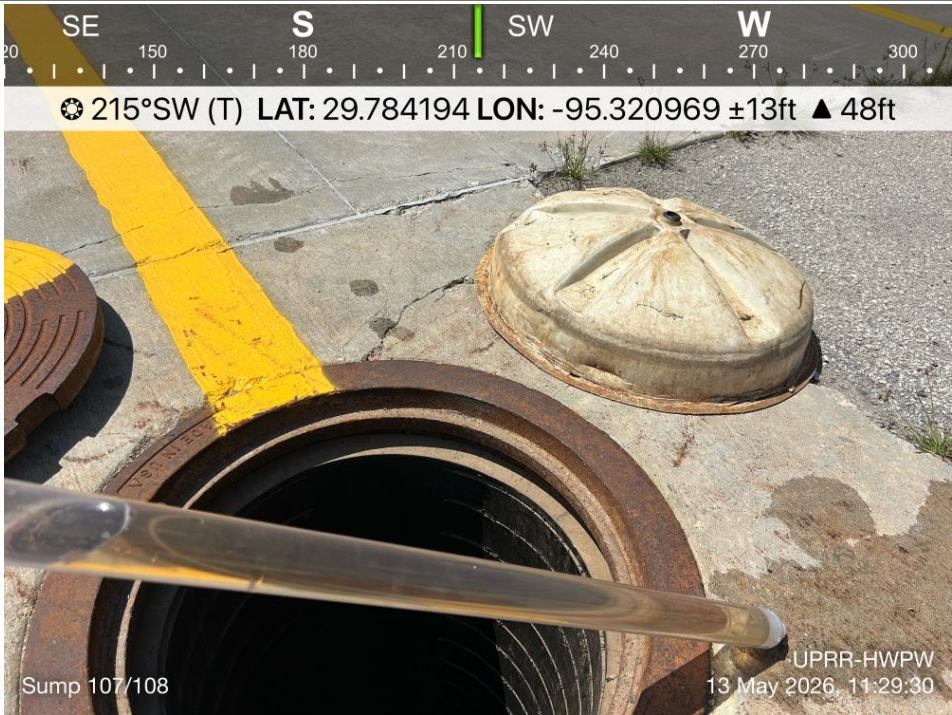
| <b>Description:</b><br>Sump 3 (B107/B108), 36.9 inches of freeboard in sump. Color is light brown, and no sheen or odor was reported.<br><br>Lat: 29.78419<br>Long: -95.32097 | | | |

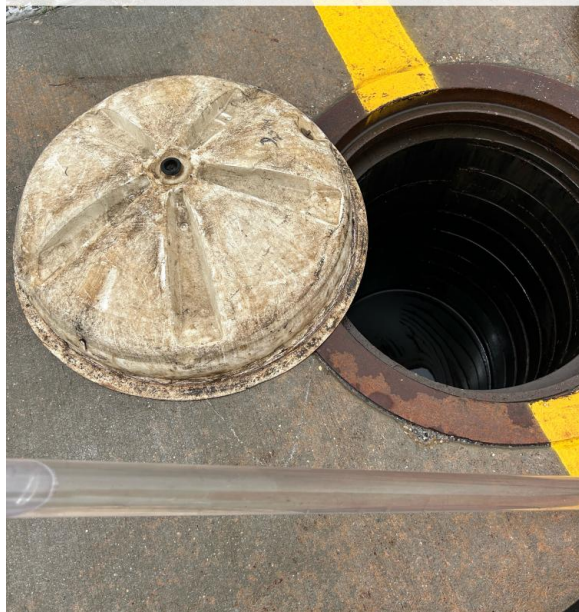
| <b>Description:</b><br>Sump 2 (B103/B104), 30.0 inches of freeboard in sump. Color is clear, and no sheen or odor was reported.<br><br>Lat: 29.78425<br>Long: -95.32086 | | | |

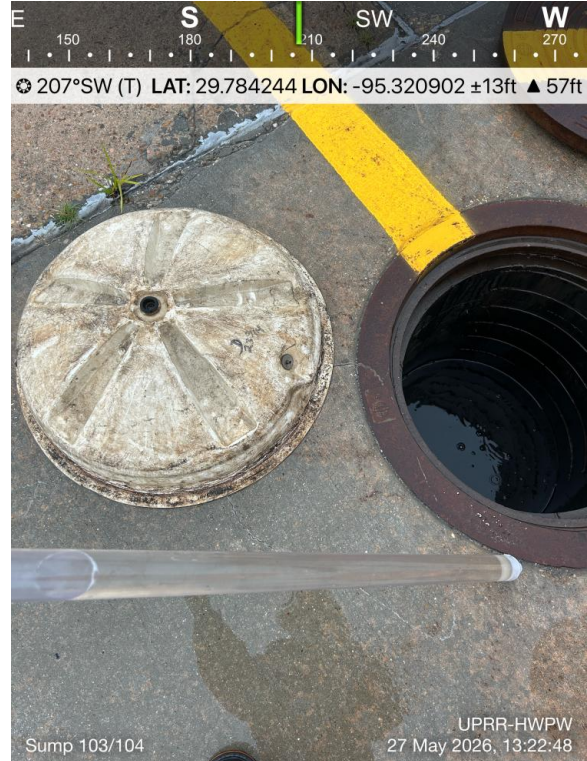
Sump 2 (B103/B104), 21.6 inches of freeboard in sump. Color is clear, and no sheen or odor was reported.

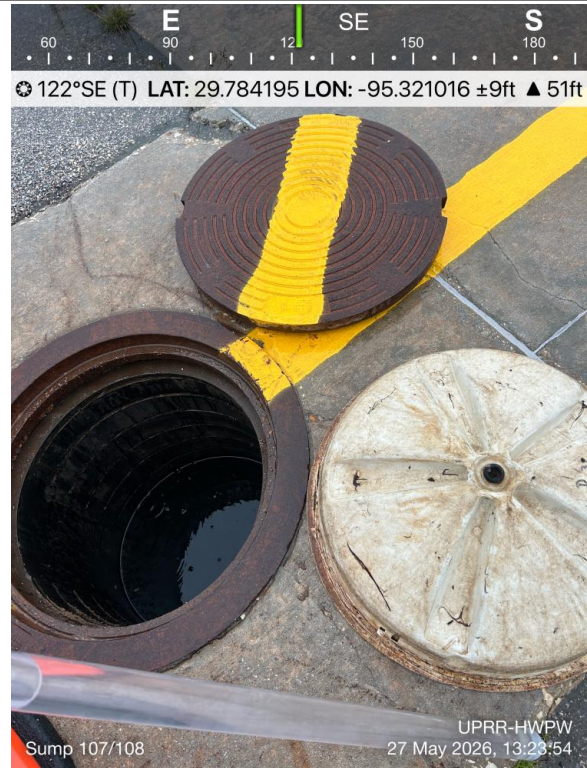
| <b>Photo No.</b><br>70 | <b>Inspection Date:</b><br>05/27/2026 |

Sump 3 (B107/B108), 21.1 inches of freeboard in sump. Color is clear, and no sheen or odor was reported.

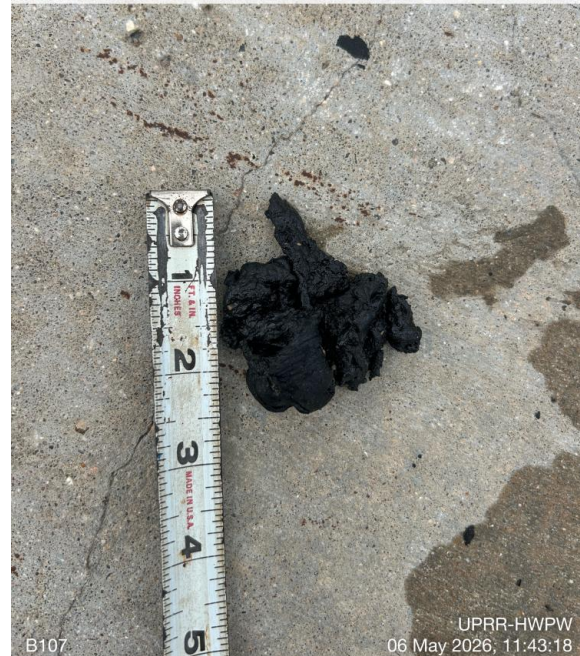
| <b>Description:</b><br>B107 weekly inspection of joint. Surrounding concrete in good condition. Approximately 3.75 cubic inches of NAPL observed at seep location.<br><br>Lat: 29.78415<br>Long: -95.32095 | | | |

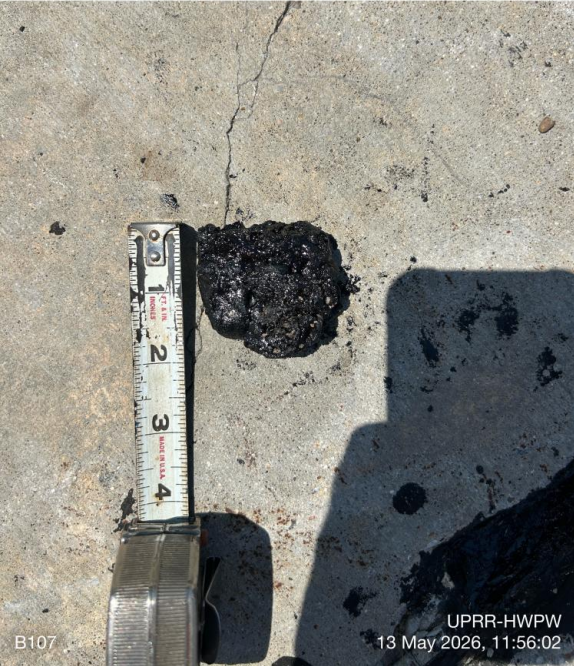
| <b>Description:</b><br>B107 weekly inspection of joint. Surrounding concrete in good condition. Approximately 2.63 cubic inches of NAPL observed at seep location.<br><br>Lat: 29.78414<br>Long: -95.32095 | | <b>Description:</b><br>B107 weekly inspection of joint. Surrounding concrete in good condition. Approximately 2.63 cubic inches of NAPL observed at seep location.<br><br>Lat: 29.78414<br>Long: -95.32096 | |

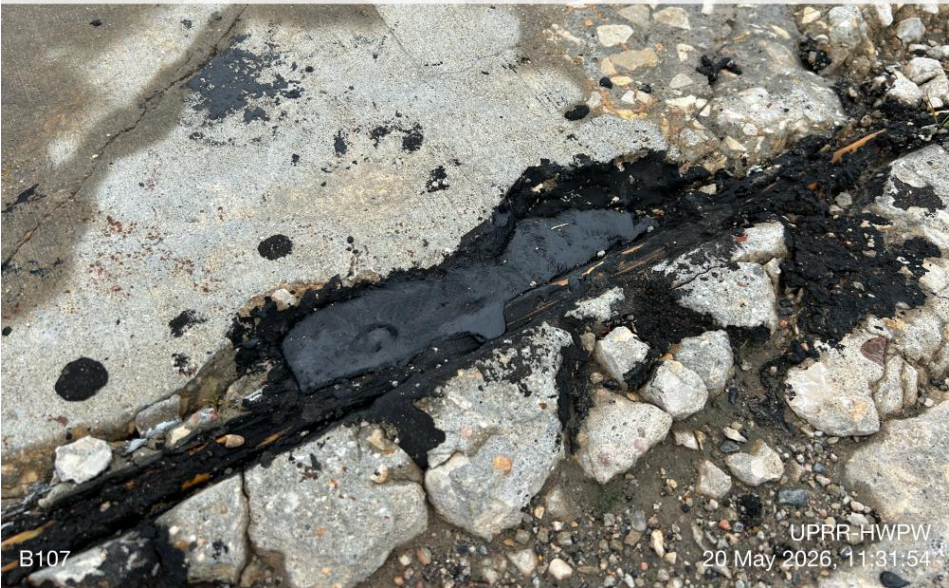
| <b>Description:</b><br>B107 weekly inspection of joint. Surrounding concrete in good condition. Approximately 2.81 cubic inches of NAPL observed at seep location.<br><br>Lat: 29.78416<br>Long: -95.32094 | | | | | |

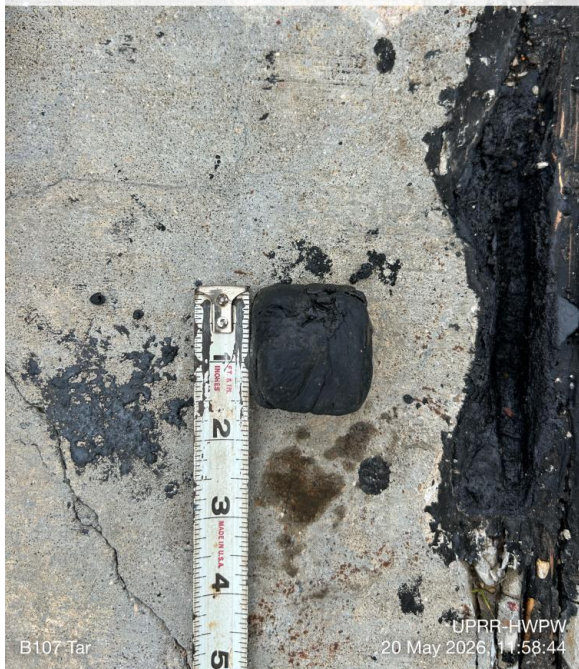
| <b>Description:</b><br>B107 weekly inspection of joint. Surrounding concrete in good condition. Approximately 2.81 cubic inches of NAPL observed at seep location.<br><br>Lat: 29.78416<br>Long: -95.32095 | | | | | |
