June 15, 2026

Project No. US0039040.3990

**Re: MONTHLY STATUS UPDATE – ENGLEWOOD INTERMODAL YARD – REVISED INTERIM MEASURES  
WORK PLAN POST-CONSTRUCTION AND NAPL COLLECTION SYSTEM/CONCRETE CAP REPAIR  
INSPECTIONS  
UNION PACIFIC RAILROAD HOUSTON WOOD PRESERVING WORKS FACILITY  
4910 LIBERTY ROAD FACILITY, HOUSTON, TEXAS  
POST-CLOSURE CARE PERMIT NO. HW-50343; INDUSTRIAL SWR NO. 31547**

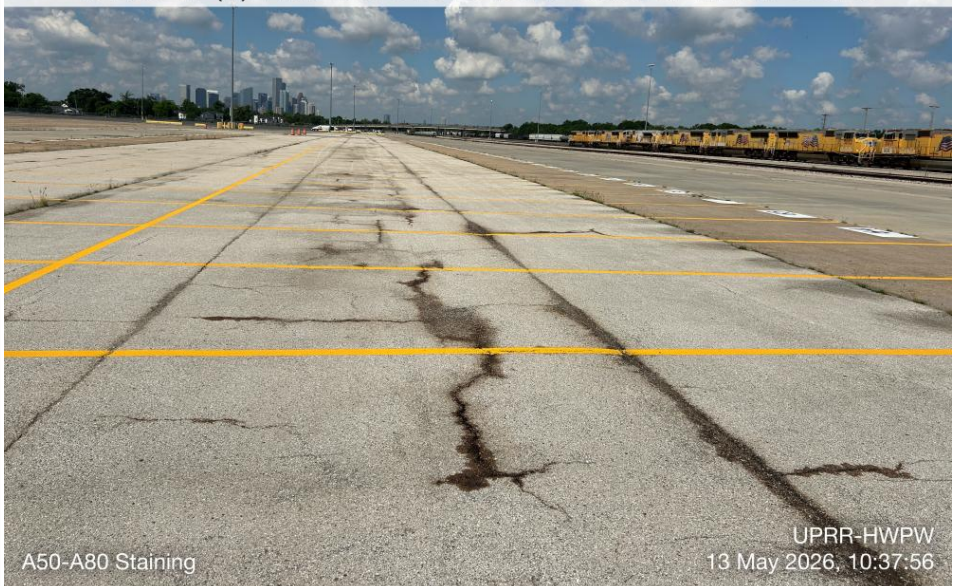
| <b>Description:</b><br>B102 Center weekly inspection of previously identified seep. Surrounding asphalt in good condition. No active NAPL seep observed along joint.<br><br>Lat: 29.78429<br>Long: -95.32084 | | <b>Description:</b><br>Brown water staining along the joint that runs from stall A050 through A080. Facing west.<br><br>Lat: 29.78485<br>Long: -95.31971 | | | |
