Re: MONTHLY STATUS UPDATE – ENGLEWOOD INTERMODAL YARD – NAPL COLLECTION SYSTEM/CONCRETE CAP REPAIRS UNION PACIFIC RAILROAD HOUSTON WOOD PRESERVING WORKS FACILITY 4910 LIBERTY ROAD FACILITY, HOUSTON, TEXAS POST-CLOSURE CARE PERMIT NO. HW-50343; INDUSTRIAL SWR NO. 31547

Weekly Inspection Photolog

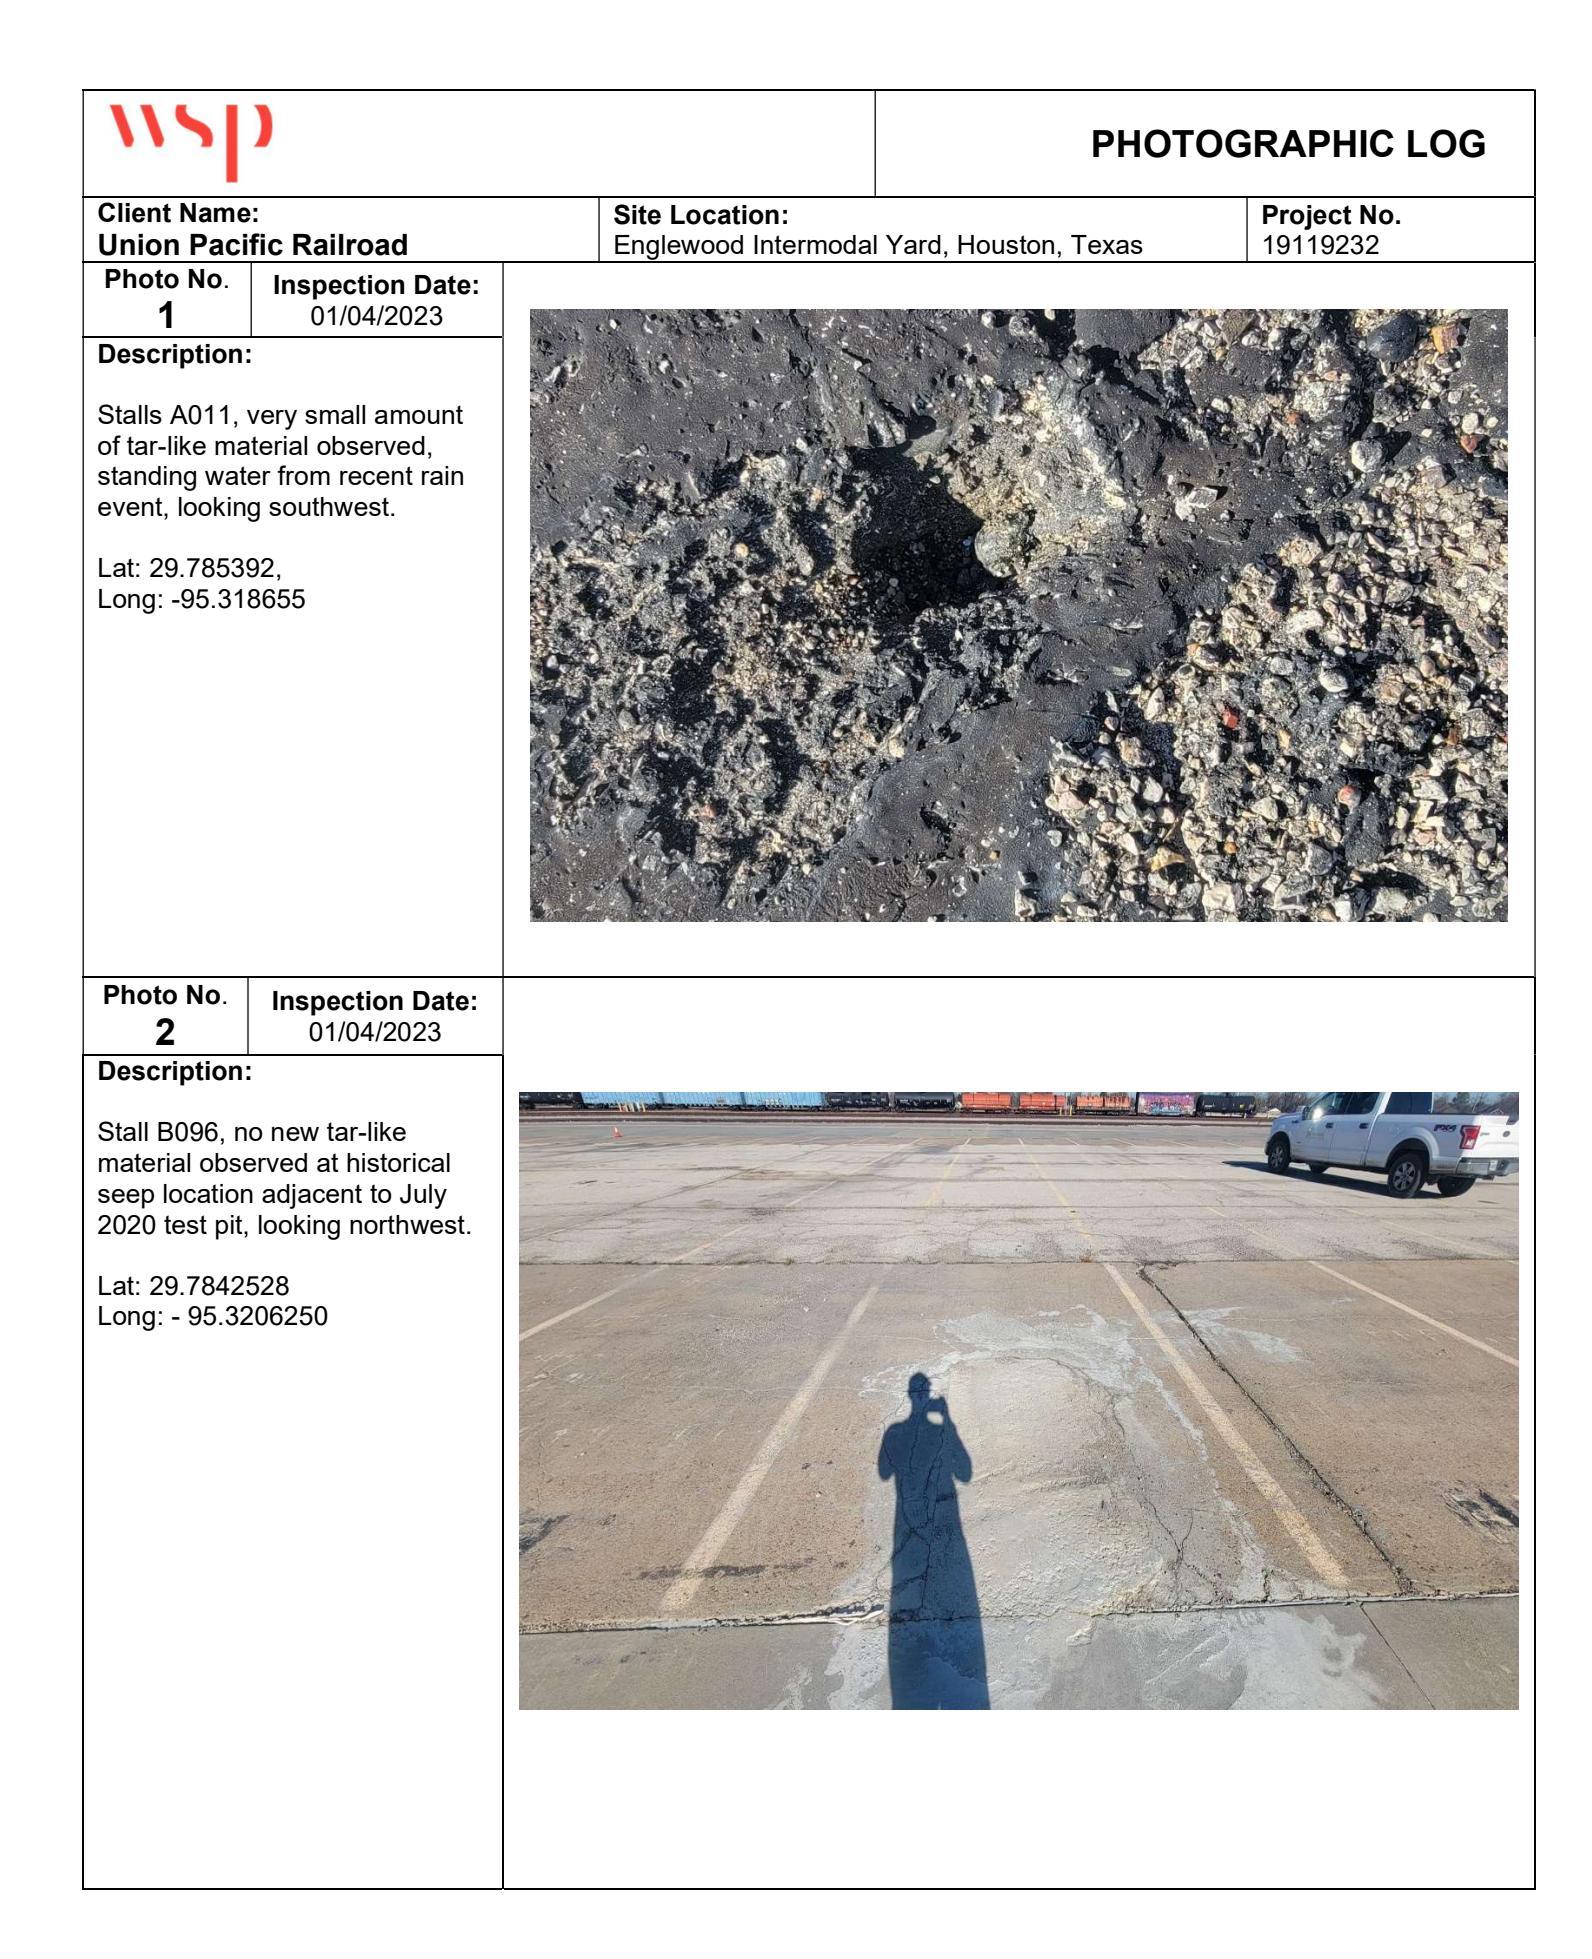
Seep Observations Outside the NAPL Collection System Area			
Stall Number	Observation Date(s)		
A011	January 4 th (Photo No. 1)

115)		рнотс	OGRAPHIC LOG
Client Name):	Site Location:		Project No.
Union Paci	fic Railroad	Englewood Intermoda	l Yard, Houston, Texas	19119232
Photo No.	Inspection Date:			
3	01/04/2023			
Description	:	4		
Stalls B099-E collection sys background o northwest. Lat: 29.7842 Long: - 95.32	B100, view of NAPL stem (Sump 1 in of photo), looking 75 20813			
Photo No.	Inspection Date:			
4 Decerimtic	01/04/2023		Y	
Stalls B107-E collection sys background of tar-like mater seep location along the sou excavated an northwest. Lat: 29.78419 Long: -95.32	3108, view of NAPL stem (Sump 3 in of photo), no new rial observed at n on concrete joint uthern edge of the rea, looking 56 20953

- Tar-like material observed during the weekly inspection events was removed and recovered using a hand tool to scrape up the material. During January, the number of tar-like material seeps observed and total amount of material removed during the weekly inspections decreased compared to the December 2022 weekly inspections. The only tar-like material seep observed during the month of January was the A011 seep on January 4th. Less than 0.01 gallons of tar-like material was recovered for the month from the seep locations. The material that was recovered was placed in a drum staged at the CSA for disposal.

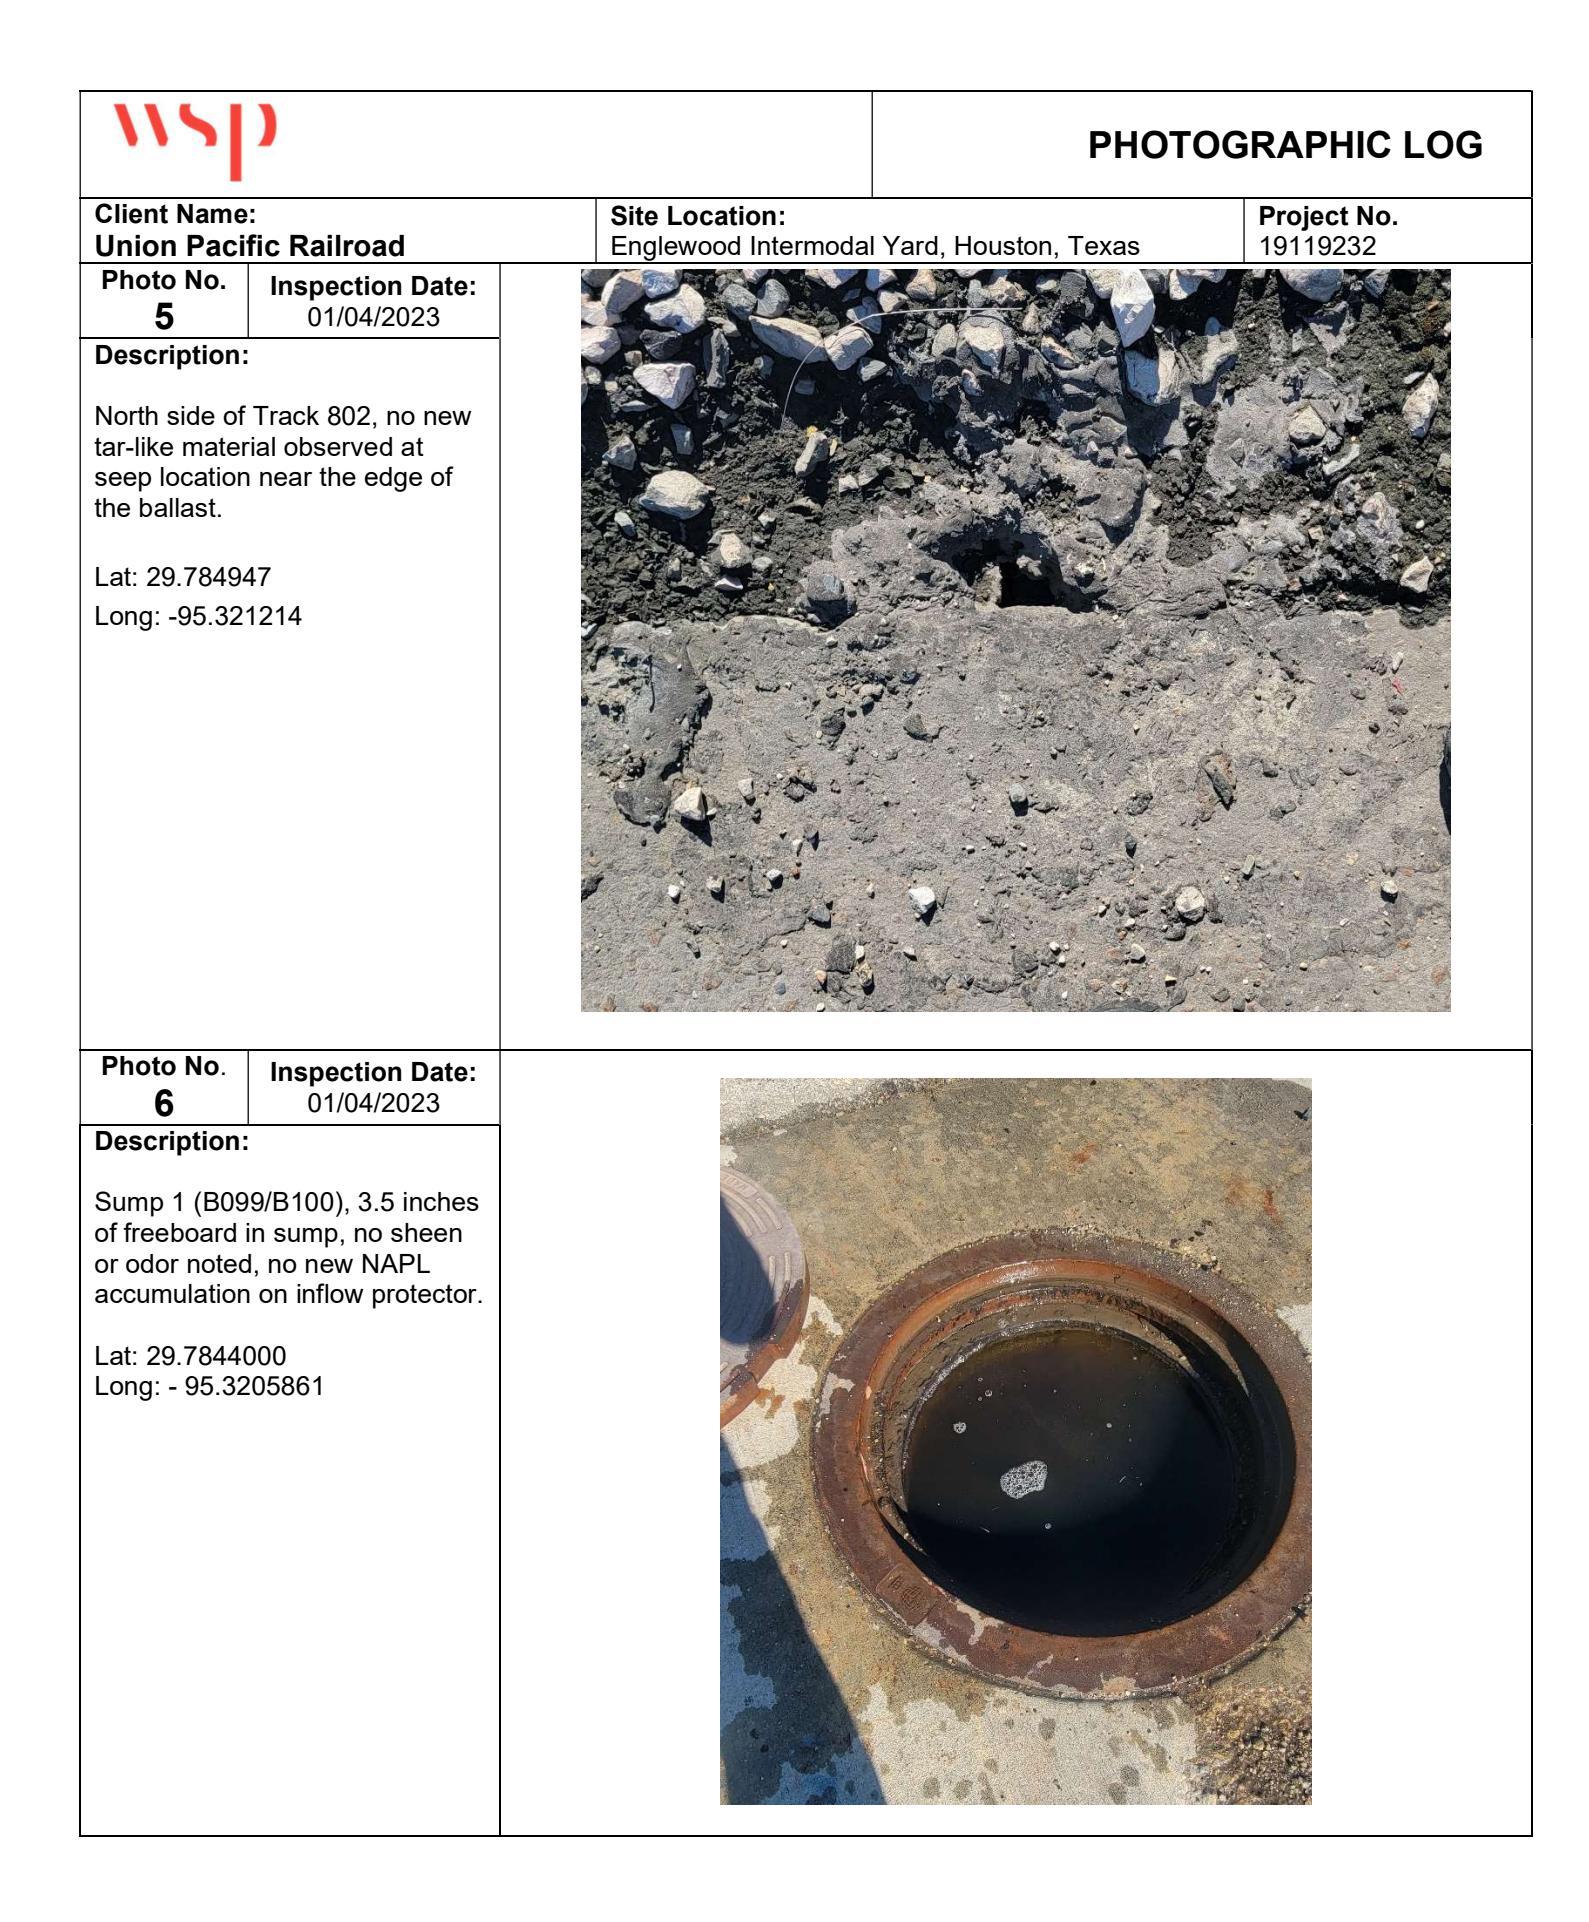
Water levels in NAPL Collection System Sump 1 (B099/B100 stalls), Sump 2 (B103/B104 stalls), and Sump 3 (B107/B108 stalls) were measured at 3.5 inches, 7.5 inches and 6 inches, respectively during the inspection on January 4, 2023 (Photo Nos. 6-8). The water level in Sump 1 remained near 3 inches from the top of the sump for the remainder of January 2023. In Sumps 2 and 3, water levels dropped to 13 inches from the top of the sumps on January 18, 2023. By the January 25, 2023 inspection, the water levels in Sump 1, 2, and 3 had risen to 3 inches, 6 inches and 5 inches, respectively, (Photo Nos. 29-31) from the top of the sumps. The water in the sumps was observed as having a light brown tint. No sheen or odors were reported during the January inspections. A sample of the sump water was collected on January 11, 2023 for re-characterization in order to update the waste profile for disposal at Delta Water Processing. A copy of the analytical report is provided in Attachment B. The next pump down event is scheduled for mid-February.

115)		рното	GRAPHIC LOG
Client Name): fic Pailroad	Site Location:	Vard Houston Texas	Project No.
Photo No. 7	Inspection Date: 01/04/2023			
Description Sump 2 (B10 inches of free odor noted. Lat: 29.7842 Long: - 95.32	203/B104), 7.5 eboard. No sheen or 861 208611			U.S. AN
Photo No. 8 Description Sump 3 (B10 inches of free sheen or odo Lat: 29.7841 Long: -95.32	Inspection Date: 01/04/2023

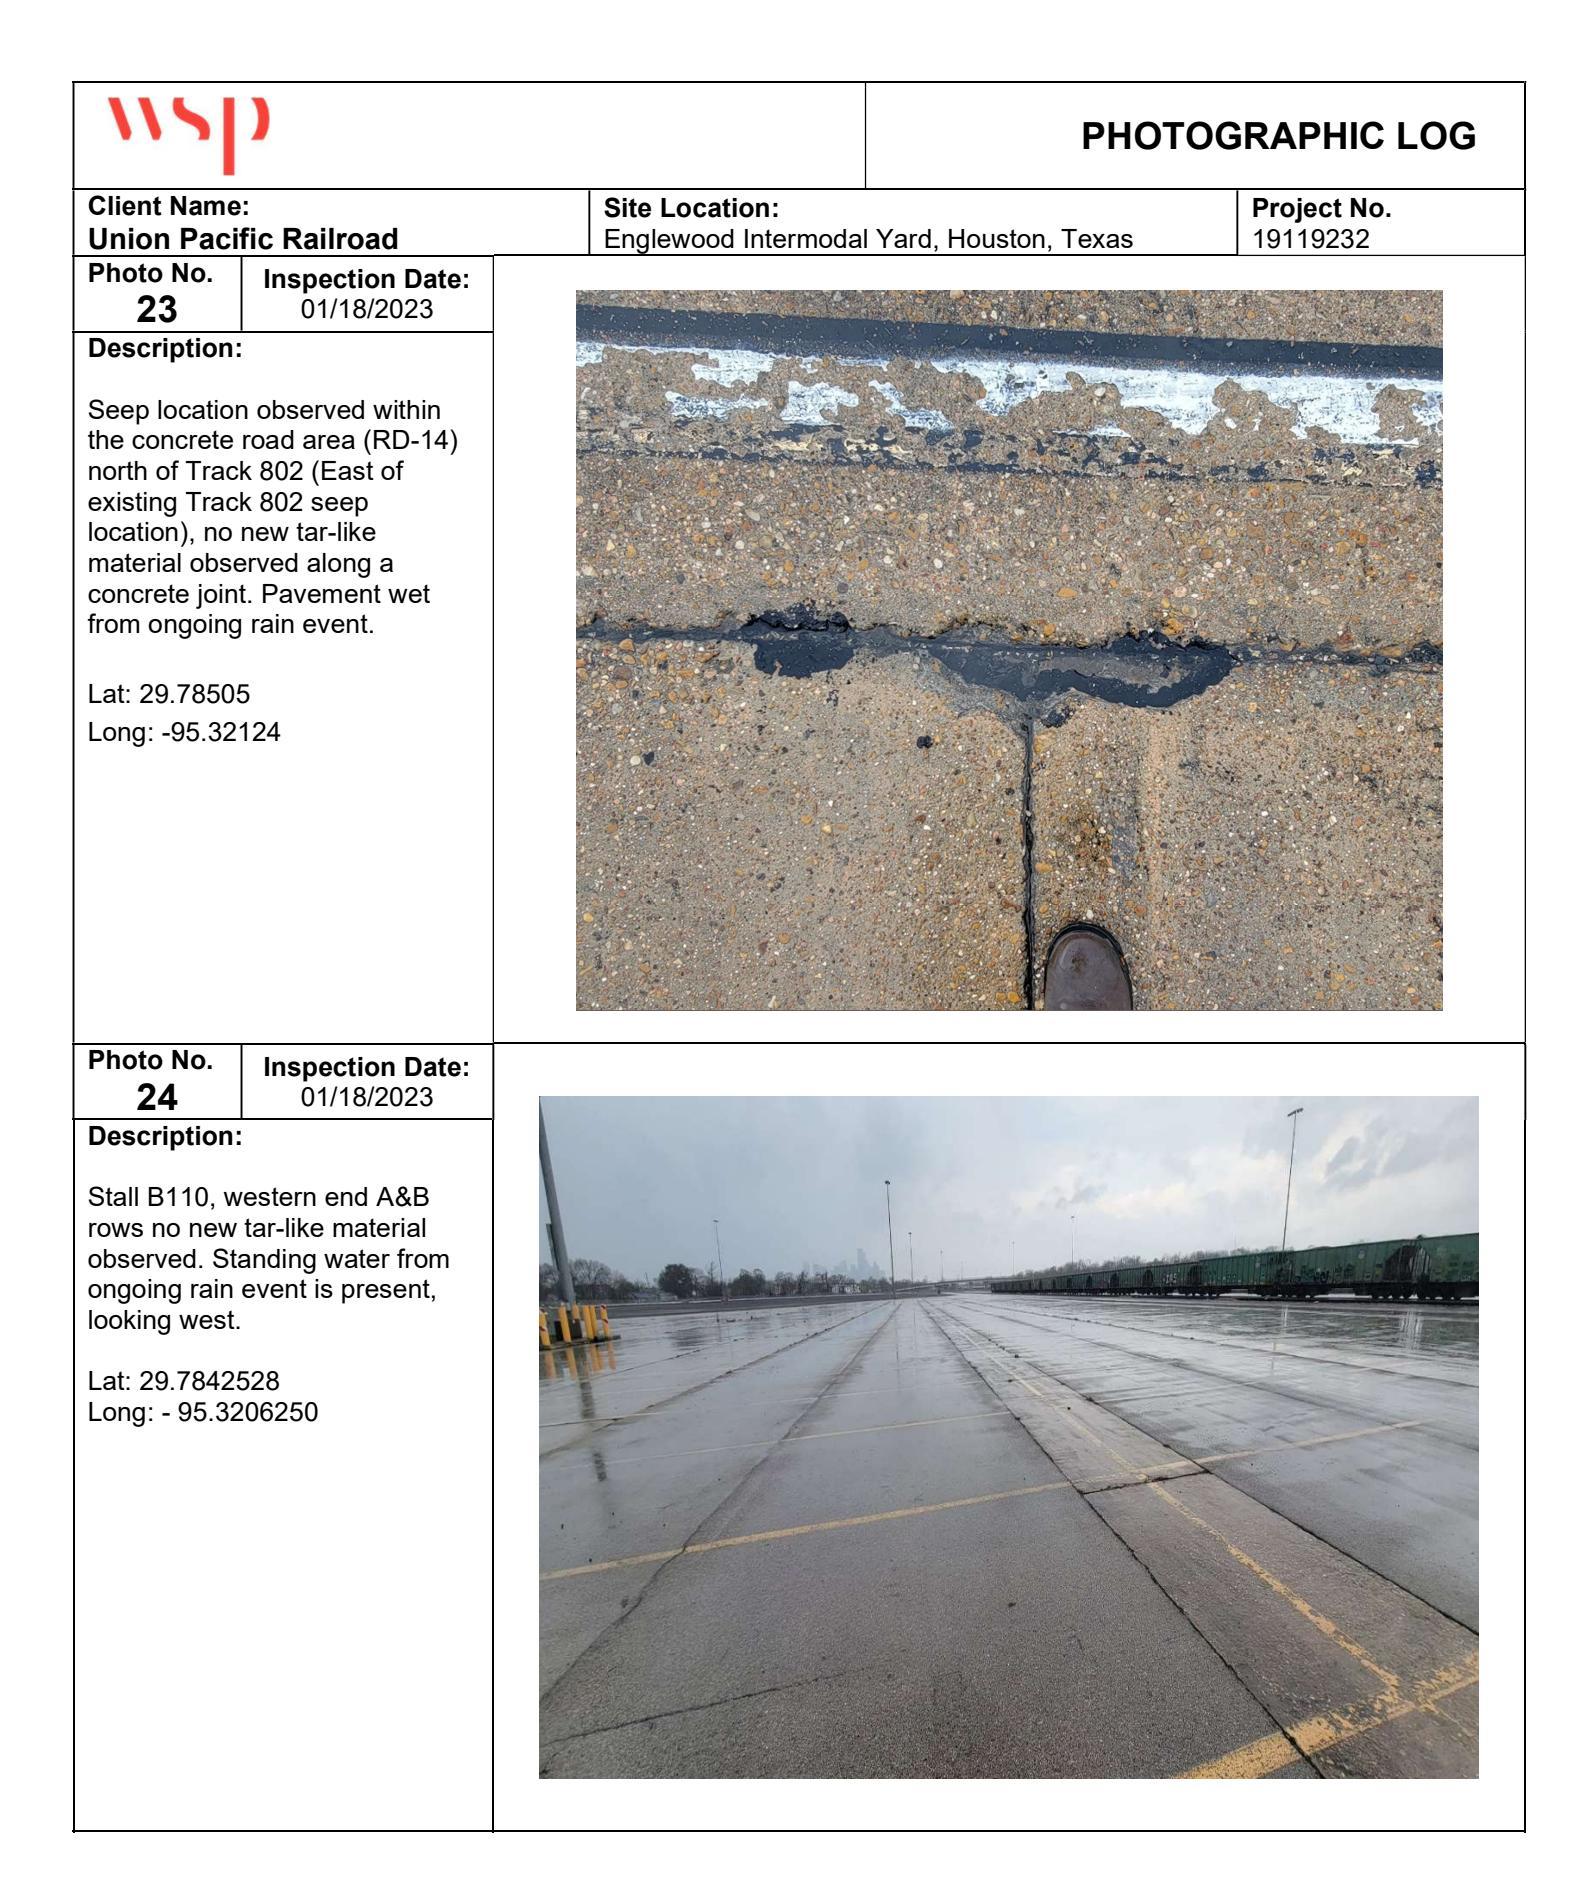
- As detailed in the July 2022 Monthly Status Update, a tar-like material seep was observed next to Track 802 that is located approximately 280 feet northwest of the NAPL Collection System. The tar-like material seep is located along on the northern side of the track at the edge of the railroad ballast (Photo No. 25). During the September 28, 2022 weekly inspection, an additional tar-like material seep was observed within the concrete road area (RD-14) about 45 feet north of Track 802 and east of the existing Track 802 seep location (Photo No. 26). However, no tar-like seep material was observed at either of these locations during January 2023.

115)		РНОТС	OGRAPHIC LOG
Client Name		Site Location:		Project No.
Union Pac	ific Railroad	Englewood Intermoda	Yard, Houston, Texas	19119232
25 Photo No.	Inspection Date: 1/25/2023			
Description	:		and the second second	
North side of tar-like mate seep location the ballast. Lat: 29.7849 Long: -95.32	f Track 802 no new rial observed at the n along the edge of 47 1214			
Photo No. 26	Inspection Date: 1/25/2023			
Description	:		10	1 1 2 2 2
Seep locatio the concrete north of Trac existing Trac location), no material obs concrete join Lat: 29.7850 Long: -95.32	n observed within road area (RD-14) k 802 (East of k 802 seep new tar-like erved along a ht. 5 2124

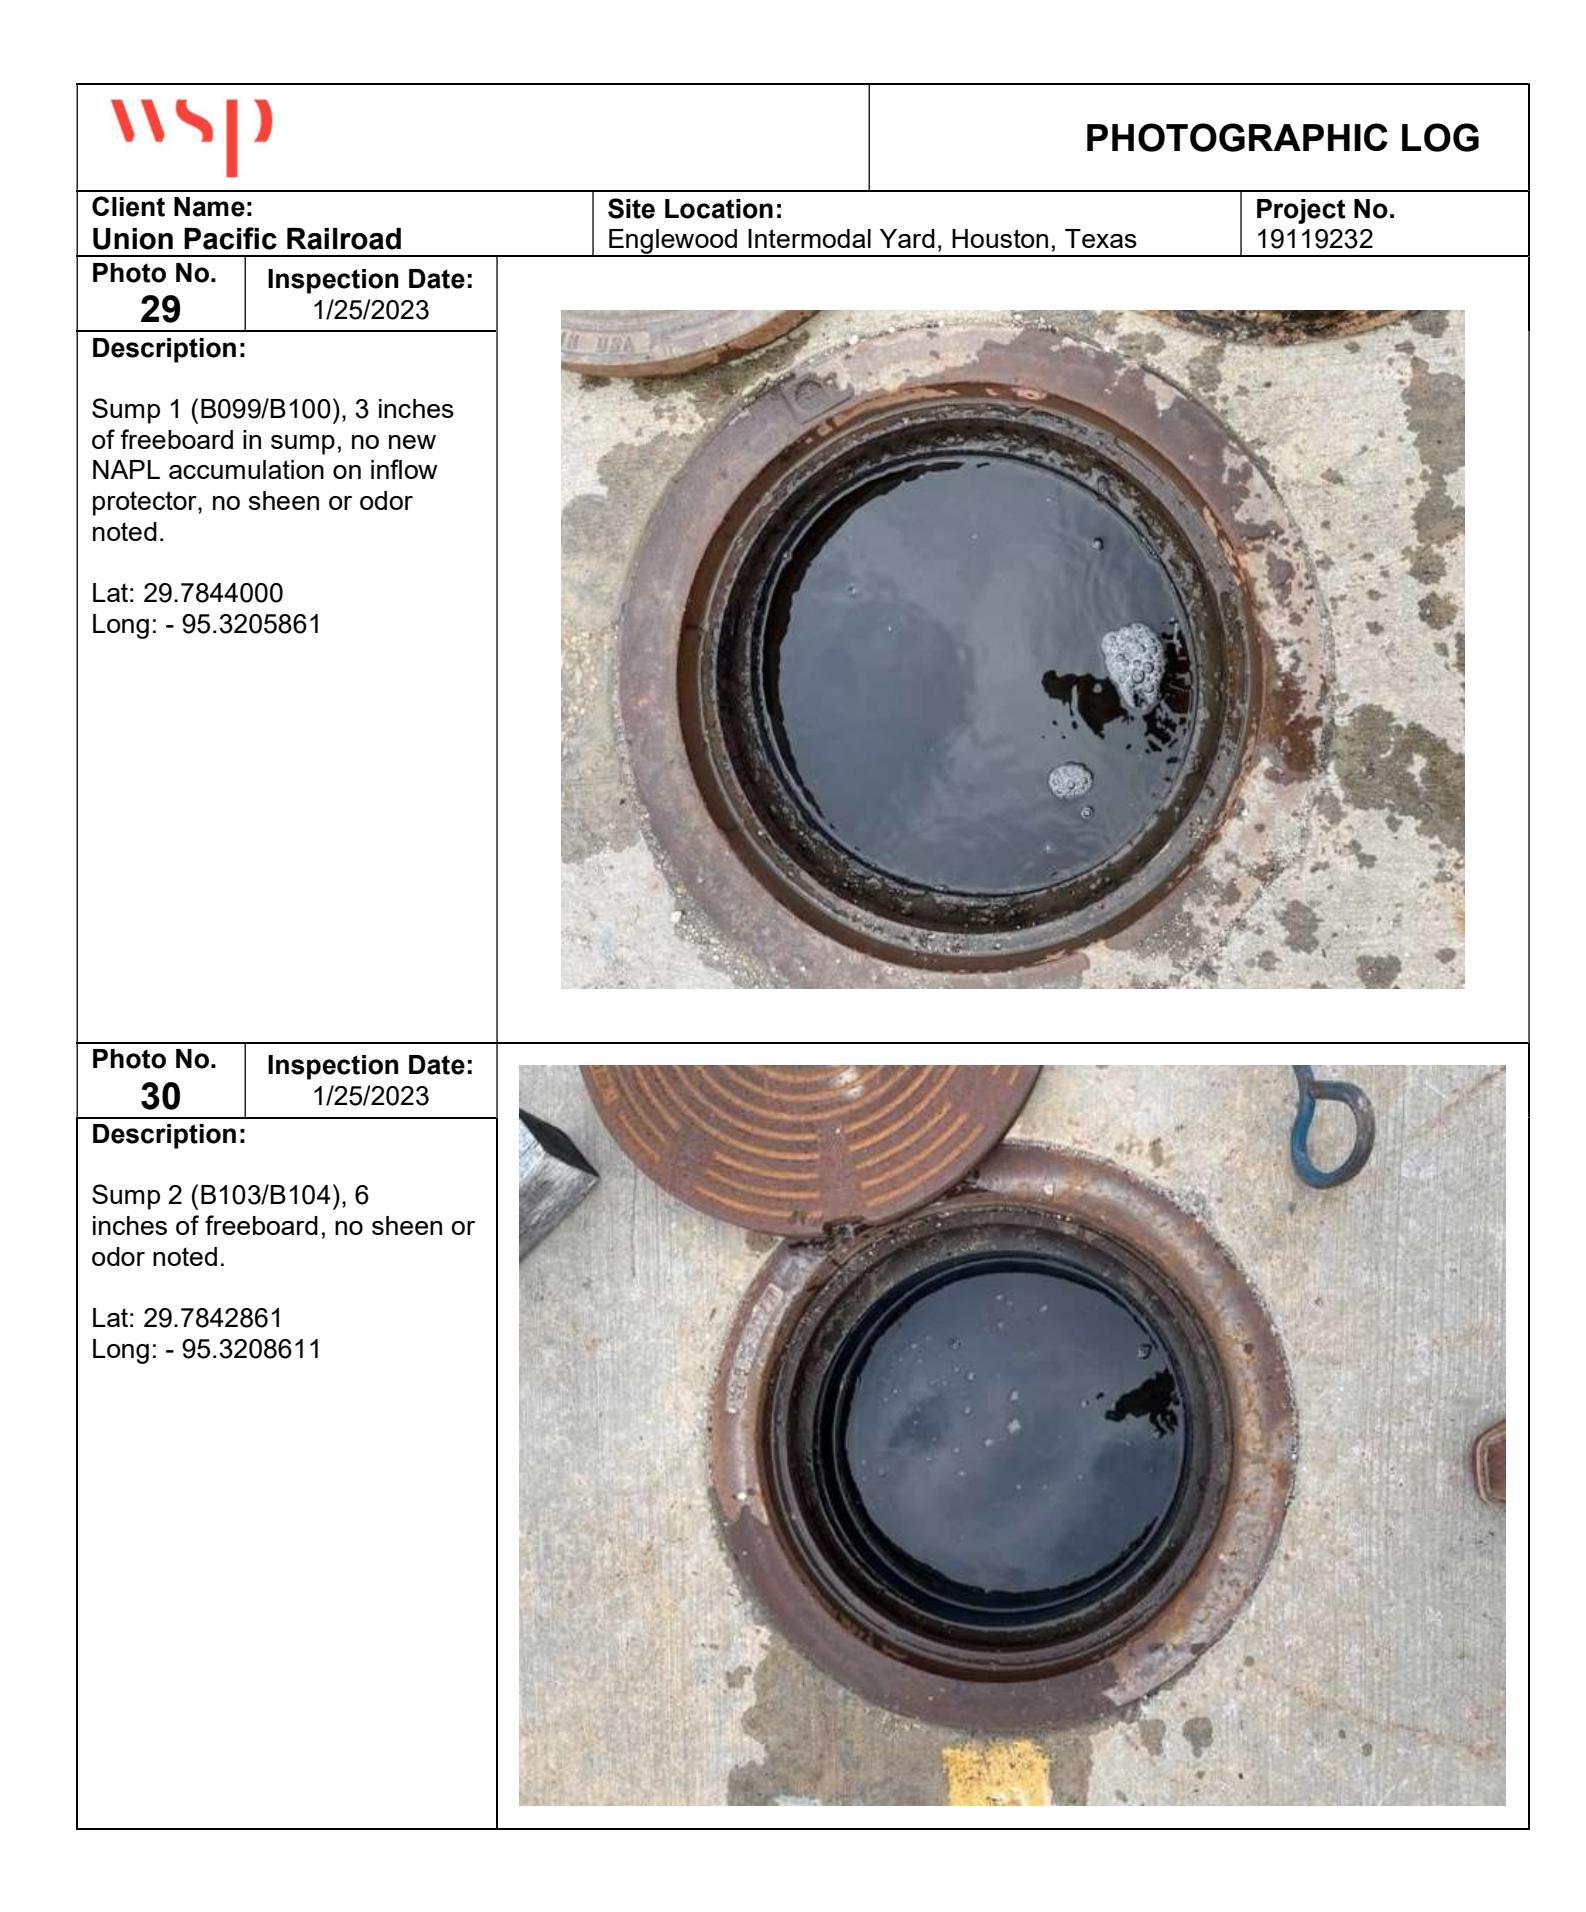
115)		PHOTOGRAPHIC L		
Client Name):	Site Location:		Project No.	
Union Paci	fic Railroad	Englewood Intermoda	l Yard, Houston, Texas	19119232	
Photo No.	Inspection Date:				
31 Description: Sump 3 (B10 of freeboard or odor noted Lat: 29.78417 Long: -95.320	1/25/2023 7/B108), 5 inches in sump, no sheen d. 72 0998				
Photo No.	Inspection Date:				
J2 Description	1/20/2023	Stan Street and Street		a de la contra de la	
Stall B109, w Collection sy material obse northwest. Lat: 29.7841 ⁻ Long: -95.32	vestern end of NAPL stem, no tar-like erved, looking 19 1007
