**RE: DNAPL RECOVERY ACTIVITIES QUARTERLY REPORT – 1ST QUARTER 2023
UNION PACIFIC RAILROAD HOUSTON WOOD PRESERVING WORKS FACILITY
4910 LIBERTY ROAD FACILITY, HOUSTON, TEXAS
POST-CLOSURE CARE PERMIT NO. HW-50343; INDUSTRIAL SWR NO. 31547**

WSP USA Inc. (WSP), on behalf of Union Pacific Railroad Company (UPRR), submits this 1st Quarter 2023 summary report for the dense non-aqueous phase liquid (DNAPL) recovery activities conducted at the UPRR Houston Wood Preserving Works Facility (the Site).

DNAPL Recovery Summary –1st Quarter 2023

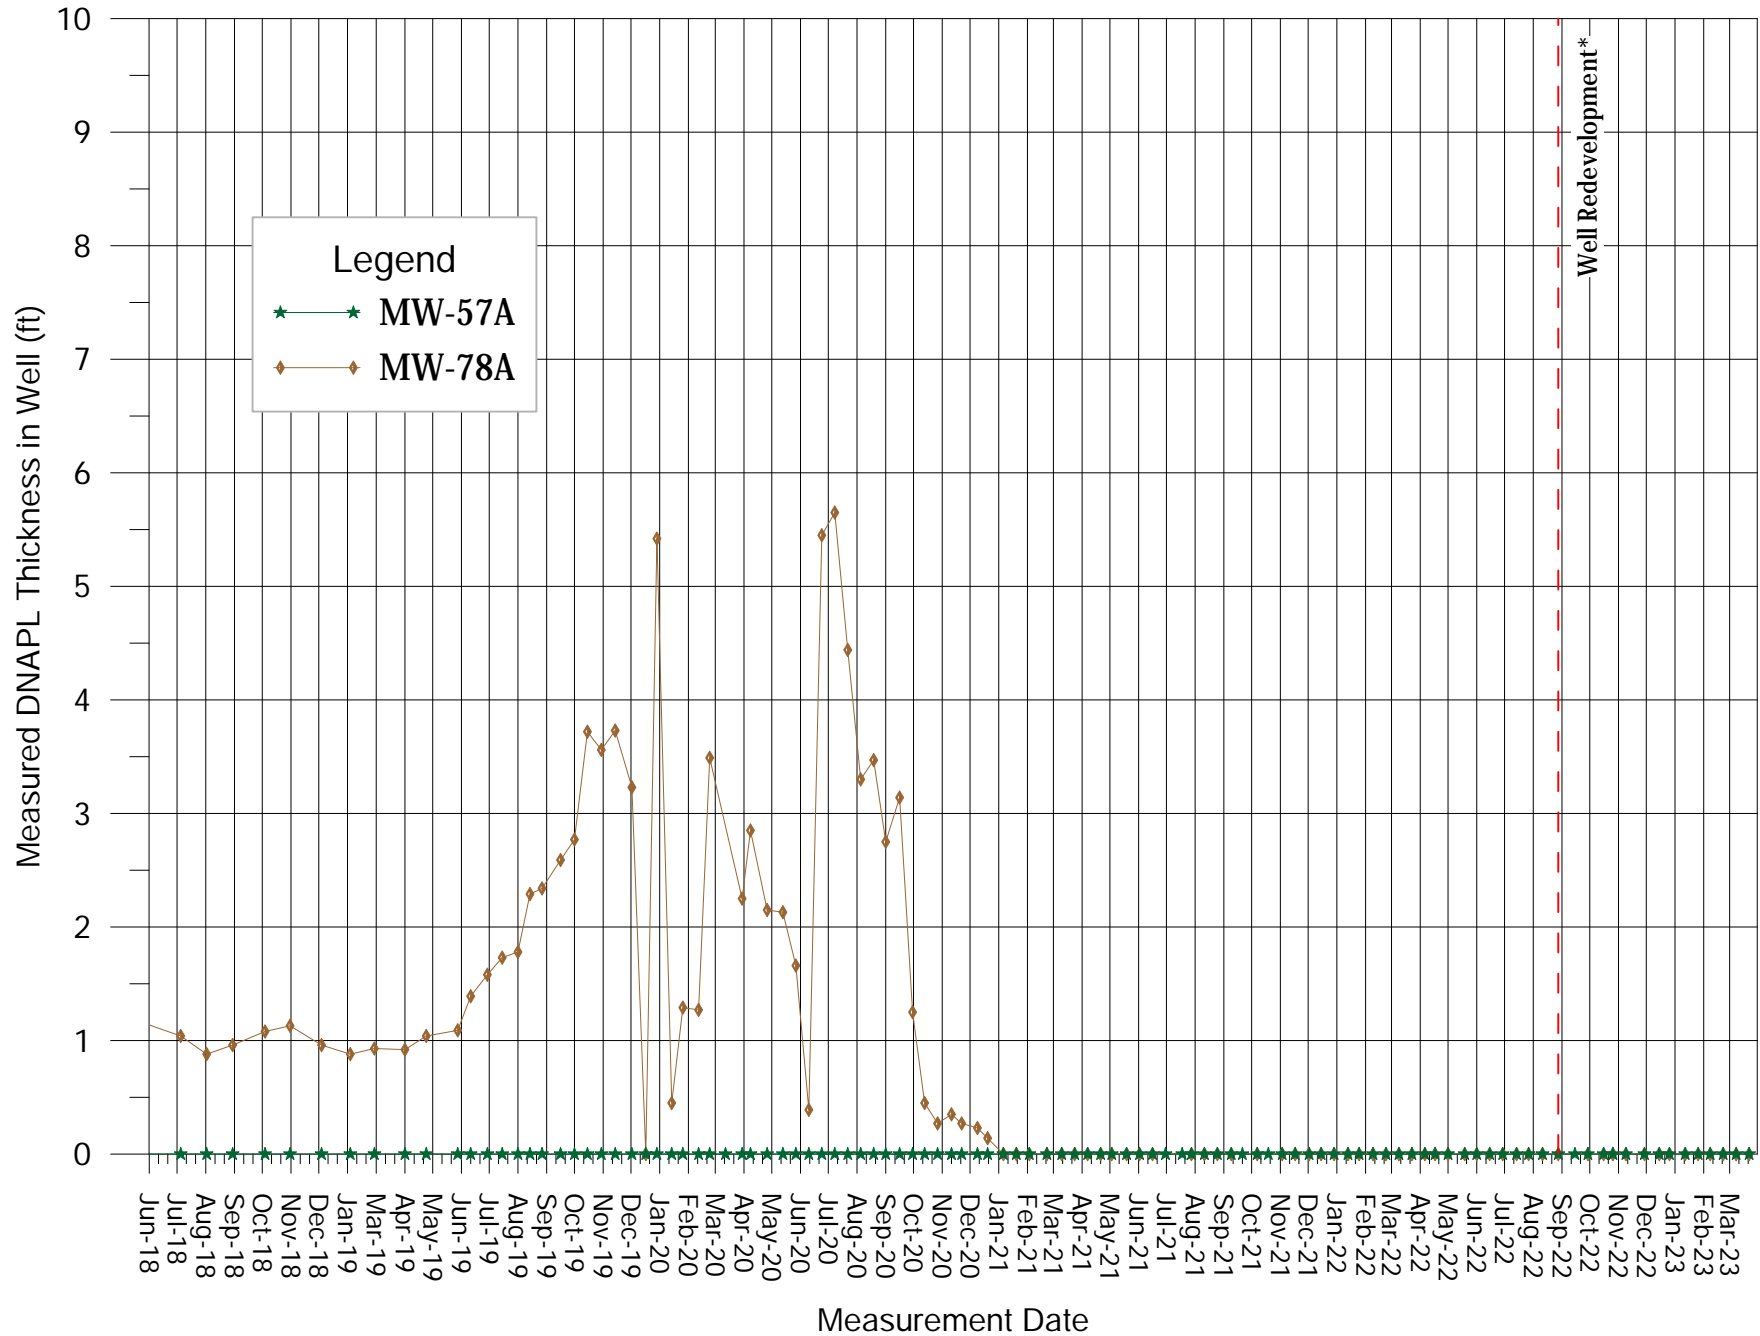
Figure 3
A-TZ Wells - DNAPL Recovery Activities July 2018 - March 2023
UPRR Houston Wood Preserving Works

*Wells MW-57A and MW-78A redeveloped on August 29, 2022

- **A-TZ Wells:** Recovery wells MW-57A and MW-78A completed in the A-TZ were evaluated for DNAPL recovery during this period (graph of DNAPL thickness from July 2018 through March 2023 shown on Figure 3).
 - **MW-57A:** No DNAPL was detected nor recovered from MW-57A during 1st Quarter 2023. DNAPL has not been detected in this well since May 2019, when a trace amount was measured. Measurable DNAPL has not been recorded in MW-57A since August 2015.
 - **MW-78A:** A trace amount of DNAPL was detected but not measurable during the February 9th and March 23rd events during the 1st Quarter 2023. Measurable DNAPL has not been detected in this well since December 2020.
- **B-TZ Wells (West Side):** Recovery wells MW-12B and MW-41B completed in the B-TZ were evaluated for DNAPL recovery during this period (graph of DNAPL thickness from July 2018 through March 2023 shown on Figure 4).

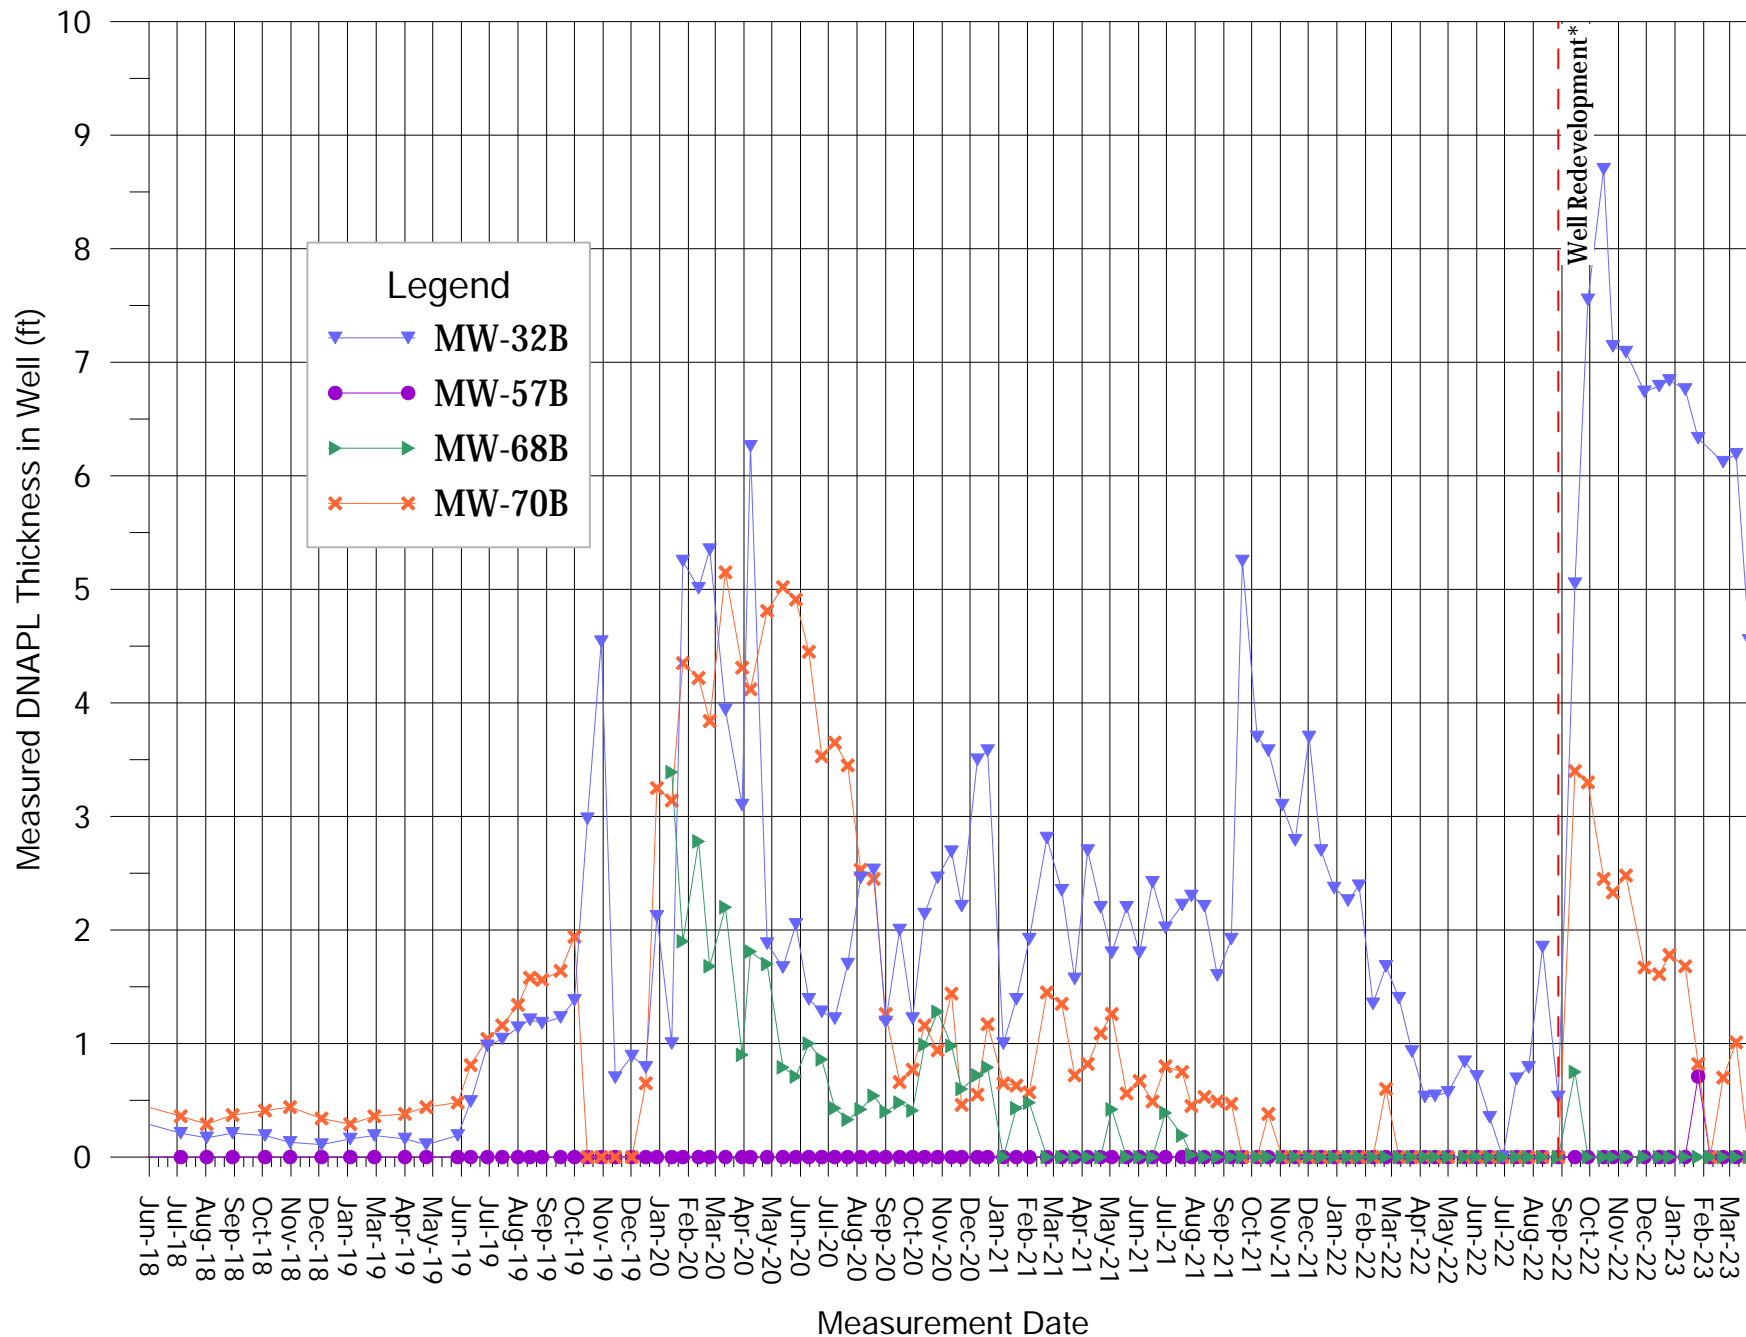
Figure 5
B-CZ/B-TZ Wells (North (On-Site and Off-Site)) - In-Well DNAPL Thickness July 2018 - March 2023
UPRR Houston Wood Preserving Works

*Wells MW-32B, MW-68B, and MW-70B were redeveloped on 8/30/2022

- **B-TZ/B-CZ Wells (North (on-site and off-site)):** Recovery wells MW-32B, MW-57B, MW-68B, and MW-70B completed in either the B-TZ or B-CZ on the north side of the Site or off-site to the north were evaluated for DNAPL recovery during this period (graph of DNAPL thickness from July 2018 through March 2023 shown on Figure 5).

- **MW-32B (off-site):** Following the redevelopment of MW-32B during the 3rd Quarter 2022, DNAPL thickness observed in the well increased in October 2022 but has since shown a decline through the 4th Quarter 2022 and 1st Quarter 2023. During the DNAPL recovery event on January 13, 2023, DNAPL thickness was measured at 6.76 feet. By March 23, 2023, the DNAPL thickness decreased to 4.55 feet. Approximately 7.0 gallons of DNAPL were recovered from MW-32B during the 1st Quarter 2023.

- **MW-70B (off-site):** Following redevelopment in the 3rd Quarter 2022, DNAPL thickness in MW-70B increased to approximately 3.4 feet in October 2022. Since then, DNAPL thickness has declined to just a trace amount. DNAPL thickness levels fluctuated during 1st Quarter 2023. DNAPL thickness measurements ranged from 1.68 feet on January 13, 2023 to trace amounts on February 9, 2023 and March 23, 2023. Approximately 1.75 gallons of DNAPL was recovered from MW-70B during 1st Quarter 2023.
