**RE: DNAPL RECOVERY ACTIVITIES QUARTERLY REPORT – 1ST QUARTER 2025
UNION PACIFIC RAILROAD HOUSTON WOOD PRESERVING WORKS FACILITY
4910 LIBERTY ROAD FACILITY, HOUSTON, TEXAS
POST-CLOSURE CARE PERMIT NO. HW-50343; INDUSTRIAL SWR NO. 31547**

DNAPL Recovery Summary 1st Quarter 2025

TABLE 1
SUMMARY OF DNAPL RECOVERY MEASUREMENTS
UPRR HOUSTON, TX - WOOD PRESERVING WORKS

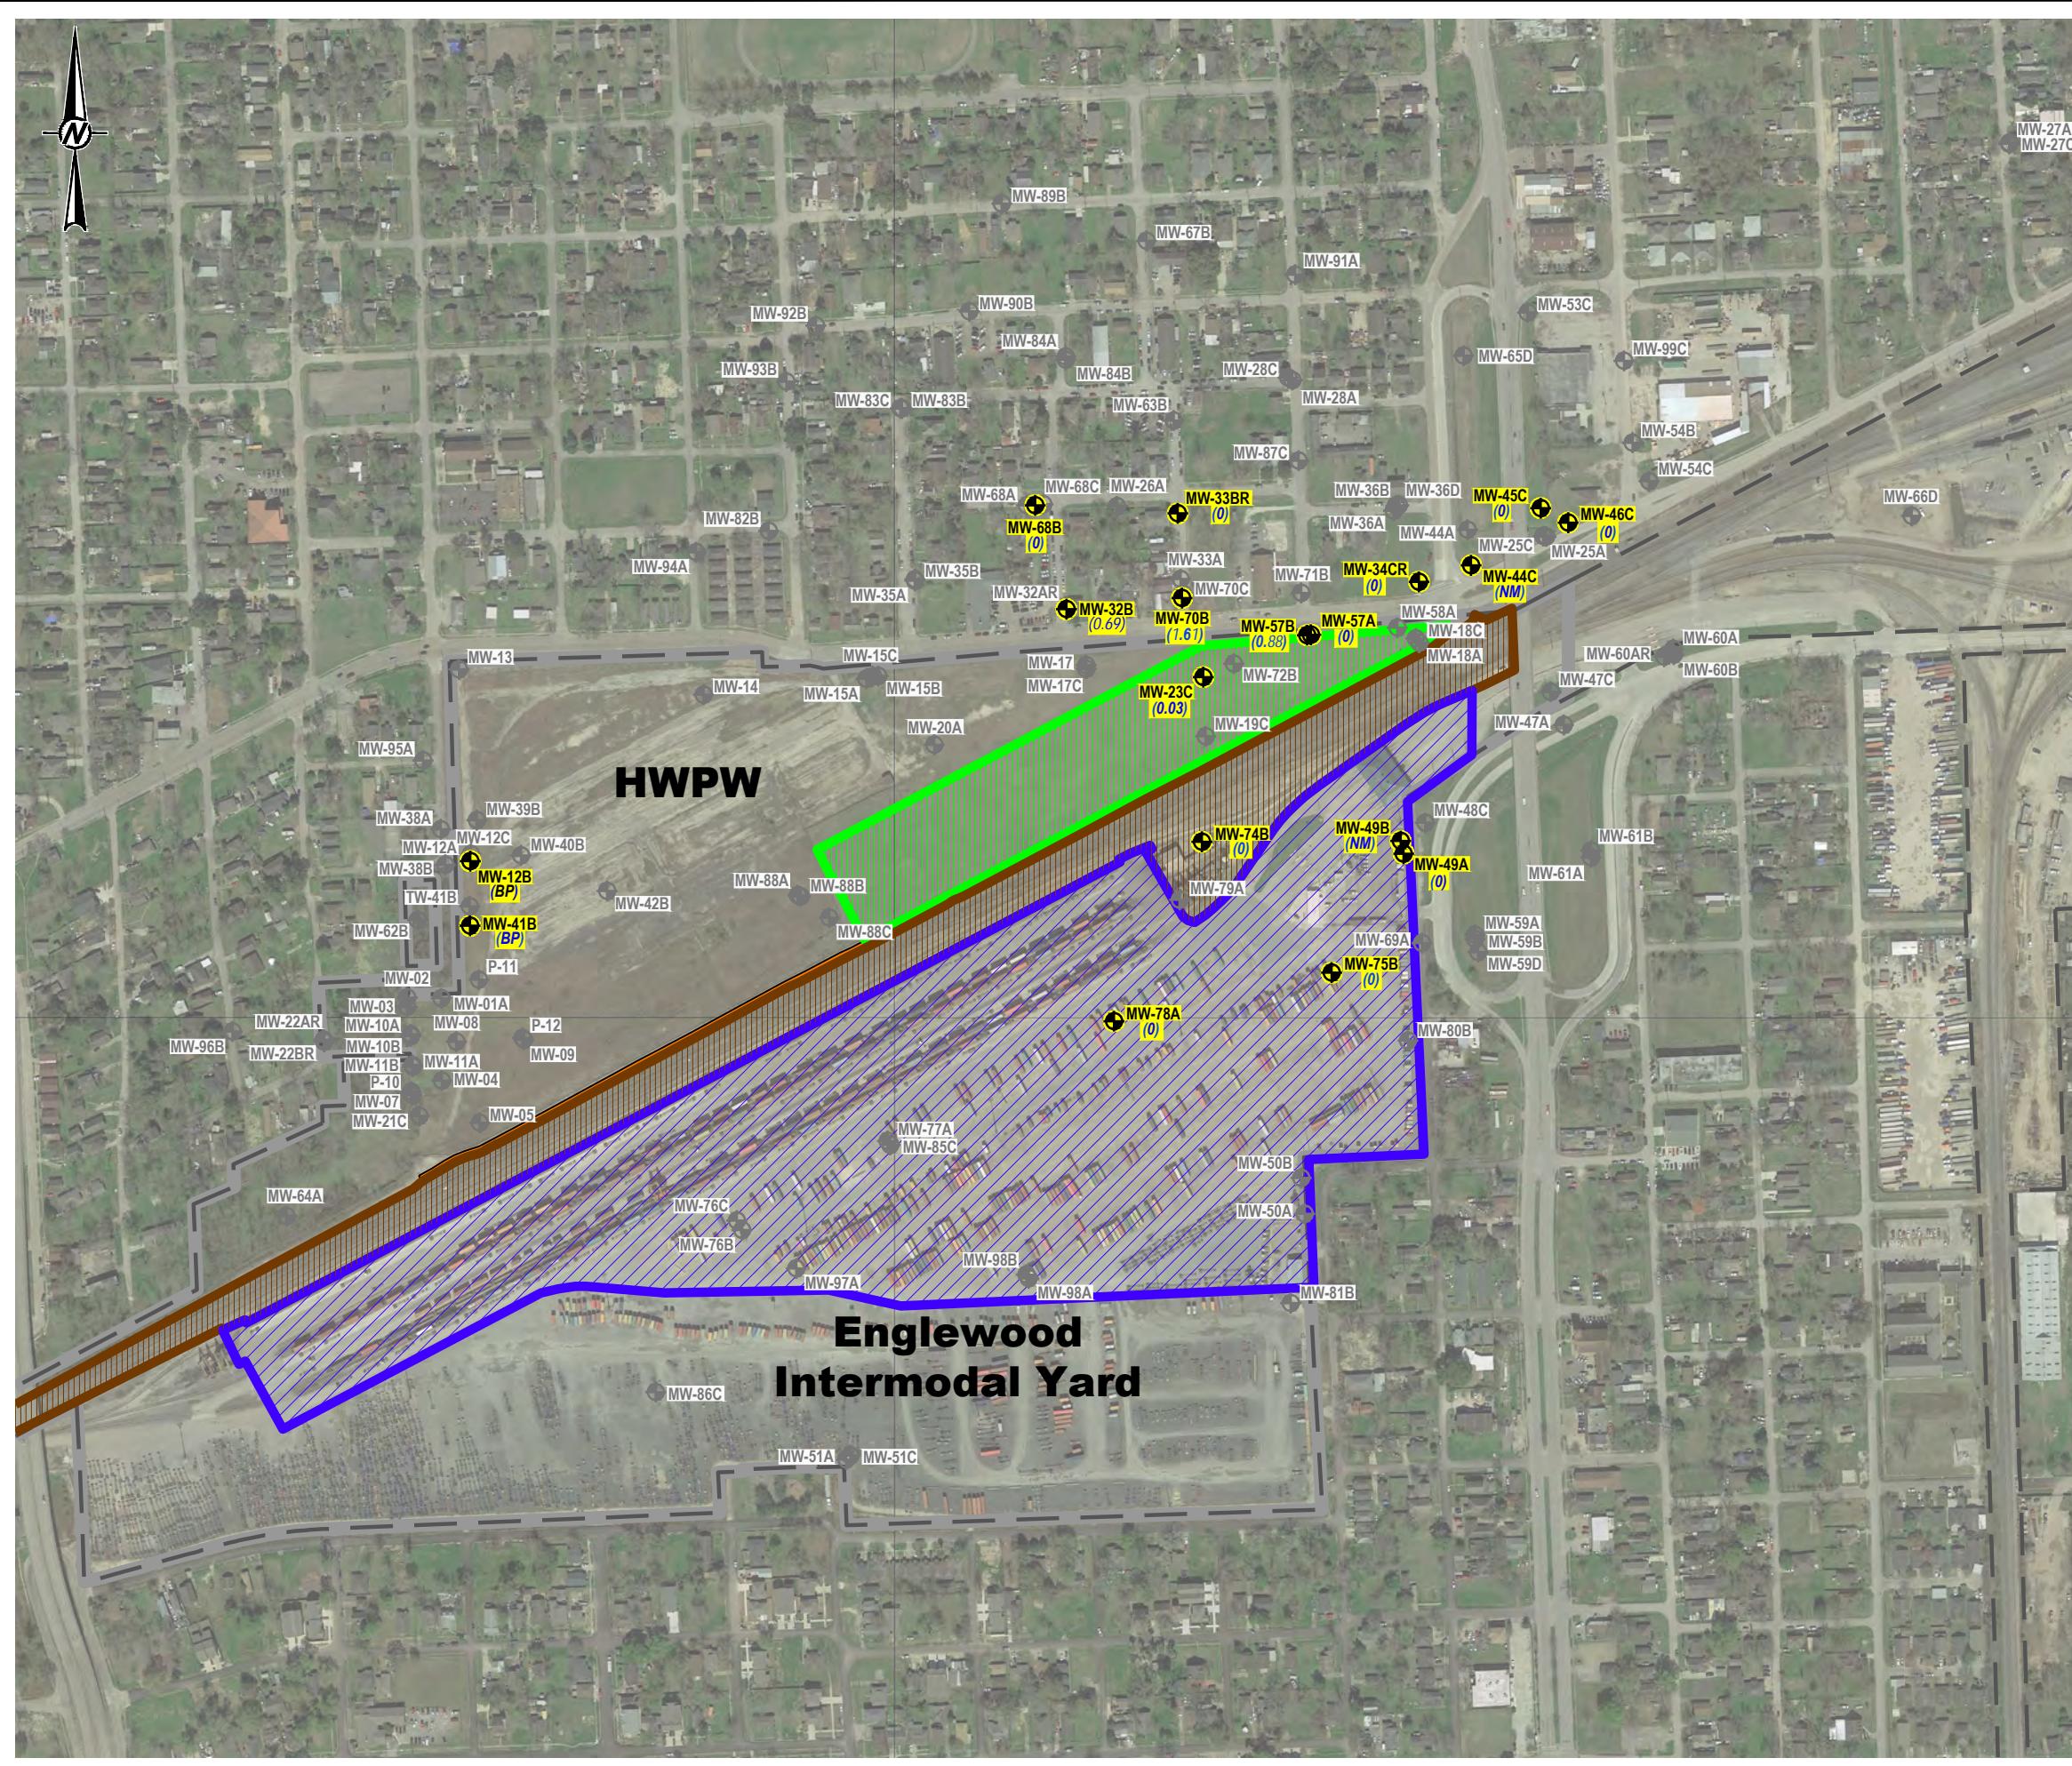
The locations of the DNAPL recovery wells are shown on Figure 1.

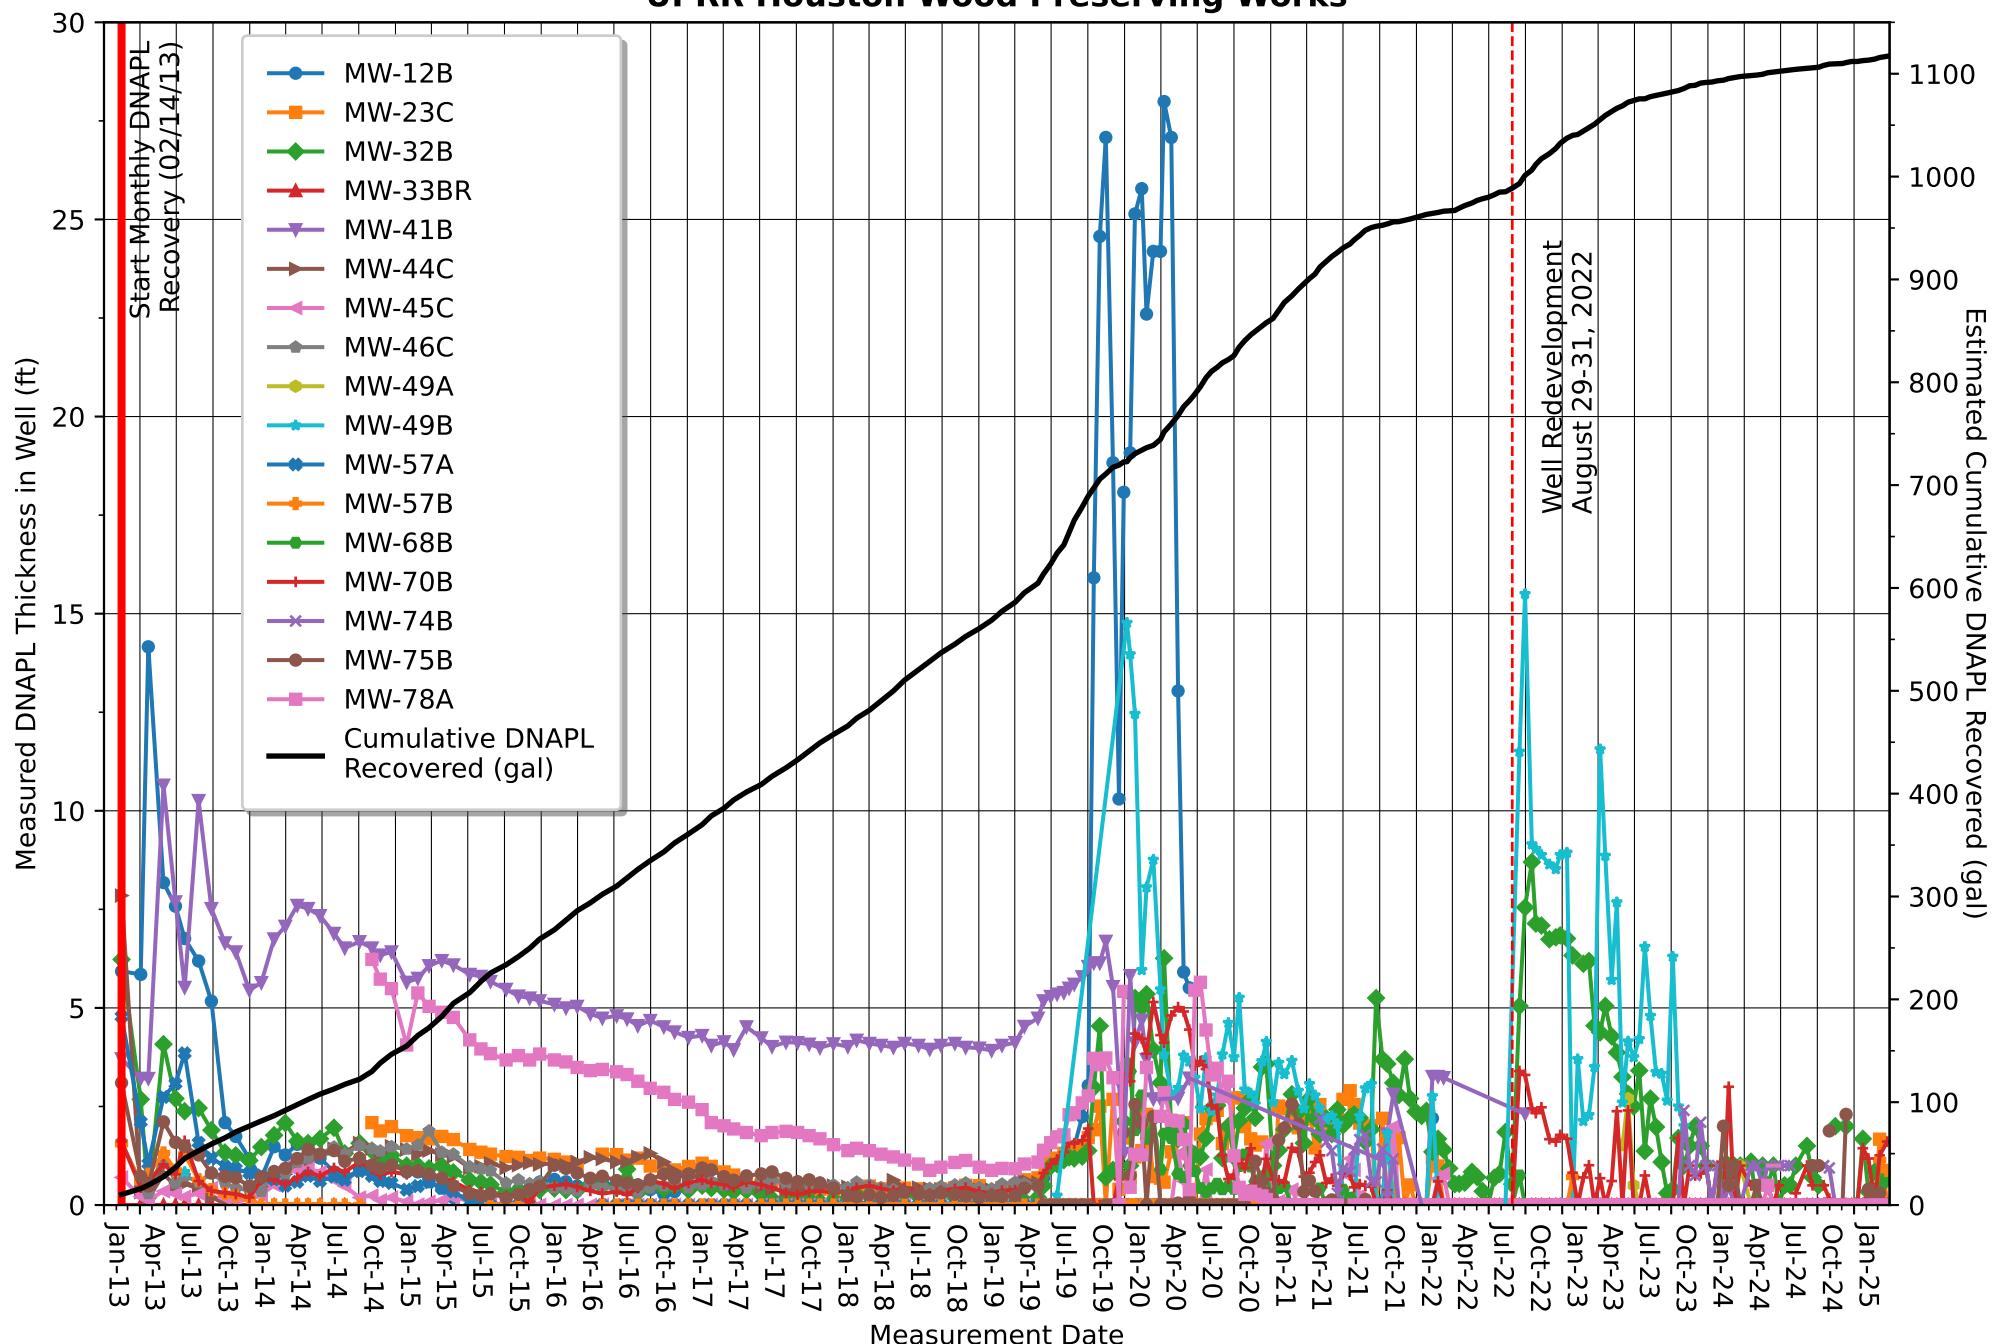
Figure 2
DNAPL Recovery Activities February 2013 - March 2025
UPRR Houston Wood Preserving Works

DNAPL Recovery: From February 2013 to March 2025, an estimated 1,117 gallons of creosote DNAPL have been recovered from the wells at the Site. Monthly DNAPL recovery volumes increased after the January 2015 event due to a change in pumping techniques. Recovery volumes began to decline in 2020 and decreased significantly beginning in September 2021. Eleven of the wells were redeveloped in August 2022 and two additional wells were redeveloped in October 2022. Following the redevelopment, DNAPL recovery volumes increased. Well development of two wells occurred in January/February 2024 prior to the sitewide semi-annual groundwater sampling event. No changes in DNAPL recovery occurred after redevelopment.

During 1st Quarter 2025, an average of 0.8 gallons of DNAPL were recovered per semi-monthly event. Approximately 5.0 gallons were recovered during the 1st Quarter 2025 (Table 1). UPRR will continue to monitor the DNAPL thicknesses twice per month as described in the response to the TCEQ 4th Technical Notice of Deficiency (TNOD) letter (April 11, 2019).

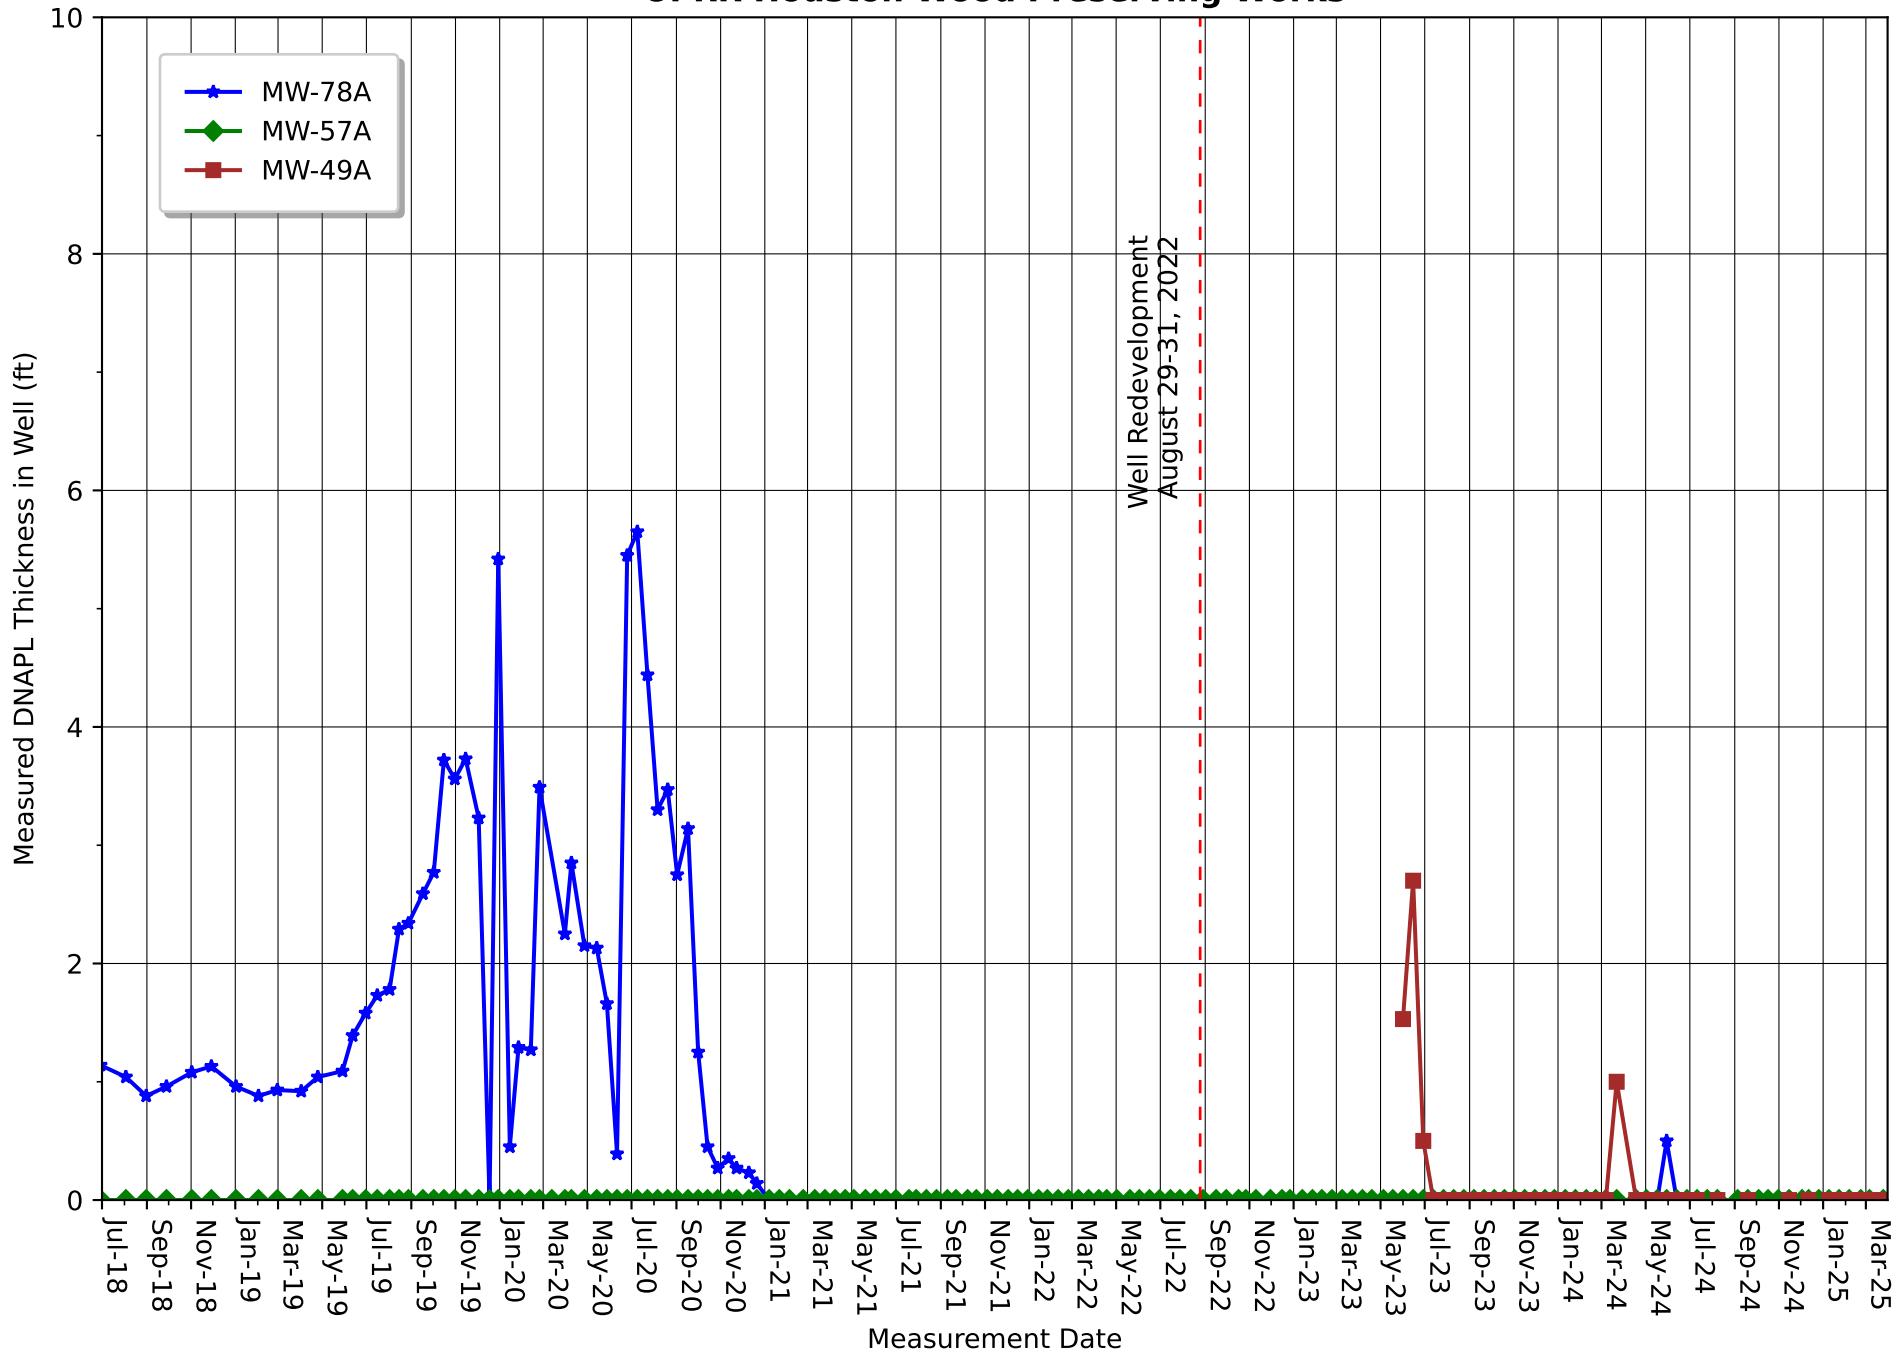
Figure 3
A-TZ Wells-DNAPL Recovery Activities July 2018 - March 2025
UPRR Houston Wood Preserving Works

- **A-TZ Wells:** Recovery wells MW-49A, MW-57A, and MW-78A completed in the A-TZ were evaluated for DNAPL recovery during this period (graph of DNAPL thickness from July 2018 through March 2025 shown on Figure 3).

- **MW-49A:** No measurable or trace amount of DNAPL was detected during any of the 1st Quarter recovery events. Measurable DNAPL has not been recorded in MW-49A since March 2024. No DNAPL was recovered from MW-49A during the 1st Quarter.

- **MW-57A:** No measurable or trace amount of DNAPL was detected during any of the 1st Quarter recovery events. Measurable DNAPL has not been recorded in MW-57A since August 2015. No DNAPL was recovered from MW-57A during the 1st Quarter.

- **MW-78A:** No measurable or trace amount of DNAPL was detected during any of the 1st Quarter recovery events. A field trailer blocked access to this well on January 23 which prevented gauging the well. Measurable DNAPL has not been recorded in MW-78A since May 2024. No DNAPL was recovered from MW-78A during the 1st Quarter.

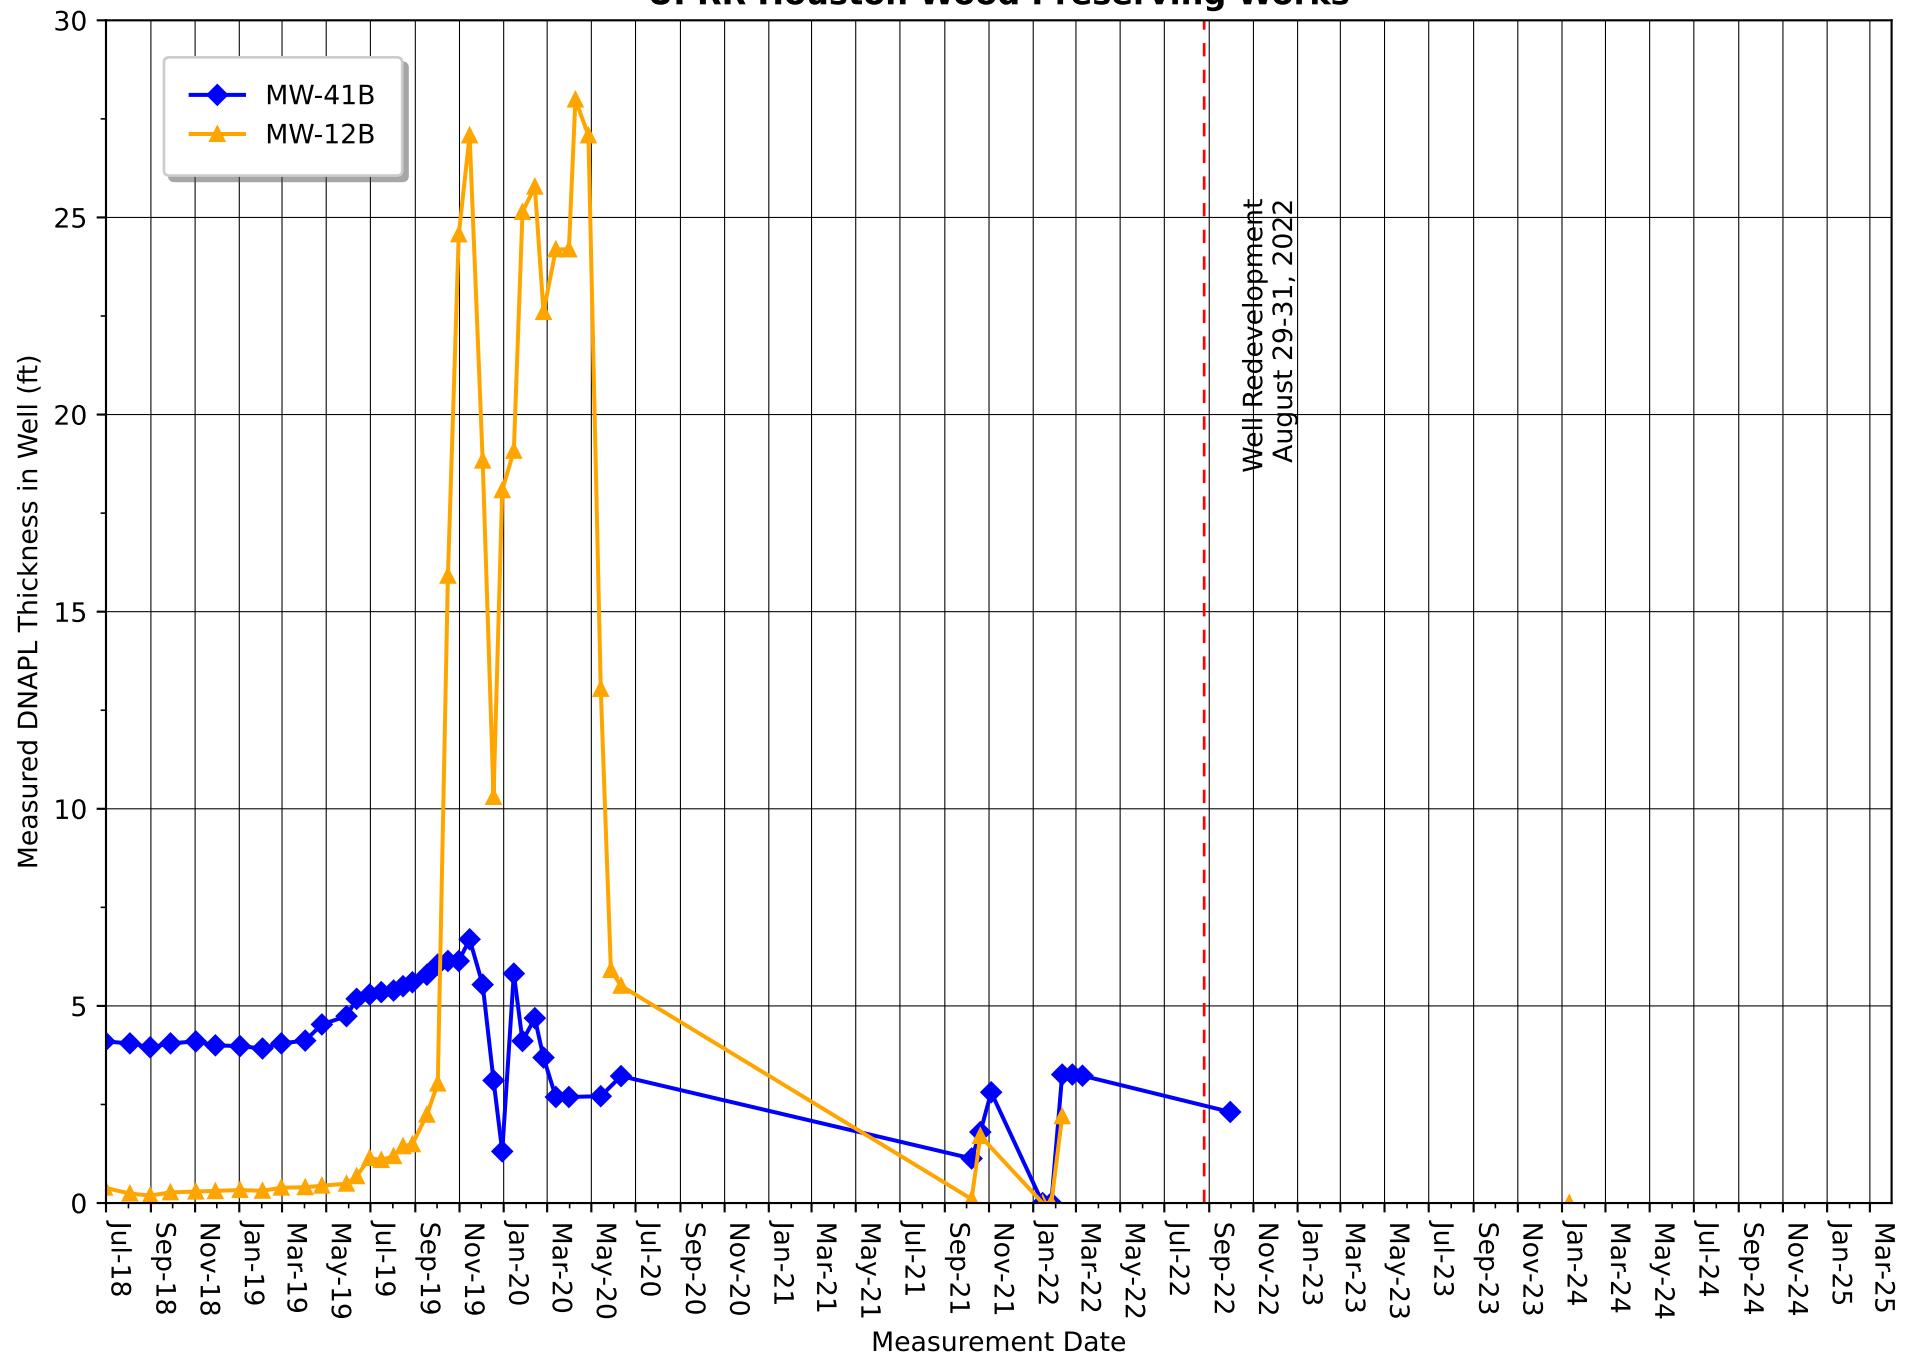
Figure 4
B-TZ Wells (West Side)-DNAPL Recovery Activities July 2018 - March 2025
UPRR Houston Wood Preserving Works

- **B-TZ Wells (West Side):** Recovery wells MW-12B and MW-41B completed in the B-TZ were evaluated for DNAPL recovery during this period (graph of DNAPL thickness from July 2018 through March 2025 shown on Figure 4).

- **MW-12B:** During the 1st Quarter recovery events at MW-12B, the groundwater/DNAPL interface was below the top of the pneumatic pulse pump. As a result, the interface probe could not get past the pump assembly, and it was not possible to record a DNAPL thickness in the well. The pump length is approximately 1.55 feet. Based on the measured length of the pump assembly, the assumption is that there is less than approximately 1.5-2 feet of DNAPL in the well. Approximately 1 gallon of DNAPL was recovered from MW-12B using the pneumatic pump during the 1st Quarter.

- **MW-41B:** Similar to MW-12B, the top of the groundwater/DNAPL interface in MW-41B was below the top of the pneumatic pulse pump during the 1st Quarter. Based on measured length of the pump assembly, the assumption is there is less than approximately 1.5-2 feet of DNAPL in the well. Approximately 1 gallon of DNAPL was recovered from MW-41B using the pneumatic pump during the 1st Quarter.

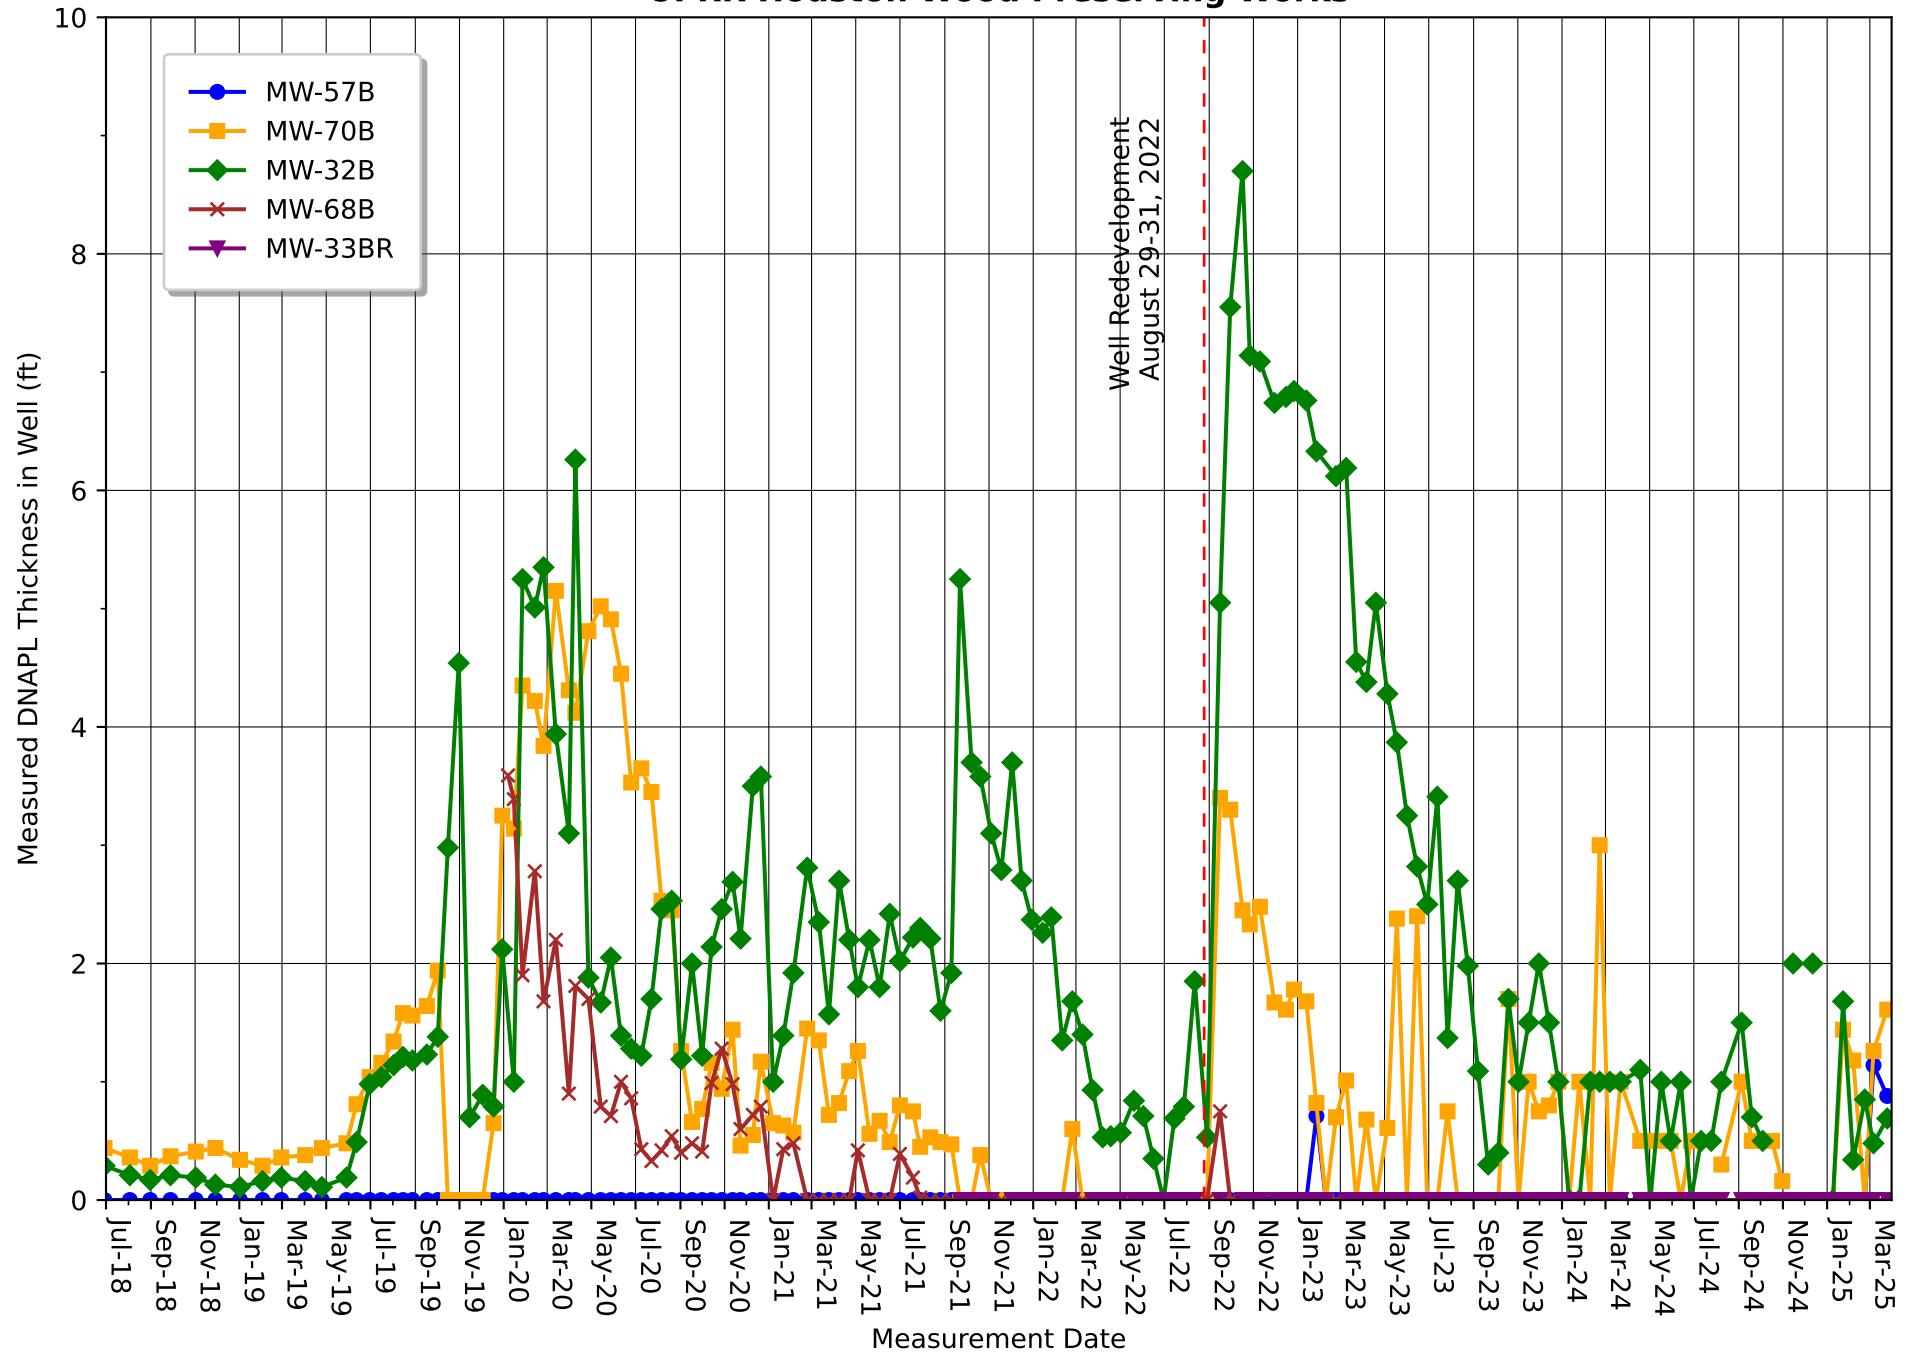
Figure 5
B-CZ/B-TZ Wells (North (On-site and Off-site)-DNAPL Recovery Activities July 2018 - March 2025
UPRR Houston Wood Preserving Works

- **B-TZ/B-CZ Wells (North (on-site and off-site)):** Recovery wells MW-32B, MW-33BR, MW-57B, MW-68B, and MW-70B completed in either the B-TZ or B-CZ on the north side of the Site or off-site to the north were evaluated for DNAPL recovery during this period (graph of DNAPL thickness from July

2018 through March 2025 shown on Figure 5).

- **MW-32B (off-site):** For the first time since January 2024, no DNAPL was detected in the well on January 9, 2025. During the 1st Quarter recovery events, DNAPL thicknesses have been sporadic ranging from not detected to approximately 1.7 feet. Approximately 1 gallon of DNAPL was recovered from MW-32B during the 1st Quarter.

- **MW-57B (on-site):** Measurable DNAPL was detected during the 1st Quarter on March 6 and March 25, measuring 1.14 and 0.88 feet in thickness, respectively. This is the first occurrence measurable DNAPL greater than a trace since 2013. Prior to March 6th, no DNAPL was detected in the well during the other 1st Quarter recovery events. Approximately 0.50 gallons of DNAPL were recovered from MW-57B during the 1st Quarter.

- **MW-70B (off-site):** Measurable DNAPL was detected during the 1st Quarter on January 23, February 6, March 6, and March 25, ranging from 1.18 feet and 1.61 feet in thickness. No DNAPL was detected during the rest of the 1st Quarter recovery events. Approximately 1 gallon of DNAPL was recovered from MW-70B during the 1st Quarter.

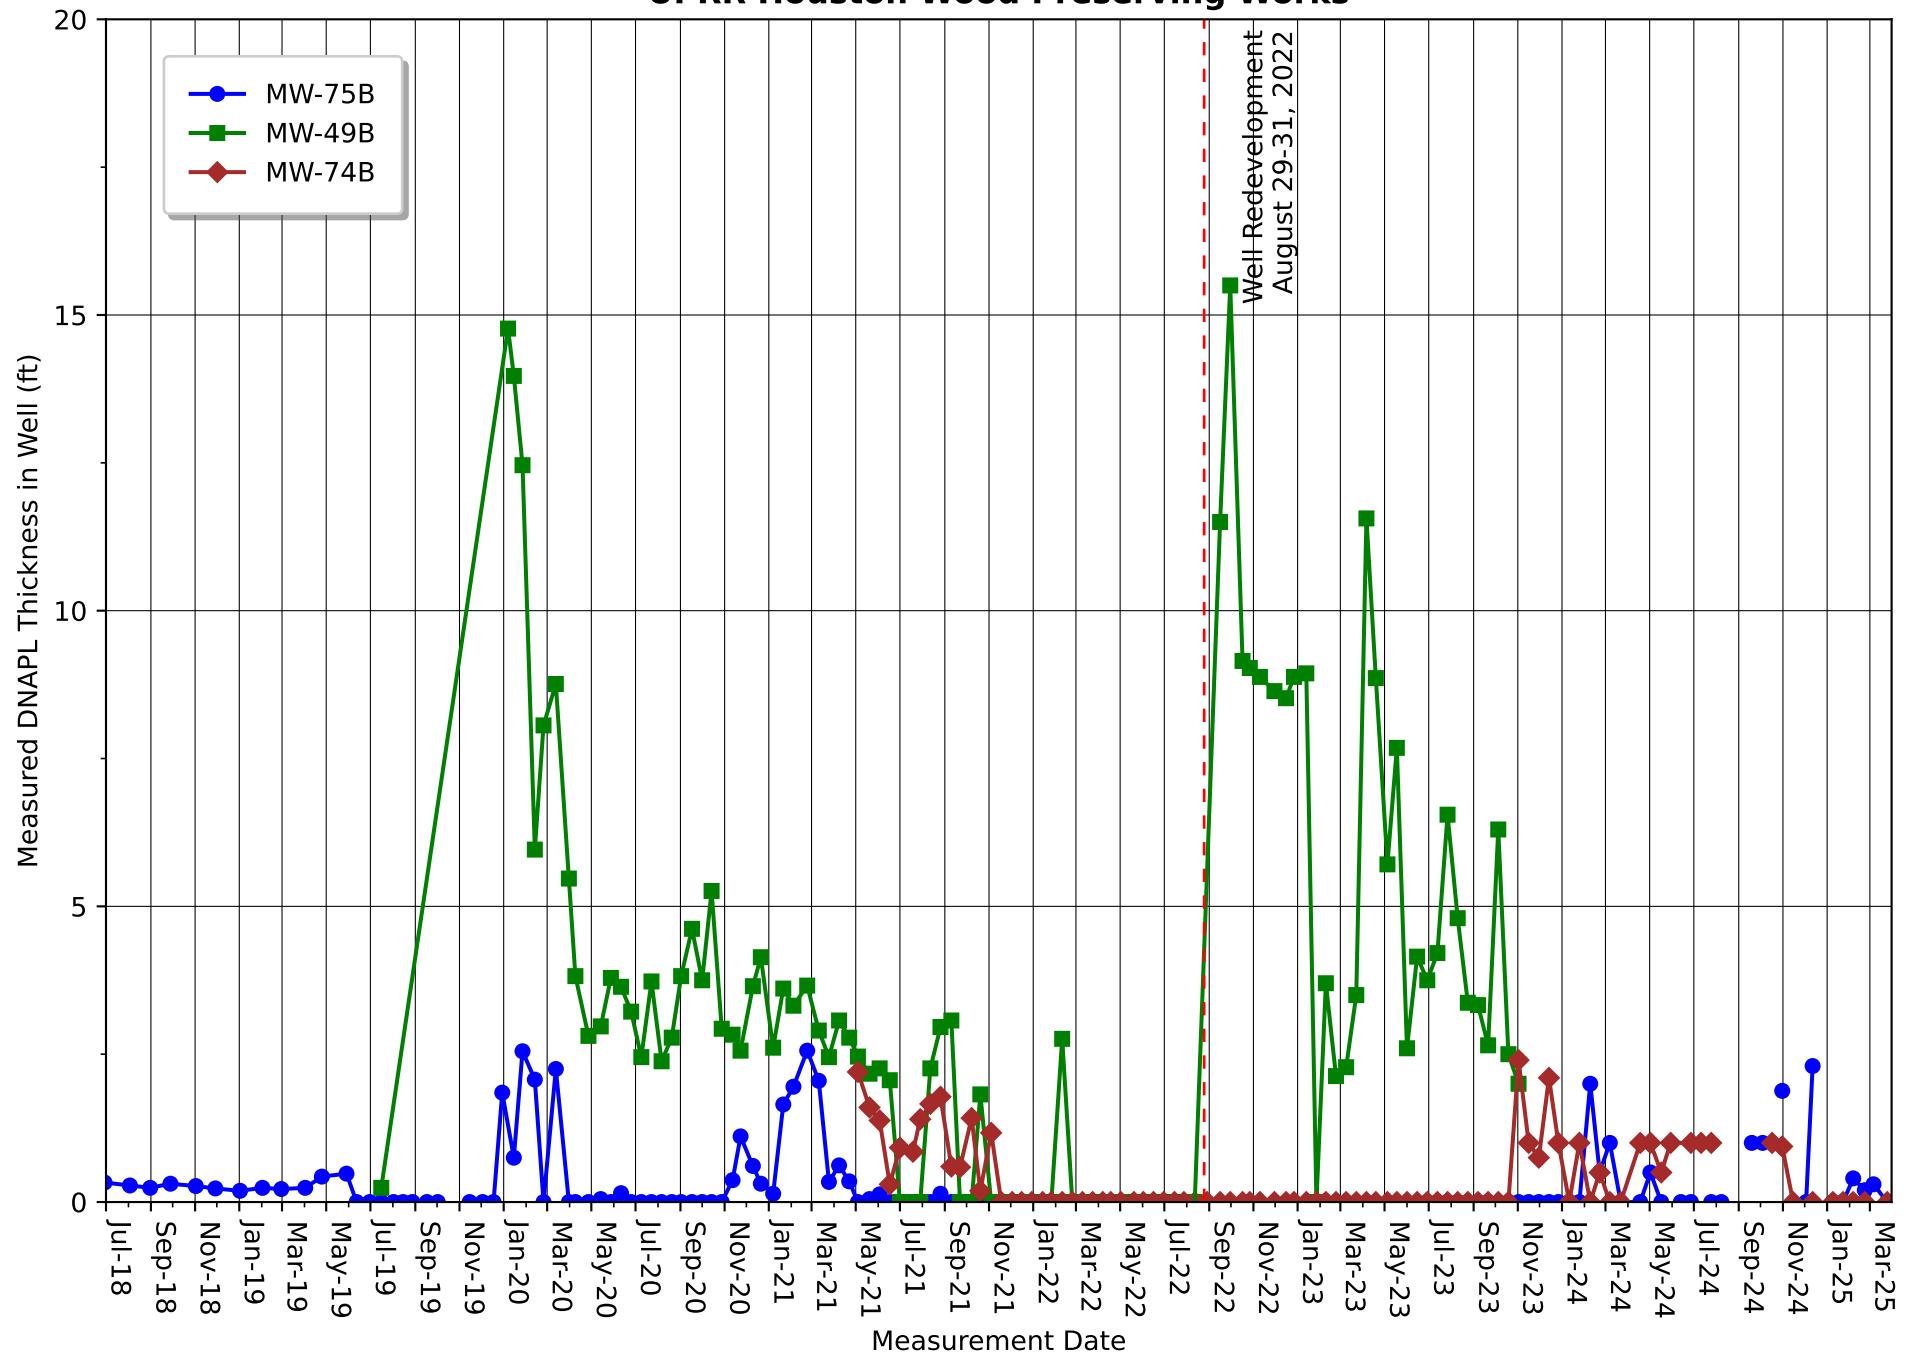
Figure 6
B-CZ/B-TZ Wells (Englewood Intermodal Yard)-DNAPL Recovery Activities July 2018 - March 2025
UPRR Houston Wood Preserving Works

- **B-TZ/B-CZ Wells (Englewood Intermodal Yard):** Recovery wells MW-49B, MW-74B, and MW-75B in the Englewood Intermodal Yard completed in the B-CZ and B-TZ were evaluated for DNAPL recovery during this period (graph of DNAPL thickness from July 2018 through March 2025 shown on Figure 6).

- **MW-74B:** No measurable DNAPL was detected during any of the 1st Quarter recovery events, with only a trace amount of DNAPL detected on March 6. No DNAPL was recovered from MW-74B during the 1st Quarter.

- **MW-75B:** Measurable DNAPL was detected during the 1st Quarter on February 6, February 20, and March 6, ranging from 0.2 to 0.4 feet in thickness. No DNAPL was detected during the rest of the 1st Quarter recovery events. Approximately 0.26 gallons of DNAPL were recovered from MW-75B during the 1st Quarter.

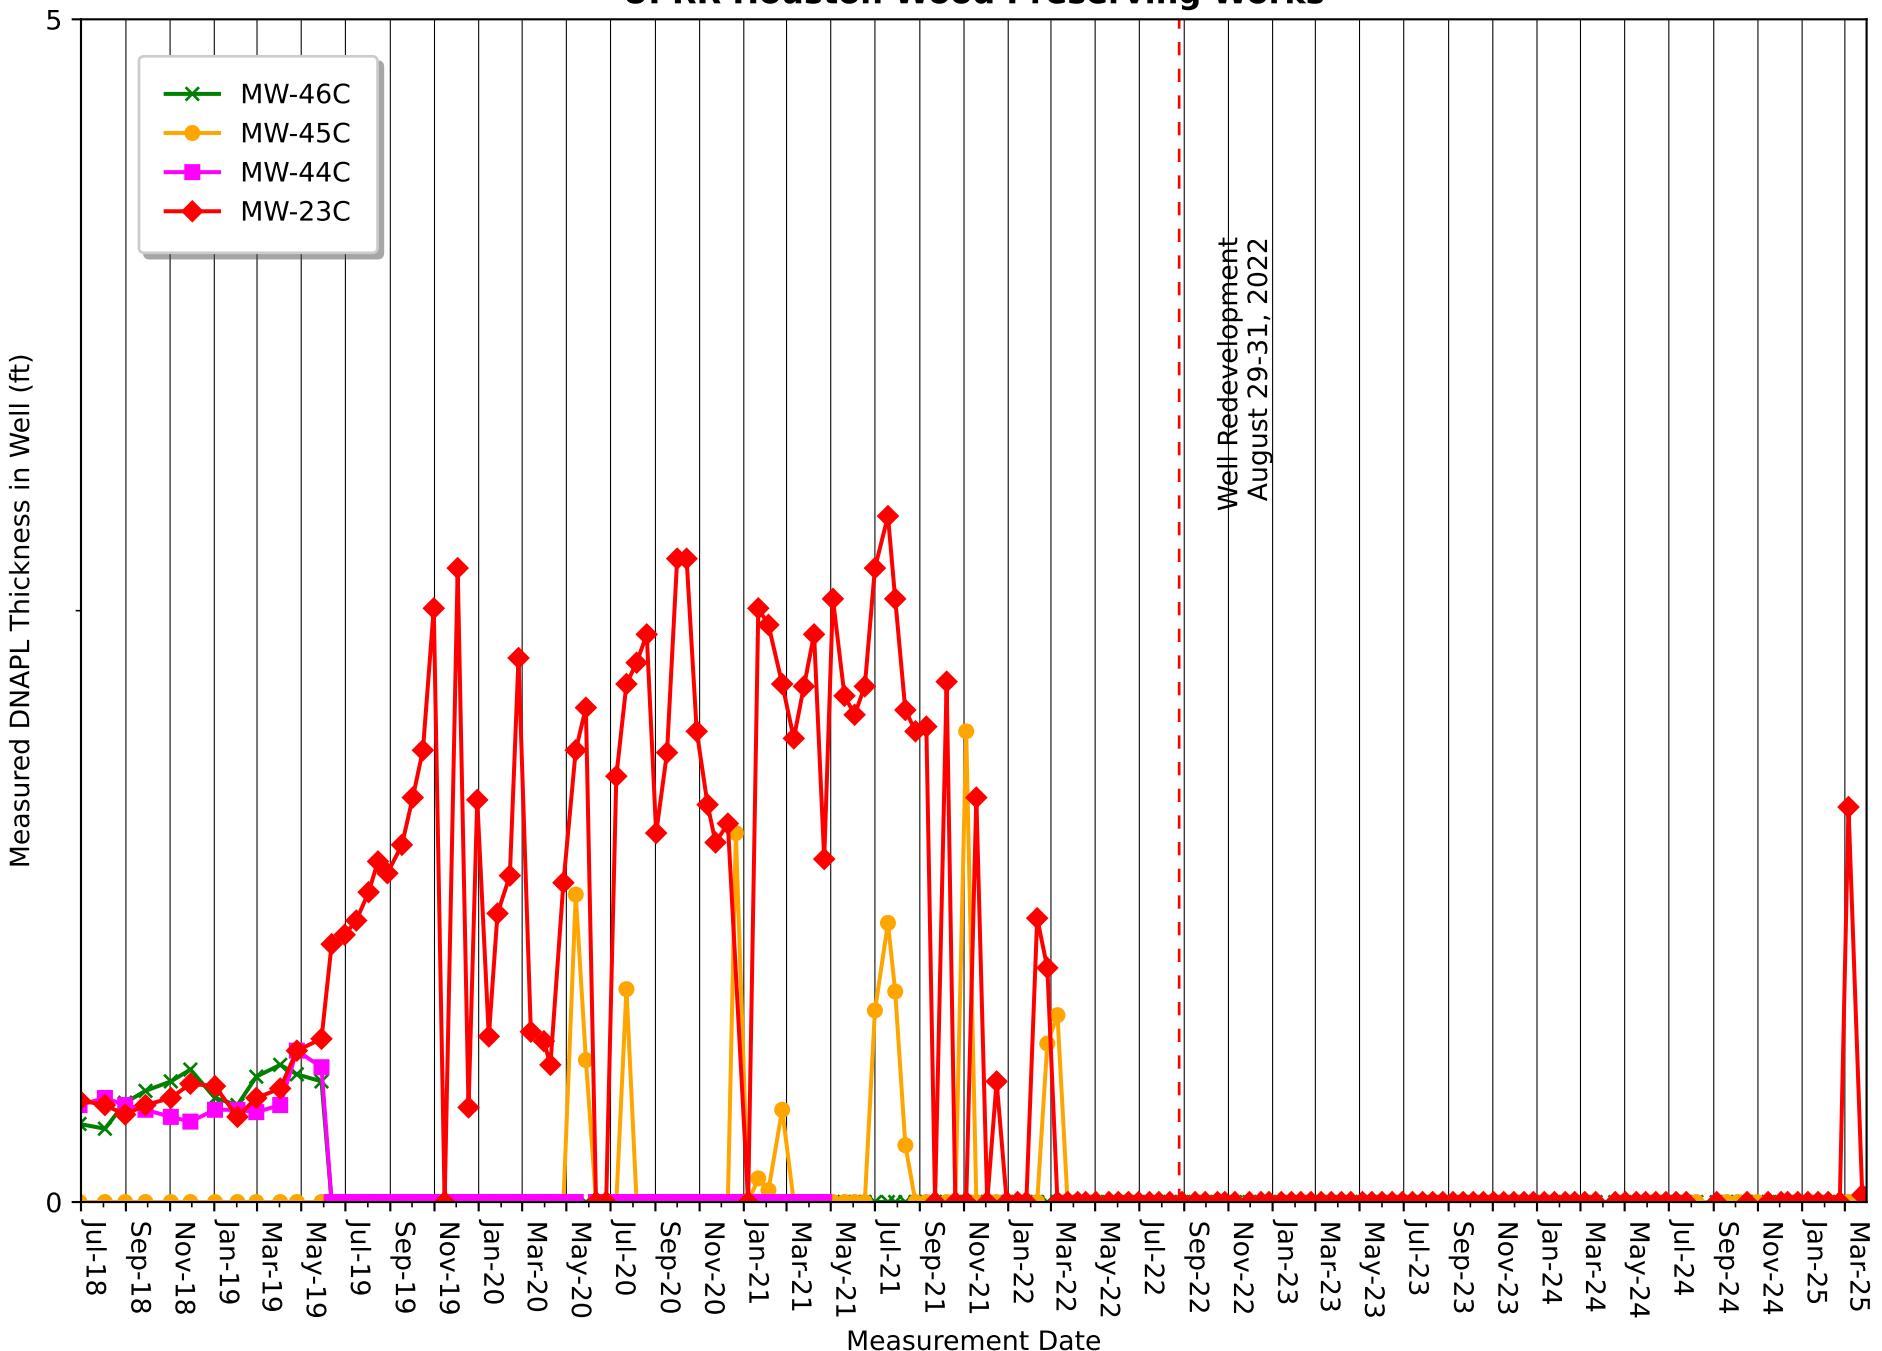
Figure 7
C-TZ Wells-DNAPL Recovery Activities July 2018 - March 2025
UPRR Houston Wood Preserving Works

- **C-TZ Wells:** Wells MW-23C, MW-34CR, MW-44C, MW-45C, and MW-46C completed in the C-TZ were evaluated for DNAPL recovery (graph of DNAPL thickness from July 2018 through March 2025 shown on Figure 7).

- **MW-23C:** Measurable DNAPL was detected during the 1st Quarter on March 6 and March 25, measuring 1.67 and 0.03 feet in thickness. No DNAPL was detected during the rest of the 1st Quarter recovery events. Approximately 0.25 gallons of DNAPL were recovered from MW-23C during the 1st Quarter.

- **MW-34CR:** In May 2014, replacement well MW-34CR was installed and gauged as part of the DNAPL recovery program. However, no DNAPL has been detected in this well. No DNAPL was observed during the well redevelopment on August 30, 2022 or on February 5, 2024. No measurable or trace amount of DNAPL was detected during any of the 1st Quarter recovery events. Given the absence of DNAPL in this well, a graph for MW-34CR is not included in Figure 7.
