January 12, 2024

Project No. 31406585.016

**Re: MONTHLY STATUS UPDATE – ENGLEWOOD INTERMODAL YARD – NAPL COLLECTION
SYSTEM/CONCRETE CAP REPAIRS
UNION PACIFIC RAILROAD HOUSTON WOOD PRESERVING WORKS FACILITY
4910 LIBERTY ROAD FACILITY, HOUSTON, TEXAS
POST-CLOSURE CARE PERMIT NO. HW-50343; INDUSTRIAL SWR NO. 31547**

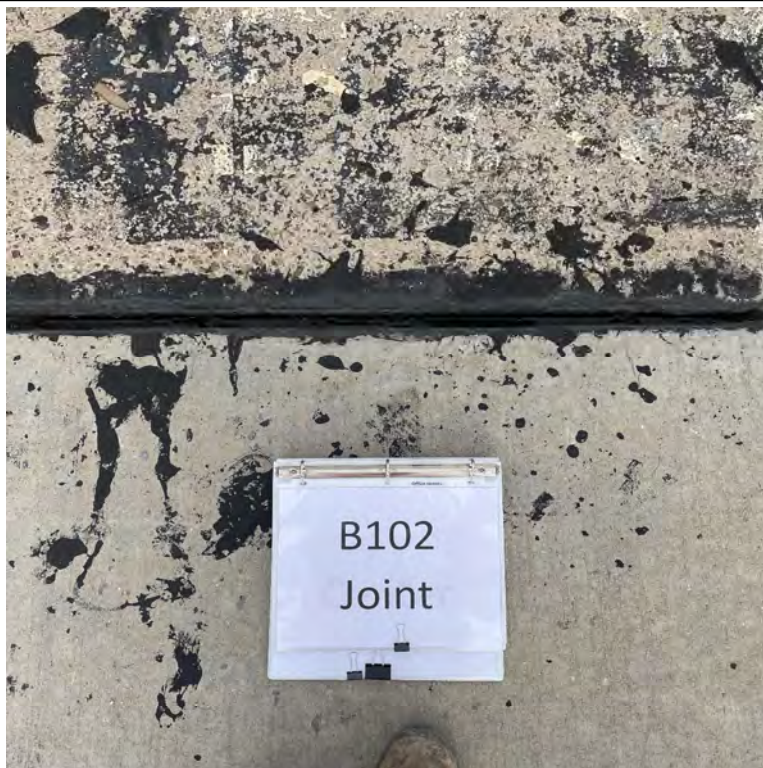
Stall B102 Joint, no new tar-like material observed at seep location along stall joint.
