March 15, 2024

Project No. 31406585.016

Re: **MONTHLY STATUS UPDATE – ENGLEWOOD INTERMODAL YARD – NAPL COLLECTION SYSTEM/CONCRETE CAP REPAIRS
UNION PACIFIC RAILROAD HOUSTON WOOD PRESERVING WORKS FACILITY
4910 LIBERTY ROAD FACILITY, HOUSTON, TEXAS
POST-CLOSURE CARE PERMIT NO. HW-50343; INDUSTRIAL SWR NO. 31547**

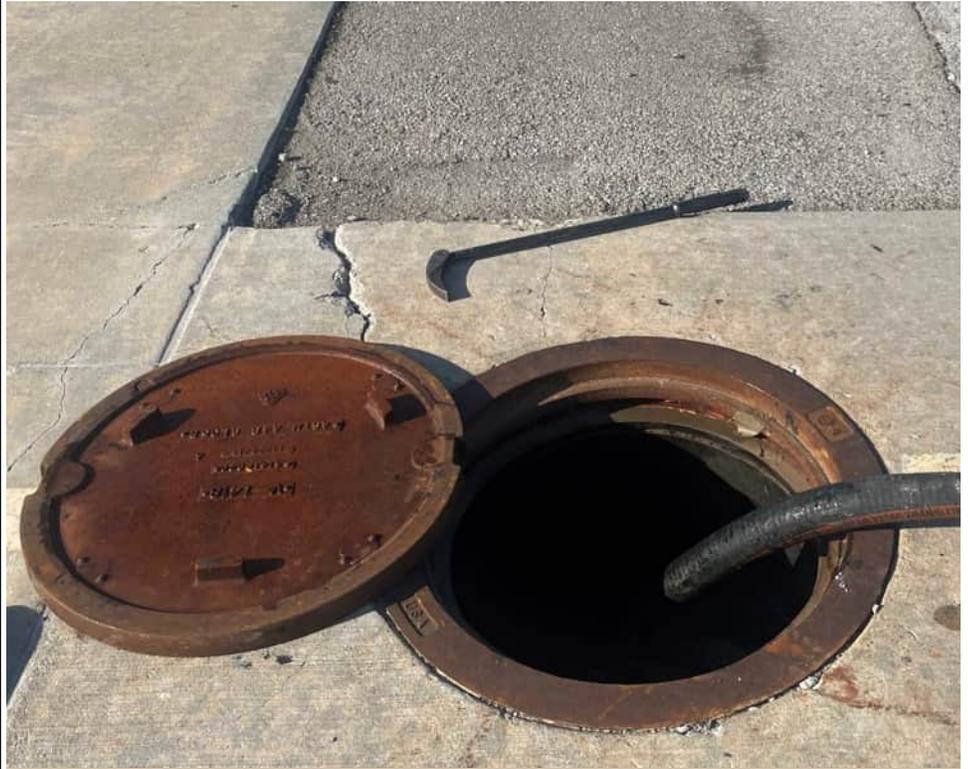
NAPL Collection System Water Pump Down

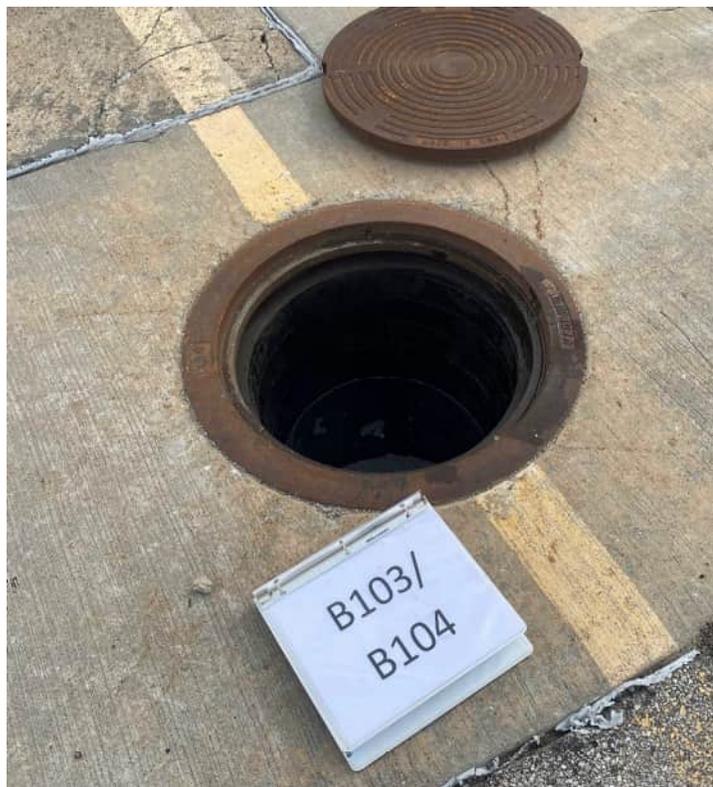
Sump 2 (B103/B104), 18 inches of freeboard in sump. No odor or sheen observed, color noted as clear.

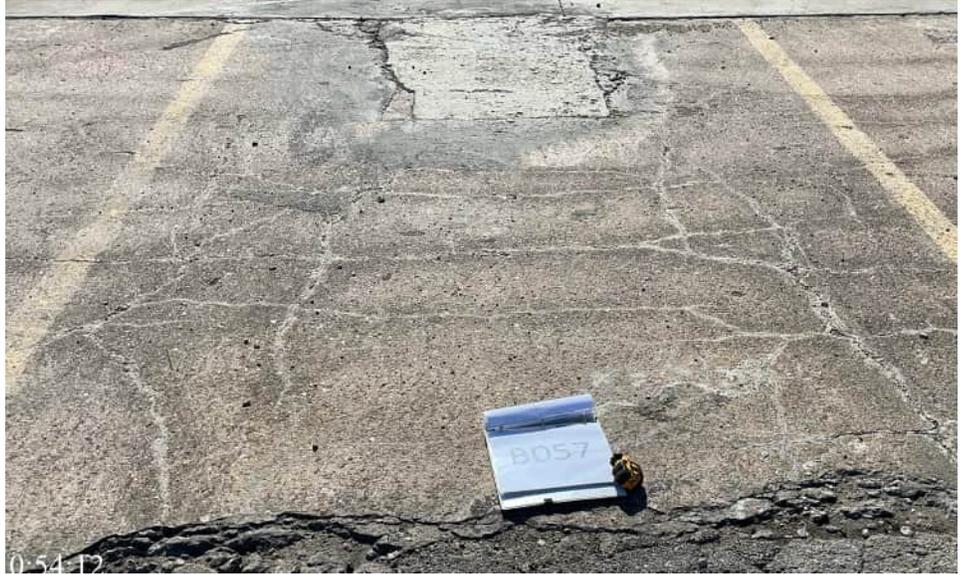
Stall B057, no new tar-like material observed along asphalt crack.

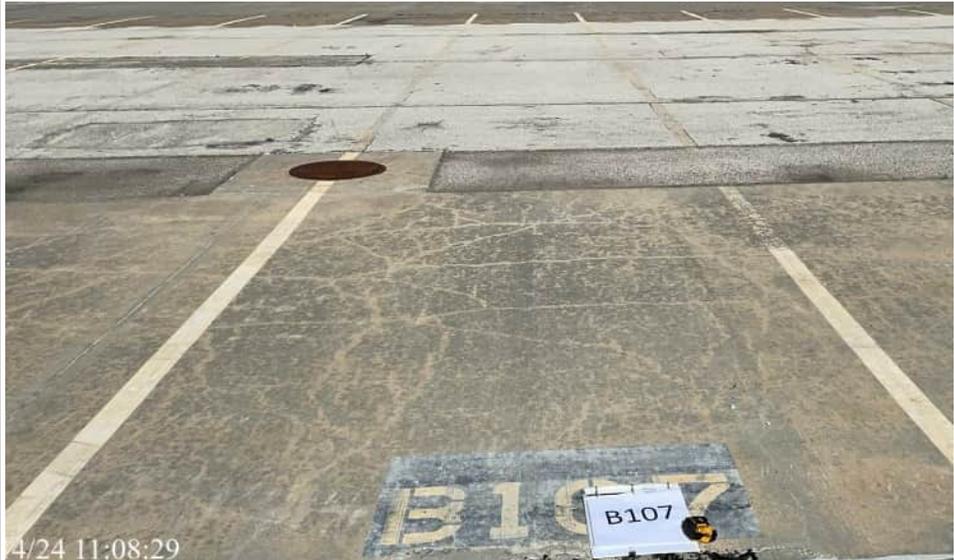
Stall B107, no new tar-like material observed at seep location on concrete joint along the southern edge of the excavated area.

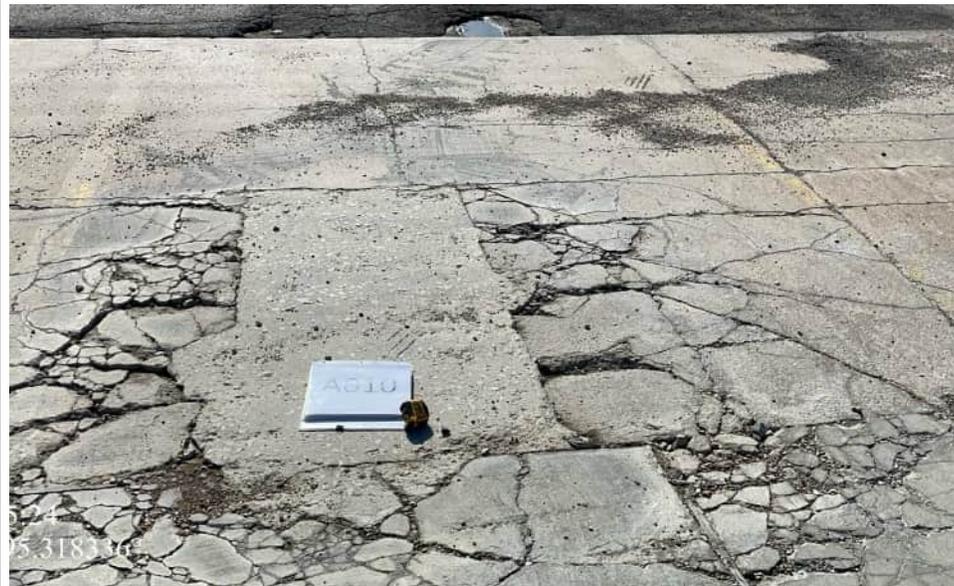
Stall A010. No tar-like material observed at Test Pit A010 location.

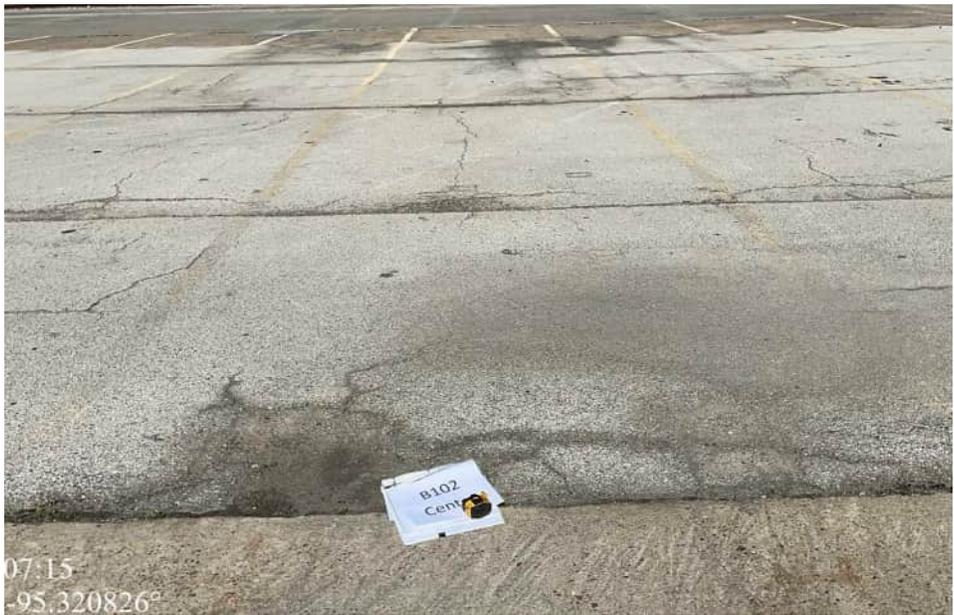
Stall B102 (center), no tar-like material observed at seep location along cracks in pavement.

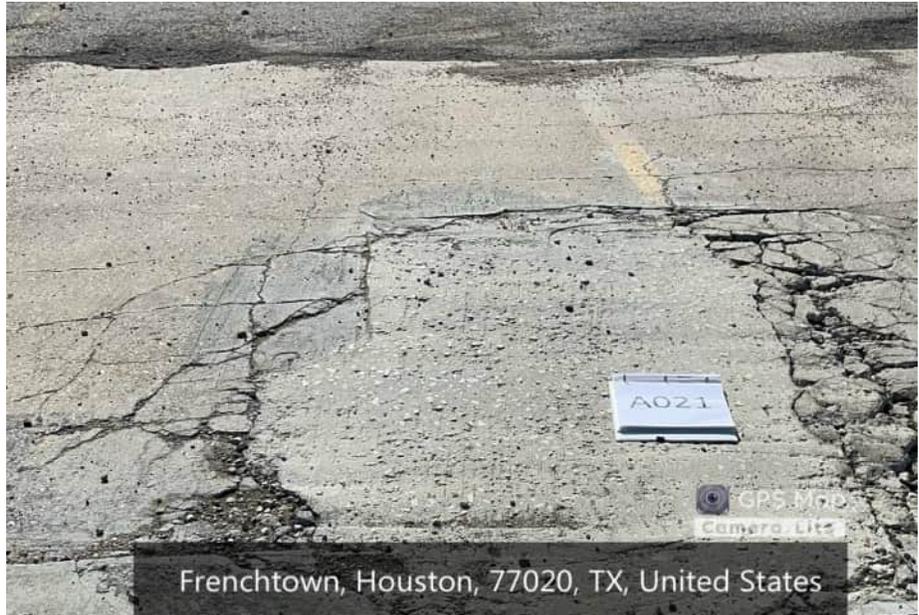
Stall A021. No seeps noted at Test Pit A021.
