April 15, 2024

Project No. 31406585.016

**Re: MONTHLY STATUS UPDATE – ENGLEWOOD INTERMODAL YARD – NAPL COLLECTION
SYSTEM/CONCRETE CAP REPAIRS
UNION PACIFIC RAILROAD HOUSTON WOOD PRESERVING WORKS FACILITY
4910 LIBERTY ROAD FACILITY, HOUSTON, TEXAS
POST-CLOSURE CARE PERMIT NO. HW-50343; INDUSTRIAL SWR NO. 31547**

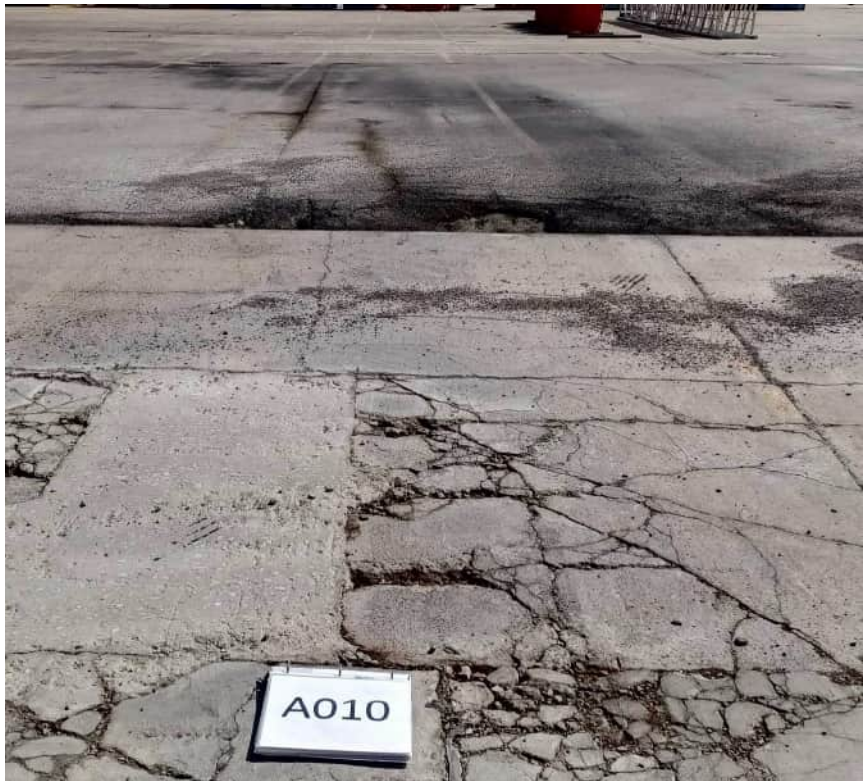
Photo No.
4

Stall A010. No tar-like material observed at Test Pit A010 location. Minimal seep water staining present in the cracks of the asphalt.

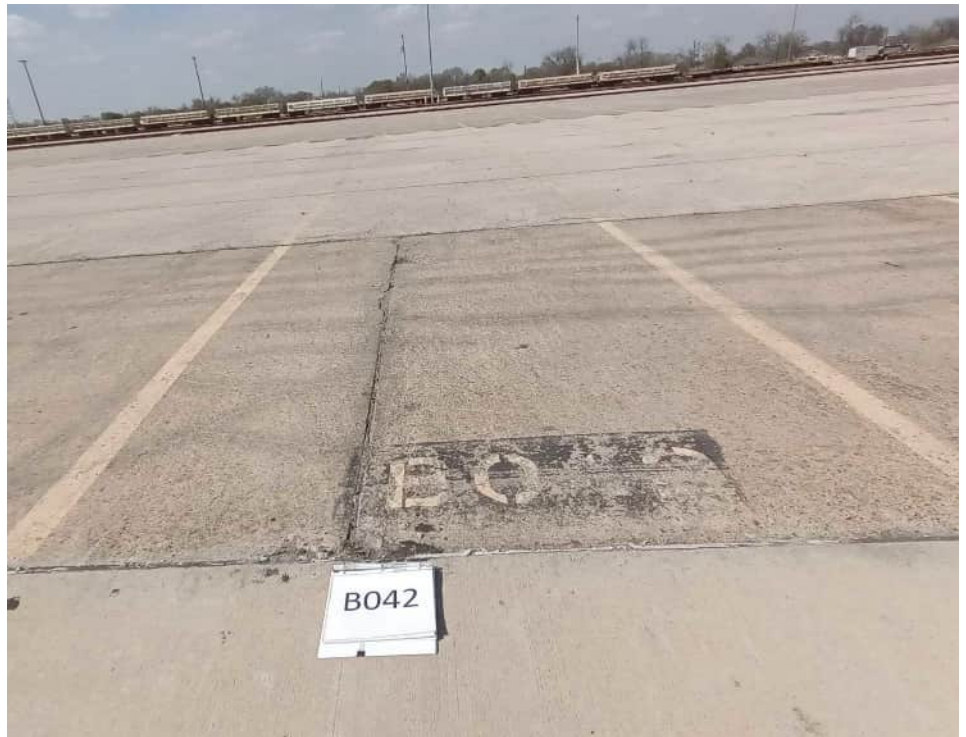
Photo No.
8

Stall B042. No new tar-like material observed at historical seep location along asphalt crack.

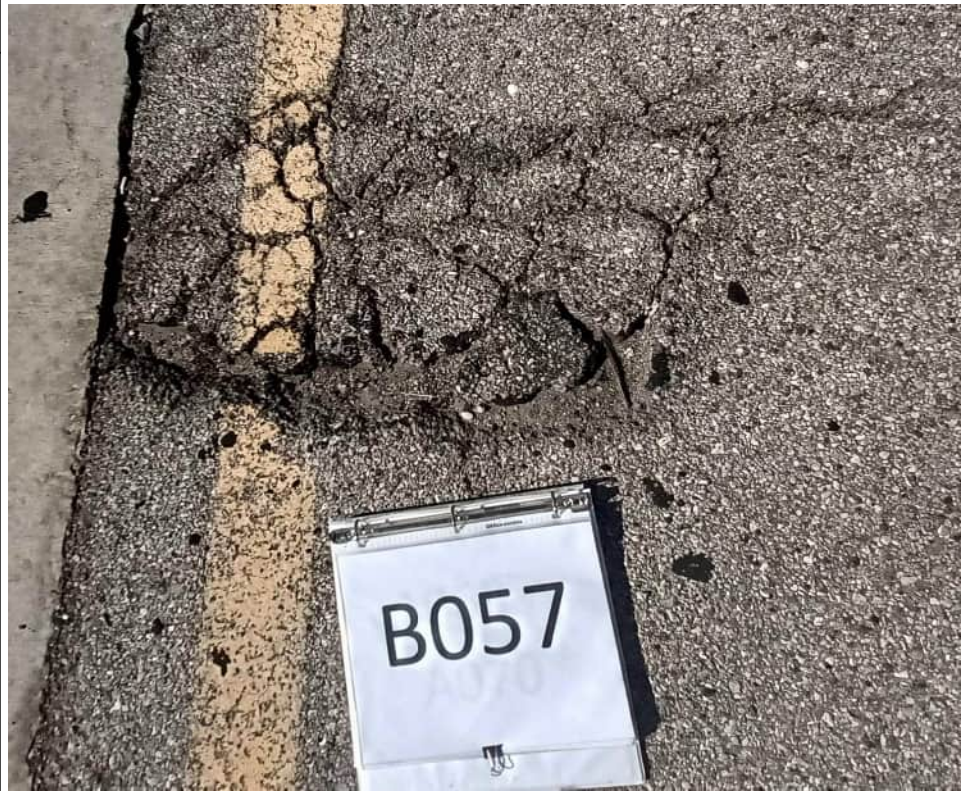
Photo No.
10

Stall B057 (joint), no tar-like material observed at historical seep location at Test Pit B057.

Stall B102 (joint) some tar-like material observed at historical seep site along concrete joint, material removed.

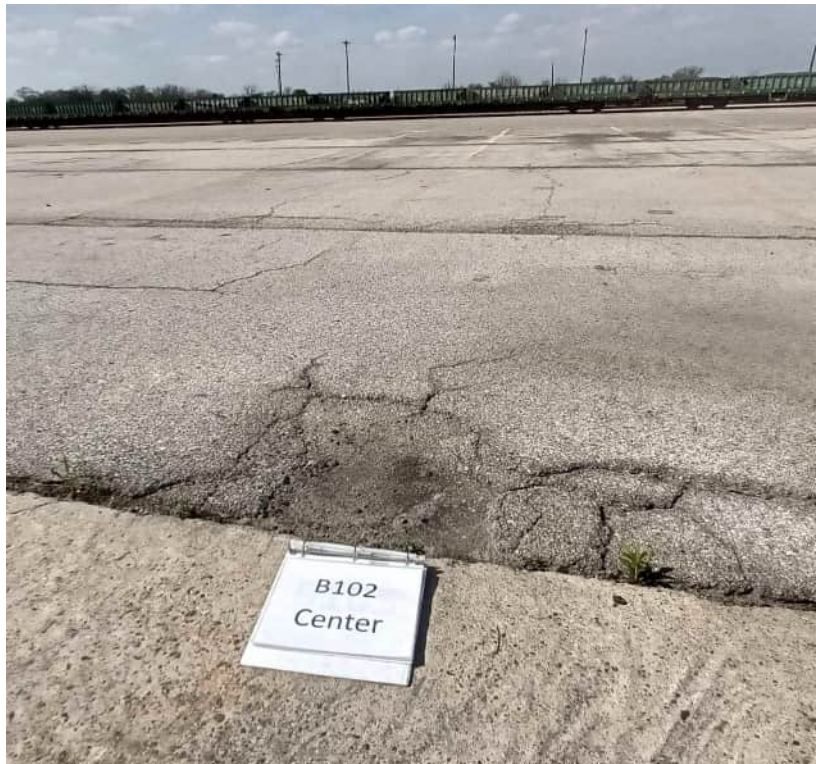
Photo No.
12

Stall B102 (center), no tar-like material observed at seep location along cracks in pavement.

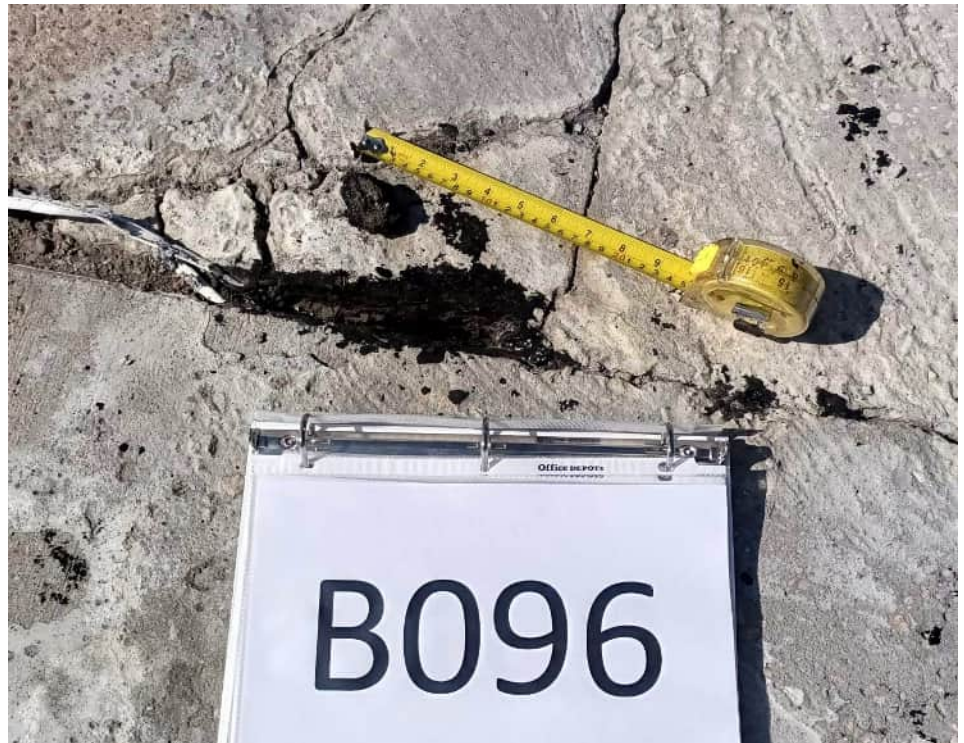
Photo No.
14

Stall B096, some tar-like material observed at historical seep location along concrete joint at Test Pit B096, material removed.

Stall B100, some tar-like material observed on concrete crack/hole in concrete, material removed.

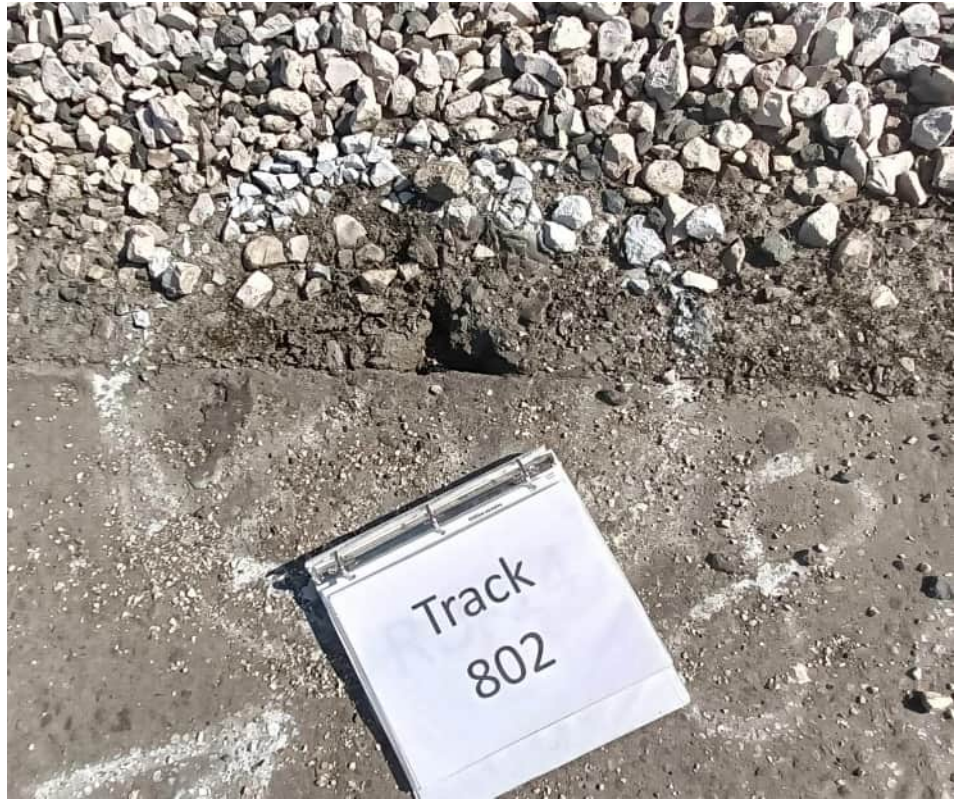
Photo No.
16

North side of Track 802, some tar-like material observed at seep location near the edge of the ballast, material removed.

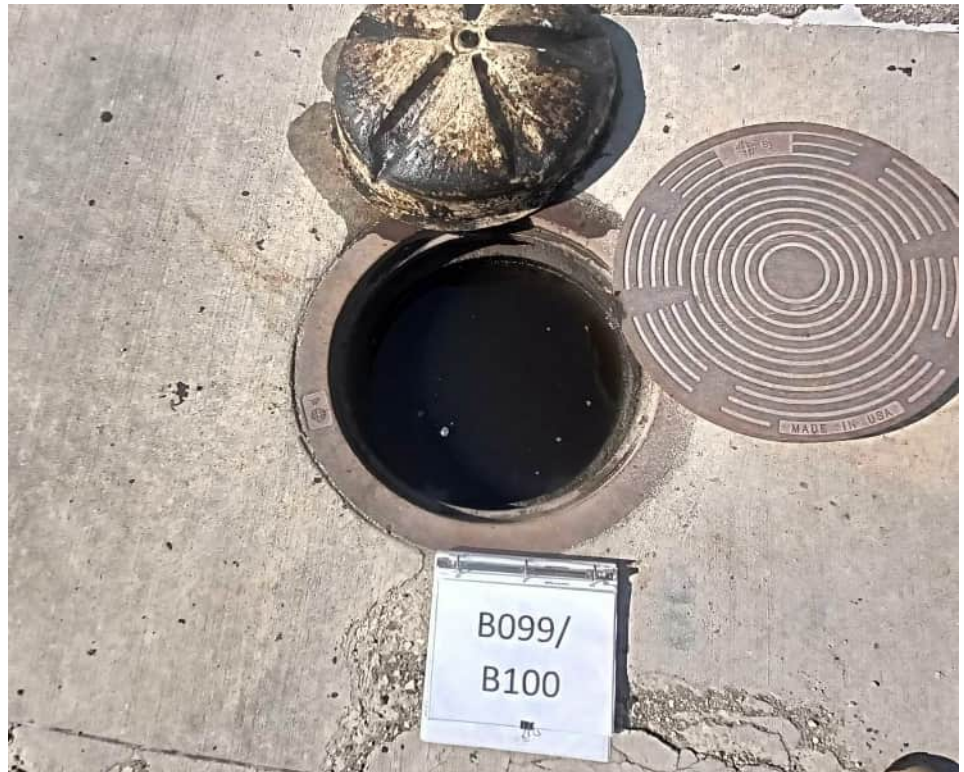
Photo No.
18

Sump 1 (B099/B100), 4 inches of freeboard in sump, no odor noted, no sheen observed, water color noted as light brown.

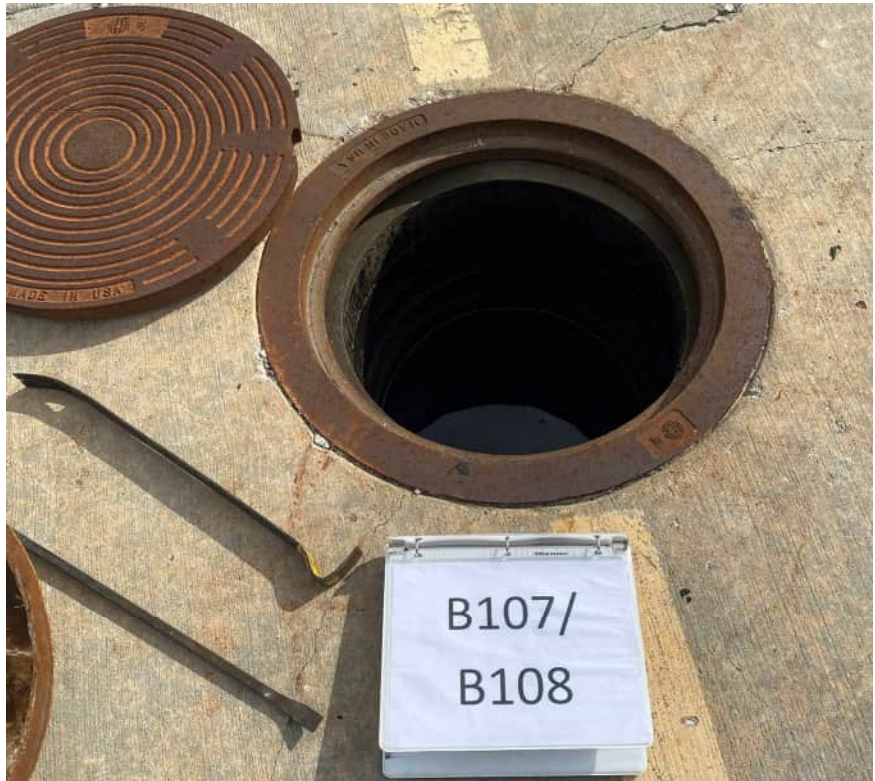
Photo No.

Sump 3 (B107/B108), 15 inches of freeboard in sump, no sheen observed, water color noted as clear.

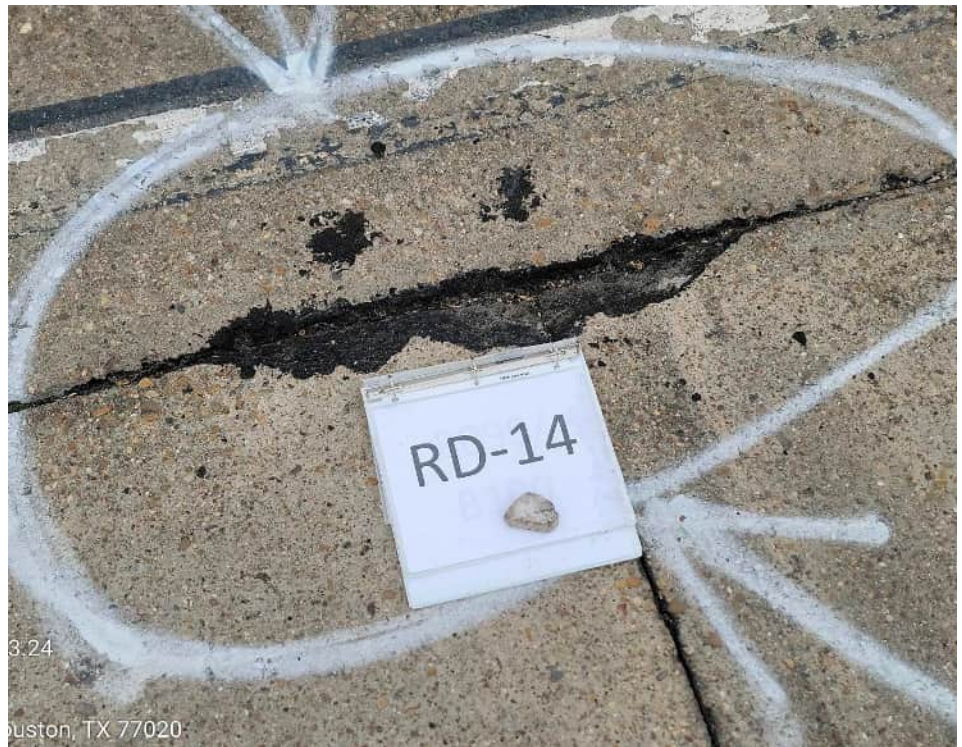
Photo No.
36

RD-14 Seep location observed within the concrete road area (RD-14) north of Track 802 (east of existing Track 802 seep location), no new tar-like material observed along a concrete joint.

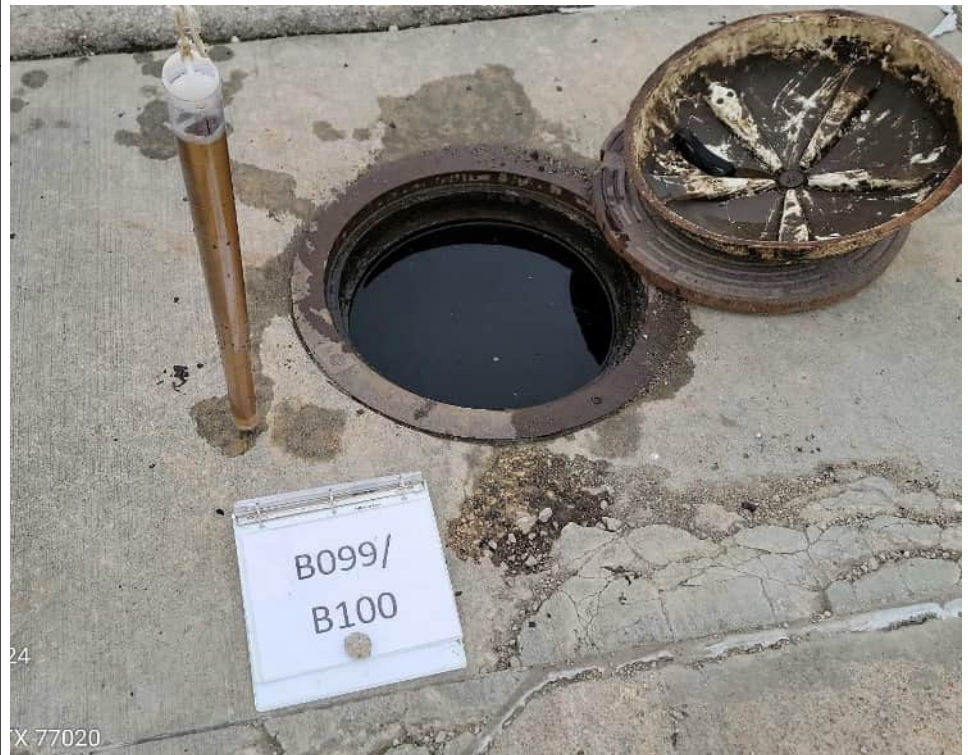
Photo No.
44

Sump 1 (B099/B100), 0 inches of freeboard in sump, no sheen observed, water color noted as light brown.

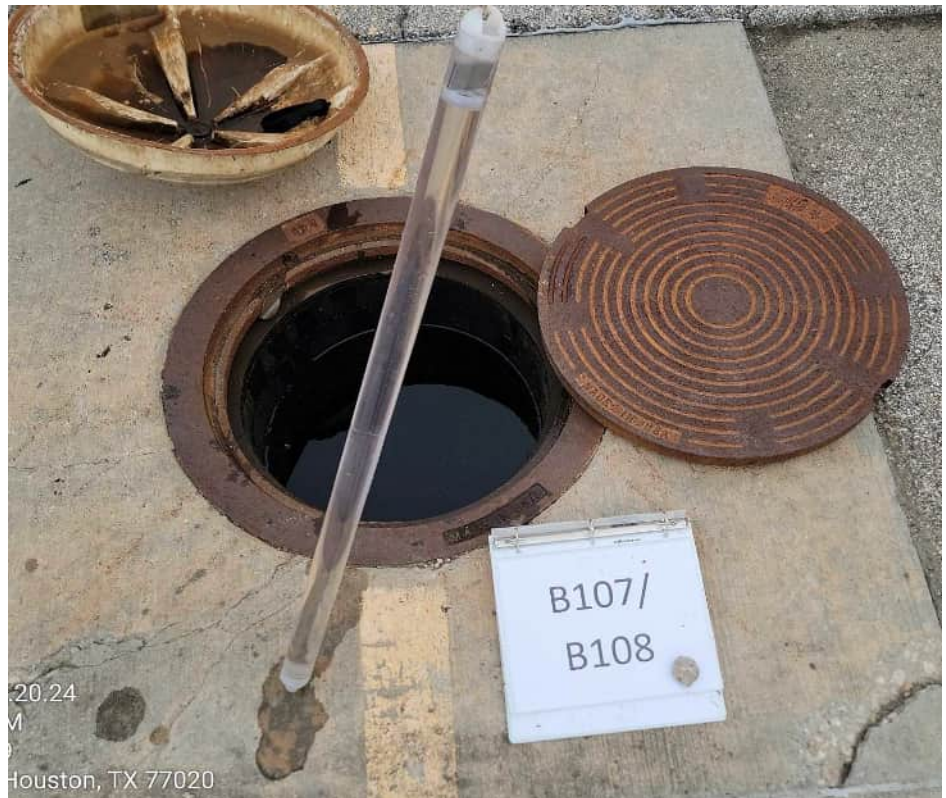
Photo No.
46

Sump 3 (B107/B108), 7.5 inches of freeboard in sump, no sheen observed, water color noted as clear.

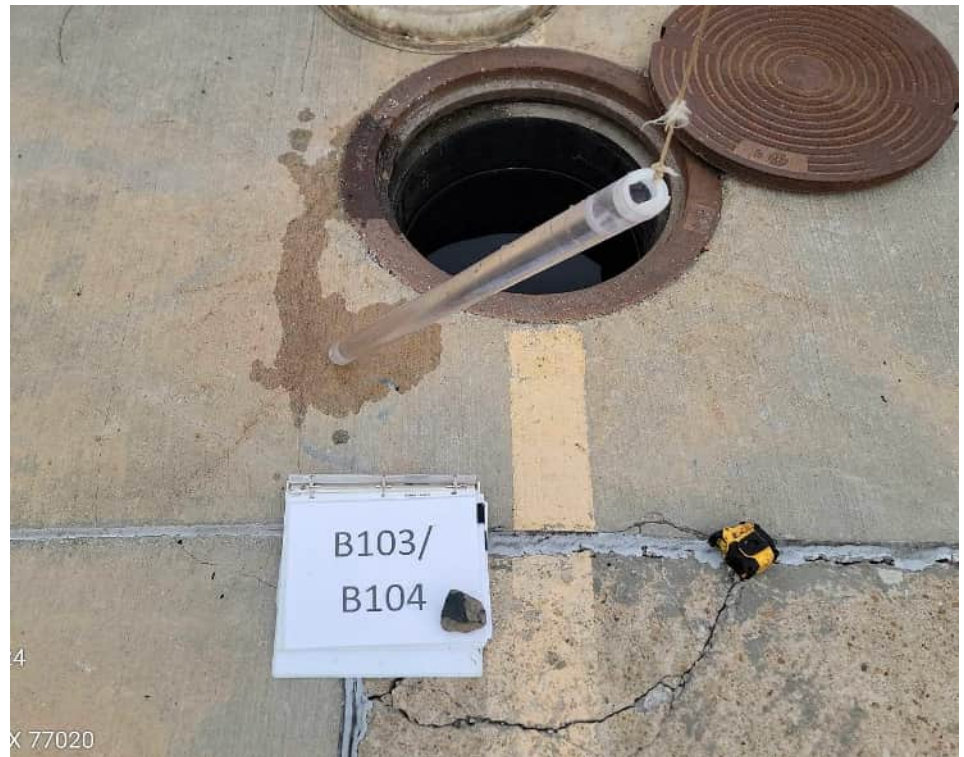
Photo No.
68

Sump 2 (B103/B104), 7 inches of freeboard in sump. No odor or sheen observed, color noted as clear.

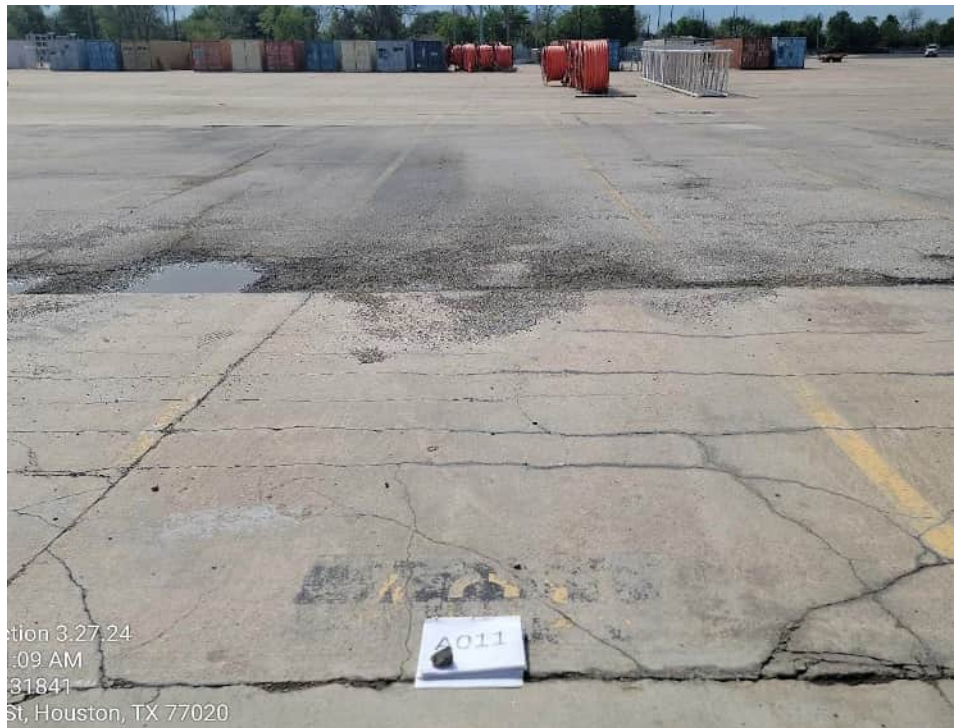
Photo No.
72

Stall A011. No new tar-like material observed at historical seep location along asphalt crack. Some staining observed along cracks in pavement.

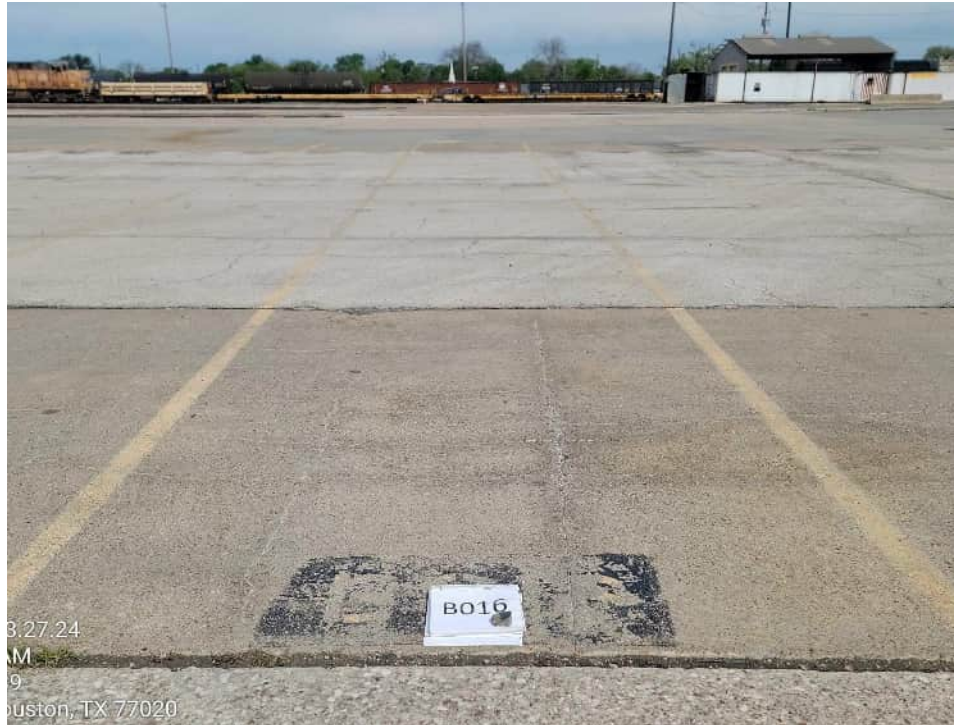
74

Stall B016. No tar-like material observed at historical seep location along asphalt crack.

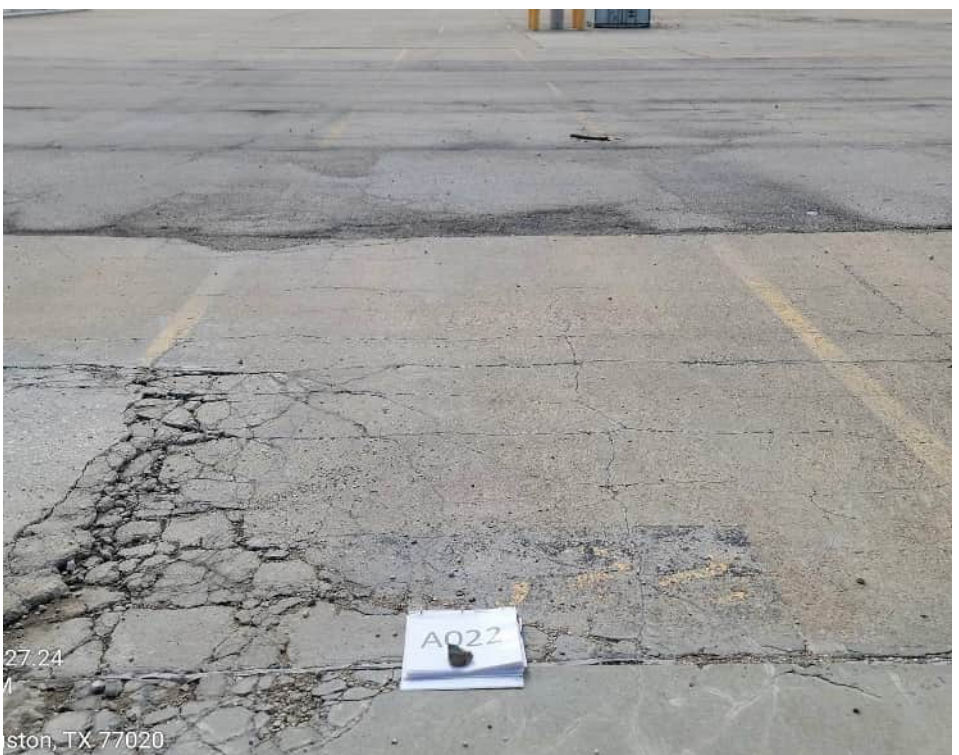
Stall A022, no new tar-like material observed at the seep location along the edge.

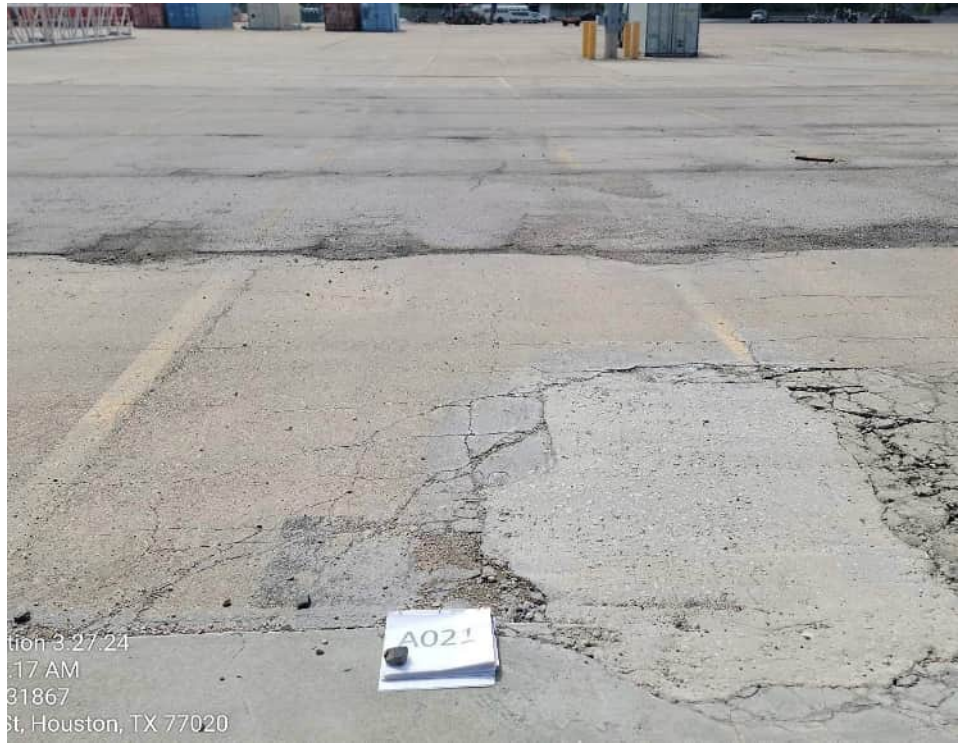
Photo No.
76

Stall A021. No seeps noted at Test Pit A021.

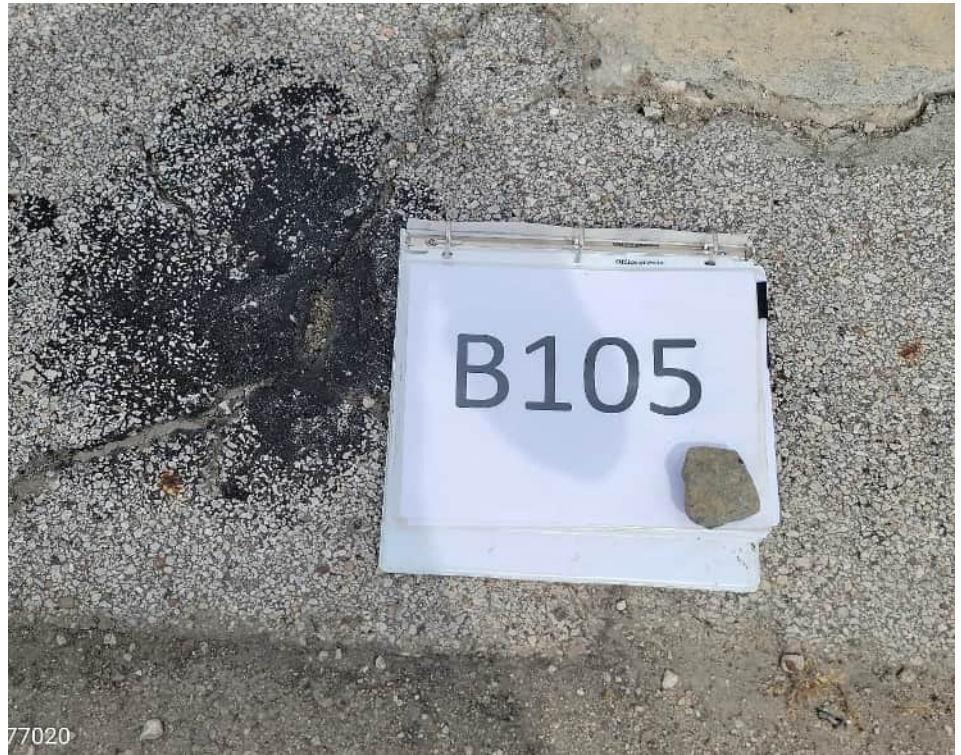
Photo No.
80

Stall B105, no new tar-like material observed at the historical seep location along asphalt crack.

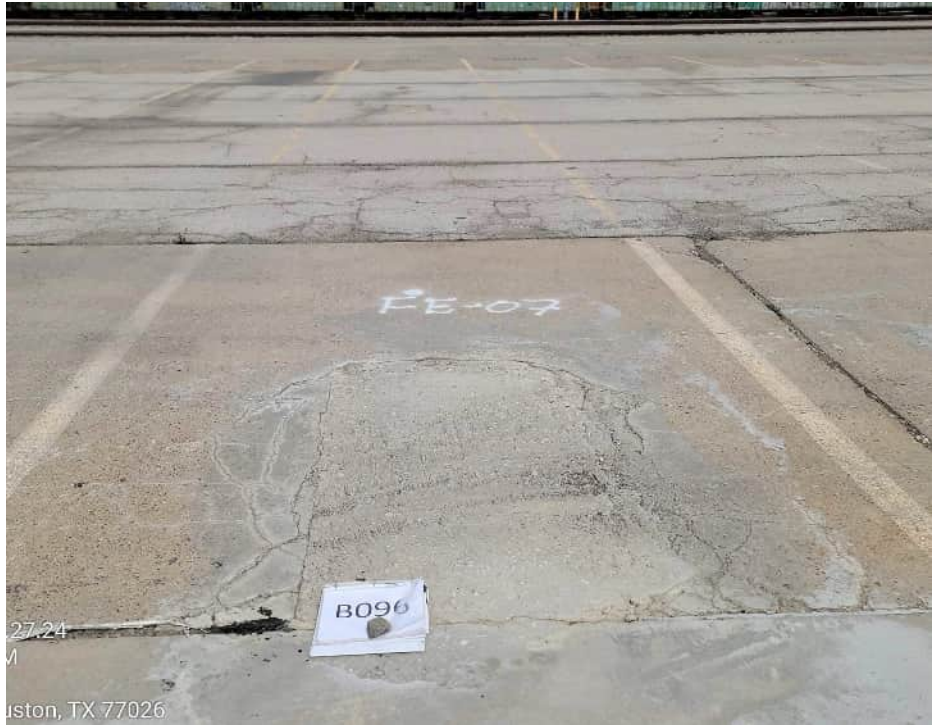
Photo No.
82

Stall B096, no new tar-like material observed at historical seep location along concrete joint next to Test Pit B096.

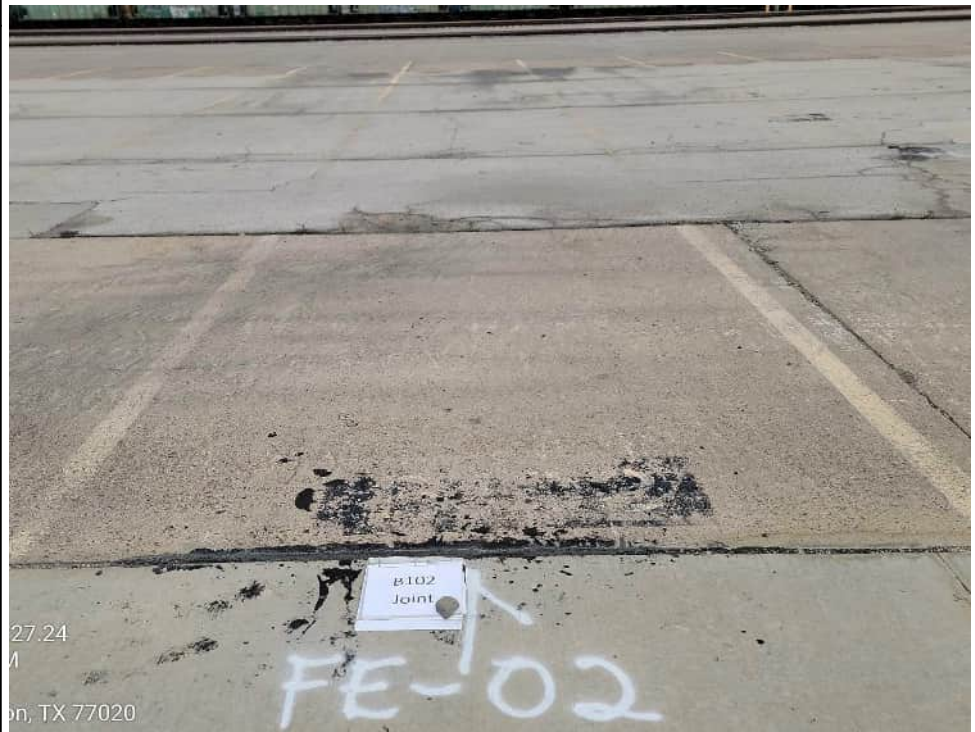
Photo No.
84

Stall B102 Joint, no new tar-like material observed at seep location along stall joint.
