May 15, 2024

Project No. 31406585.016

Re: **MONTHLY STATUS UPDATE – ENGLEWOOD INTERMODAL YARD – NAPL COLLECTION
SYSTEM/CONCRETE CAP REPAIRS/REVISED INTERIM MEASURES WORK PLAN CONSTRUCTION
ACTIVITIES
UNION PACIFIC RAILROAD HOUSTON WOOD PRESERVING WORKS FACILITY
4910 LIBERTY ROAD FACILITY, HOUSTON, TEXAS
POST-CLOSURE CARE PERMIT NO. HW-50343; INDUSTRIAL SWR NO. 31547**

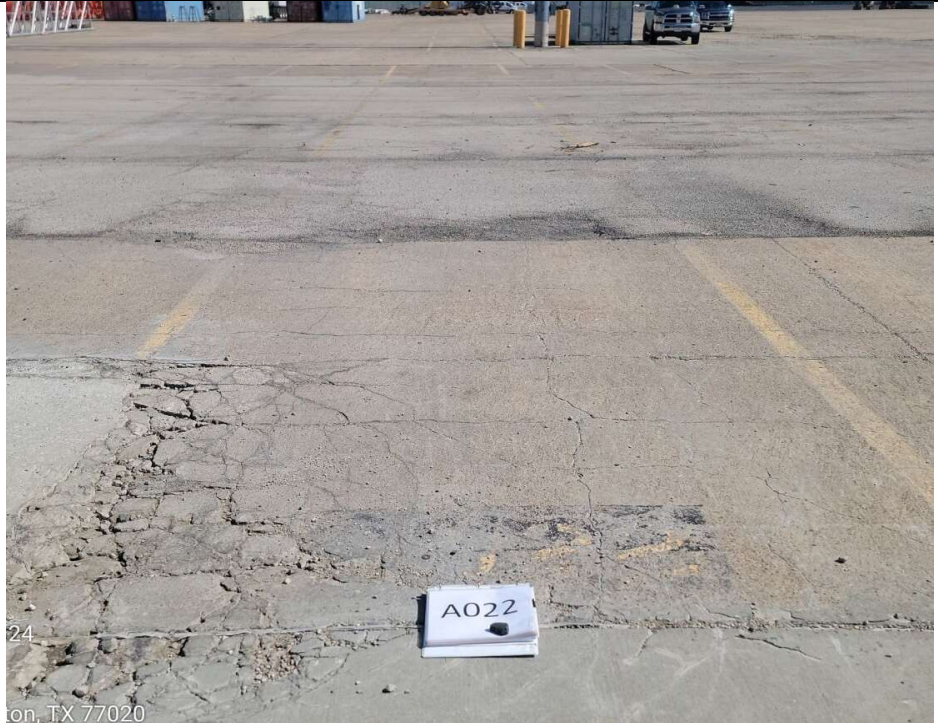
Stall A022. No tar-like material observed at Test Pit A022 location.

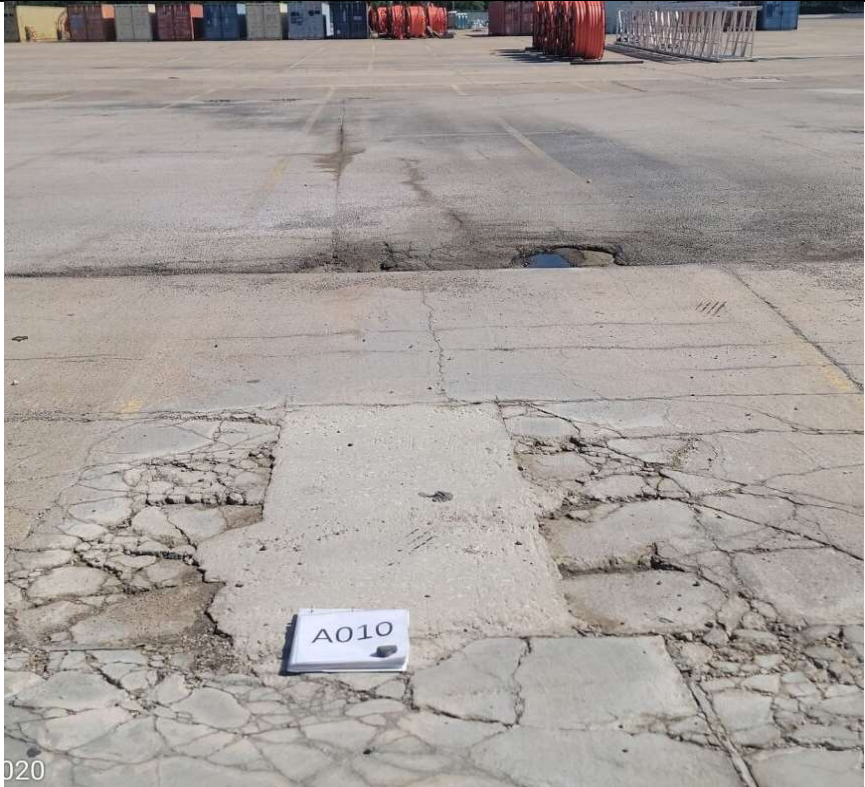
Photo No.
4

Stall A010. No tar-like material observed at Test Pit A010 location. Minimal seep water staining present in the cracks of the asphalt.

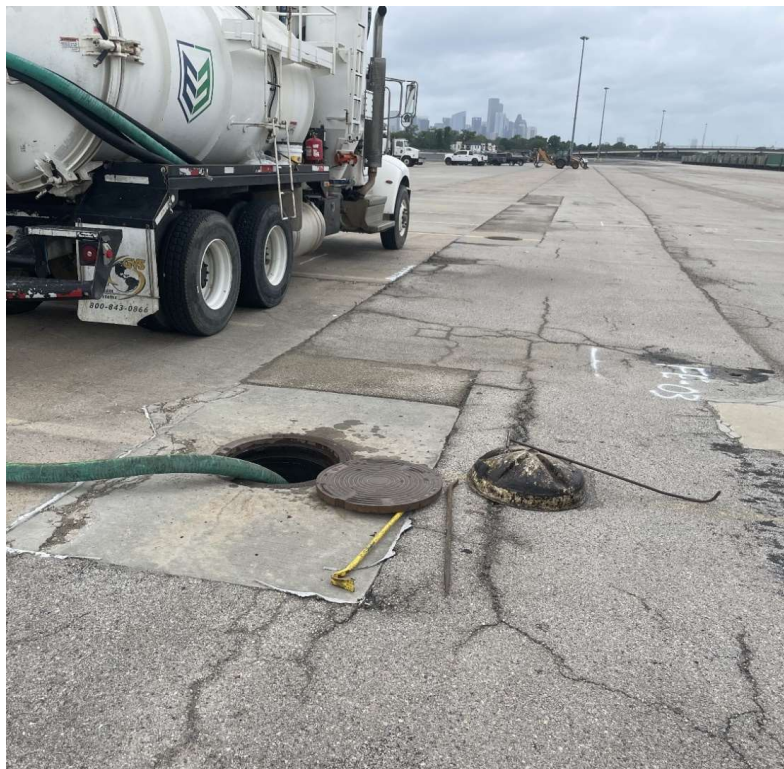
NAPL Collection System Water Pump Down
