November 15, 2024

Project No. 31406585.016

Re: **MONTHLY STATUS UPDATE – ENGLEWOOD INTERMODAL YARD – NAPL COLLECTION SYSTEM/CONCRETE CAP REPAIRS AND REVISED INTERIM MEASURES WORK PLAN CONSTRUCTION ACTIVITIES  
UNION PACIFIC RAILROAD HOUSTON WOOD PRESERVING WORKS FACILITY  
4910 LIBERTY ROAD FACILITY, HOUSTON, TEXAS  
POST-CLOSURE CARE PERMIT NO. HW-50343; INDUSTRIAL SWR NO. 31547**

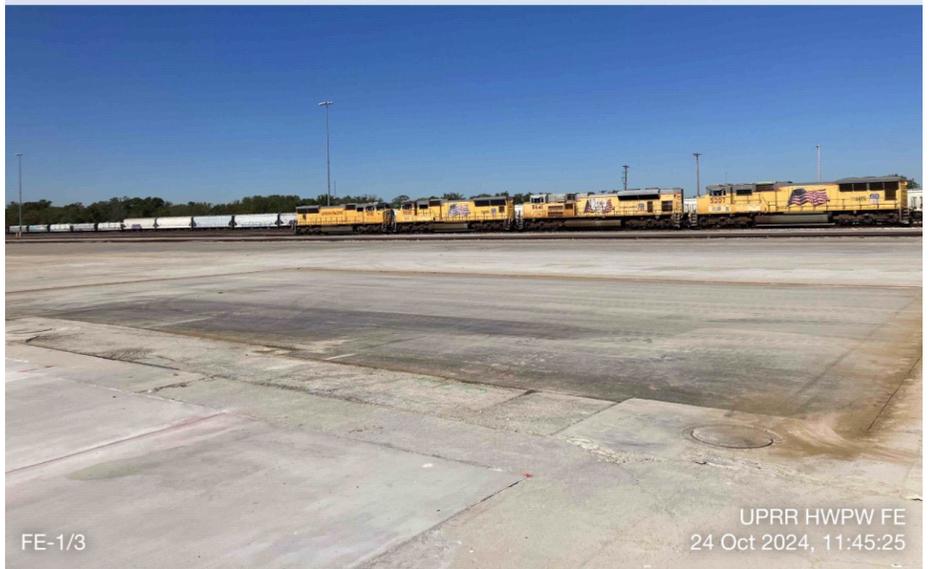
FE-1/3

**Description:**  
Finished cut joints for FE-1&3.

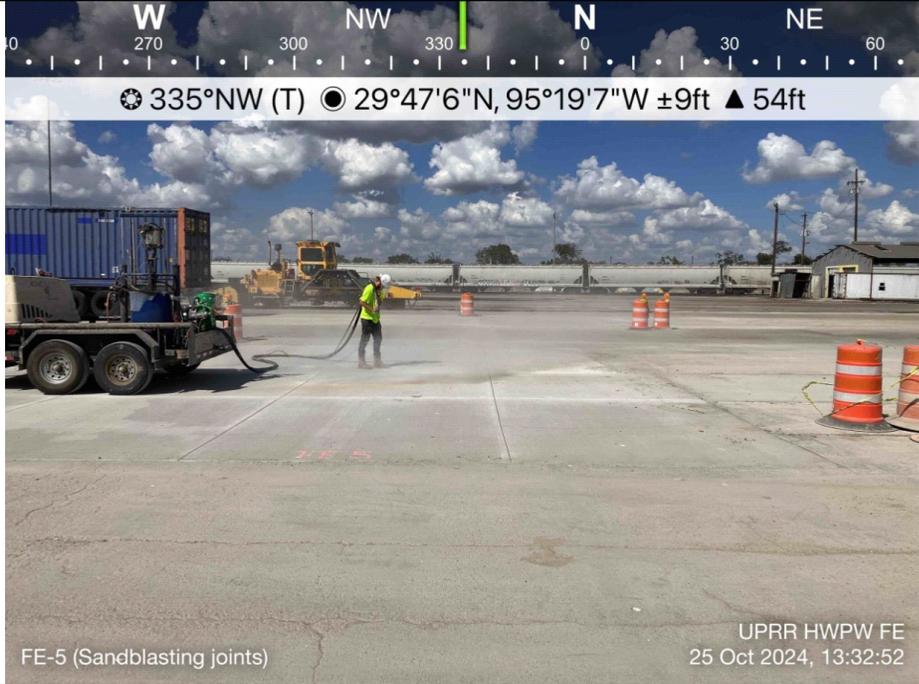
**Description:**  
Diamond Polish, Ashton's sealant contractor, sandblasted joints at FE-5.

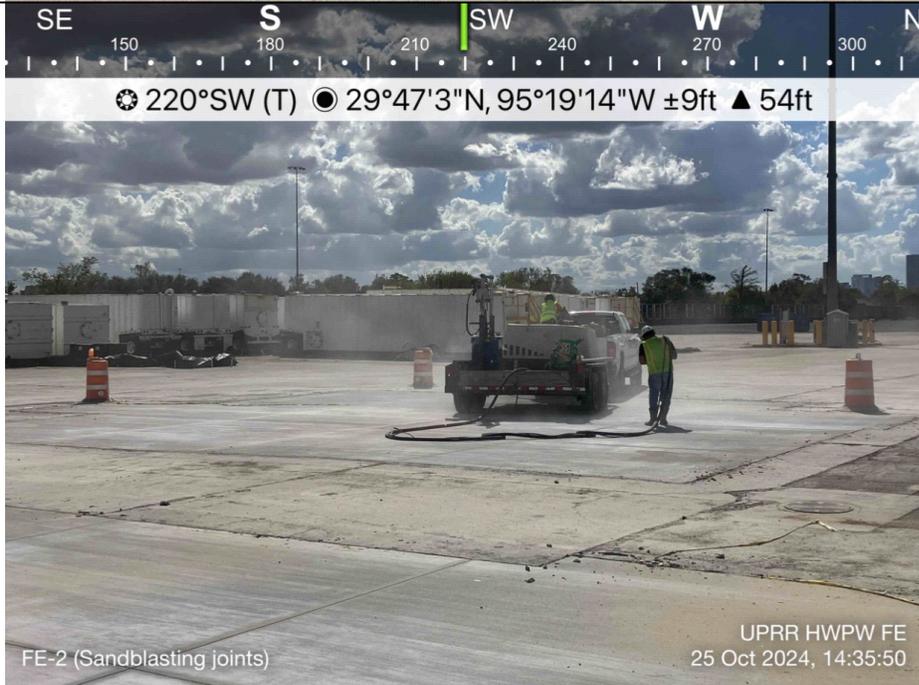
<b>Photo No.</b> <b>4</b>	<b>Inspection Date:</b> 10/25/2024
------------------------------	---------------------------------------

**Description:**  
Diamond Polish sandblasted joints at FE-2.

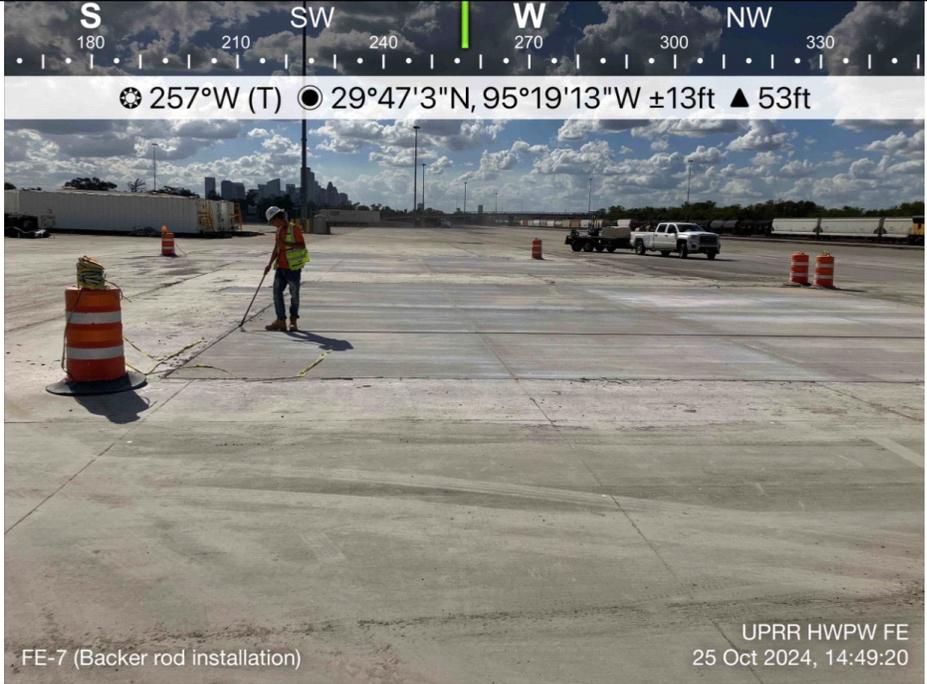
**Description:**  
Diamond Polish installed backer rod at FE-7.

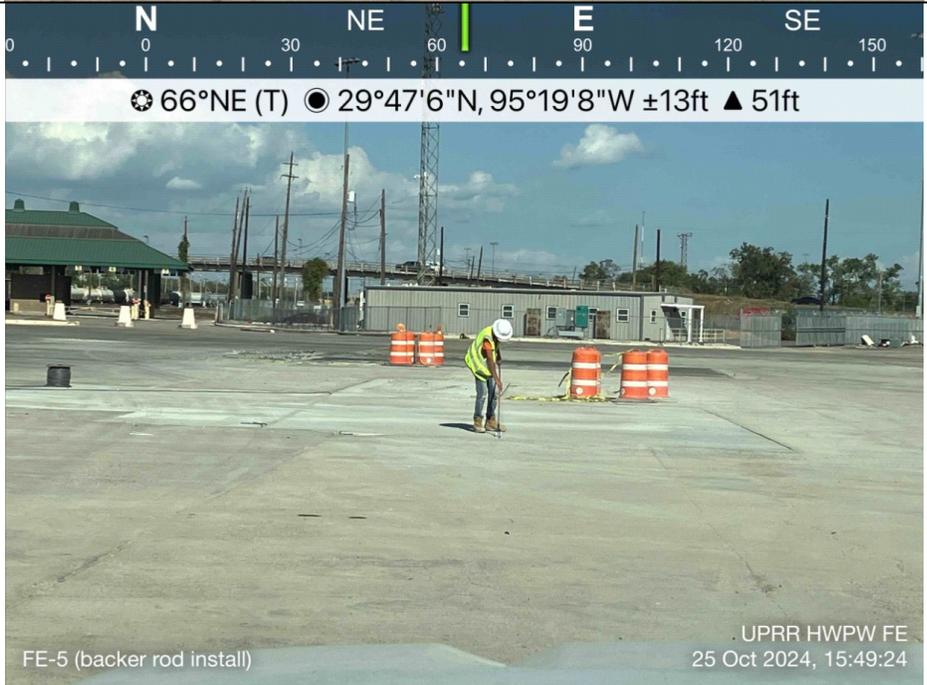
<b>Photo No.:</b> 6	<b>Inspection Date:</b> 10/25/2024
------------------------	---------------------------------------

**Description:**  
Diamond Polish installed backer rod at FE-5.

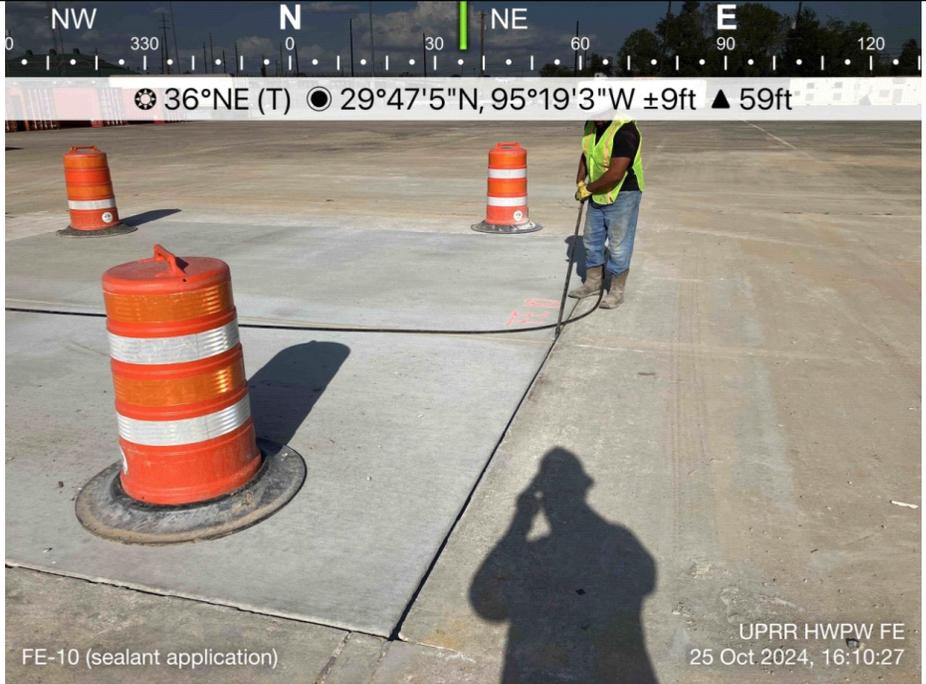
**Description:**  
Diamond Polish applying sealant to joints at FE-10.

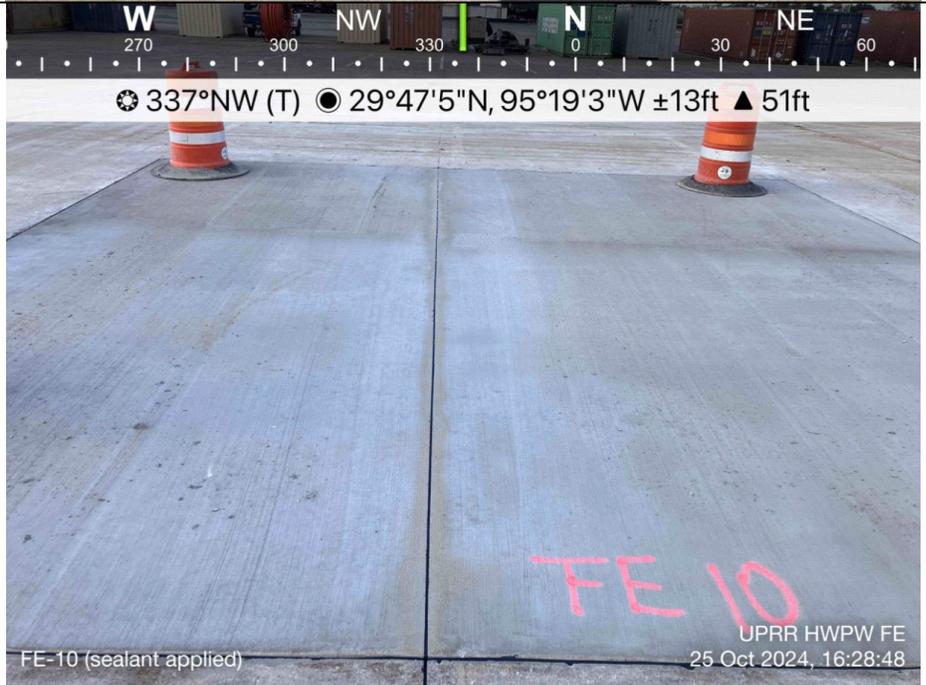
<b>Photo No.:</b> 10	<b>Inspection Date:</b> 10/25/2024
-------------------------	---------------------------------------

**Description:**  
Finished sealant on joints at FE-10.

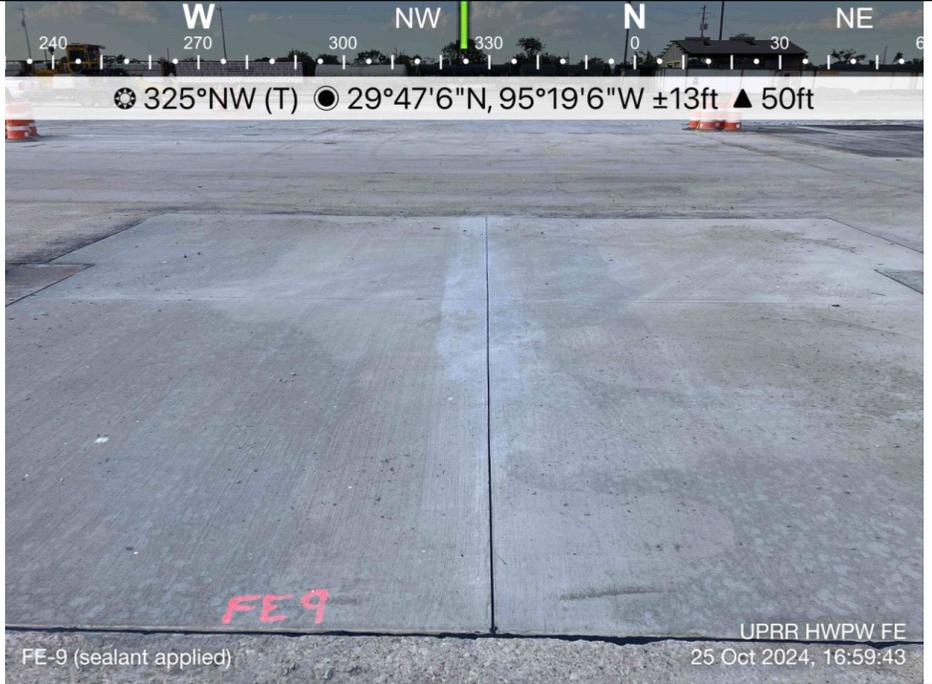
**Description:**  
Finished sealant on joints at FE-9.
